2017 Site Photos

Pre-condition report and project manager's first visit

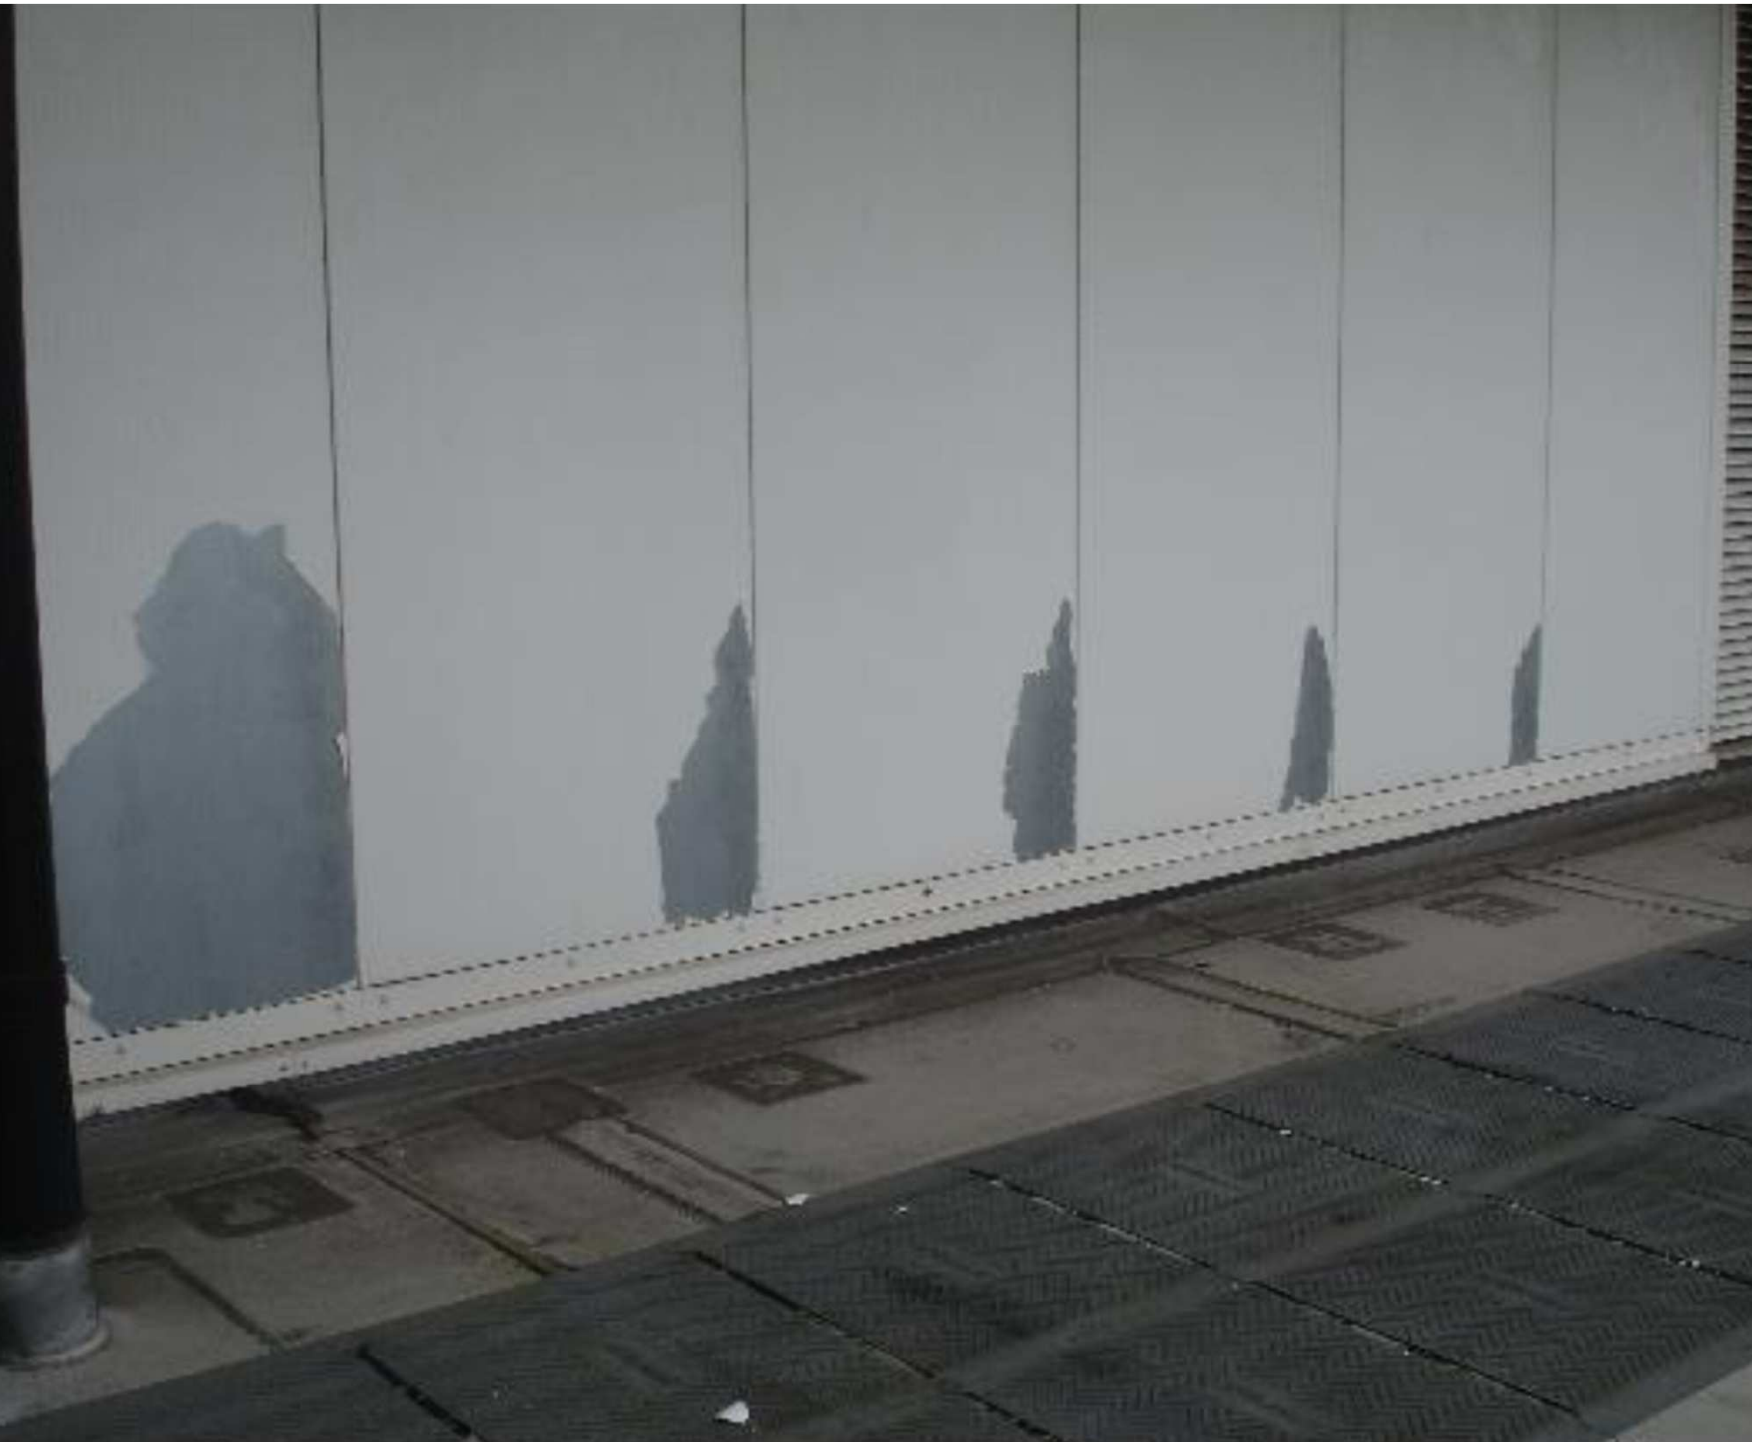
Weather
damage to
external
paintwork above
flat roofing

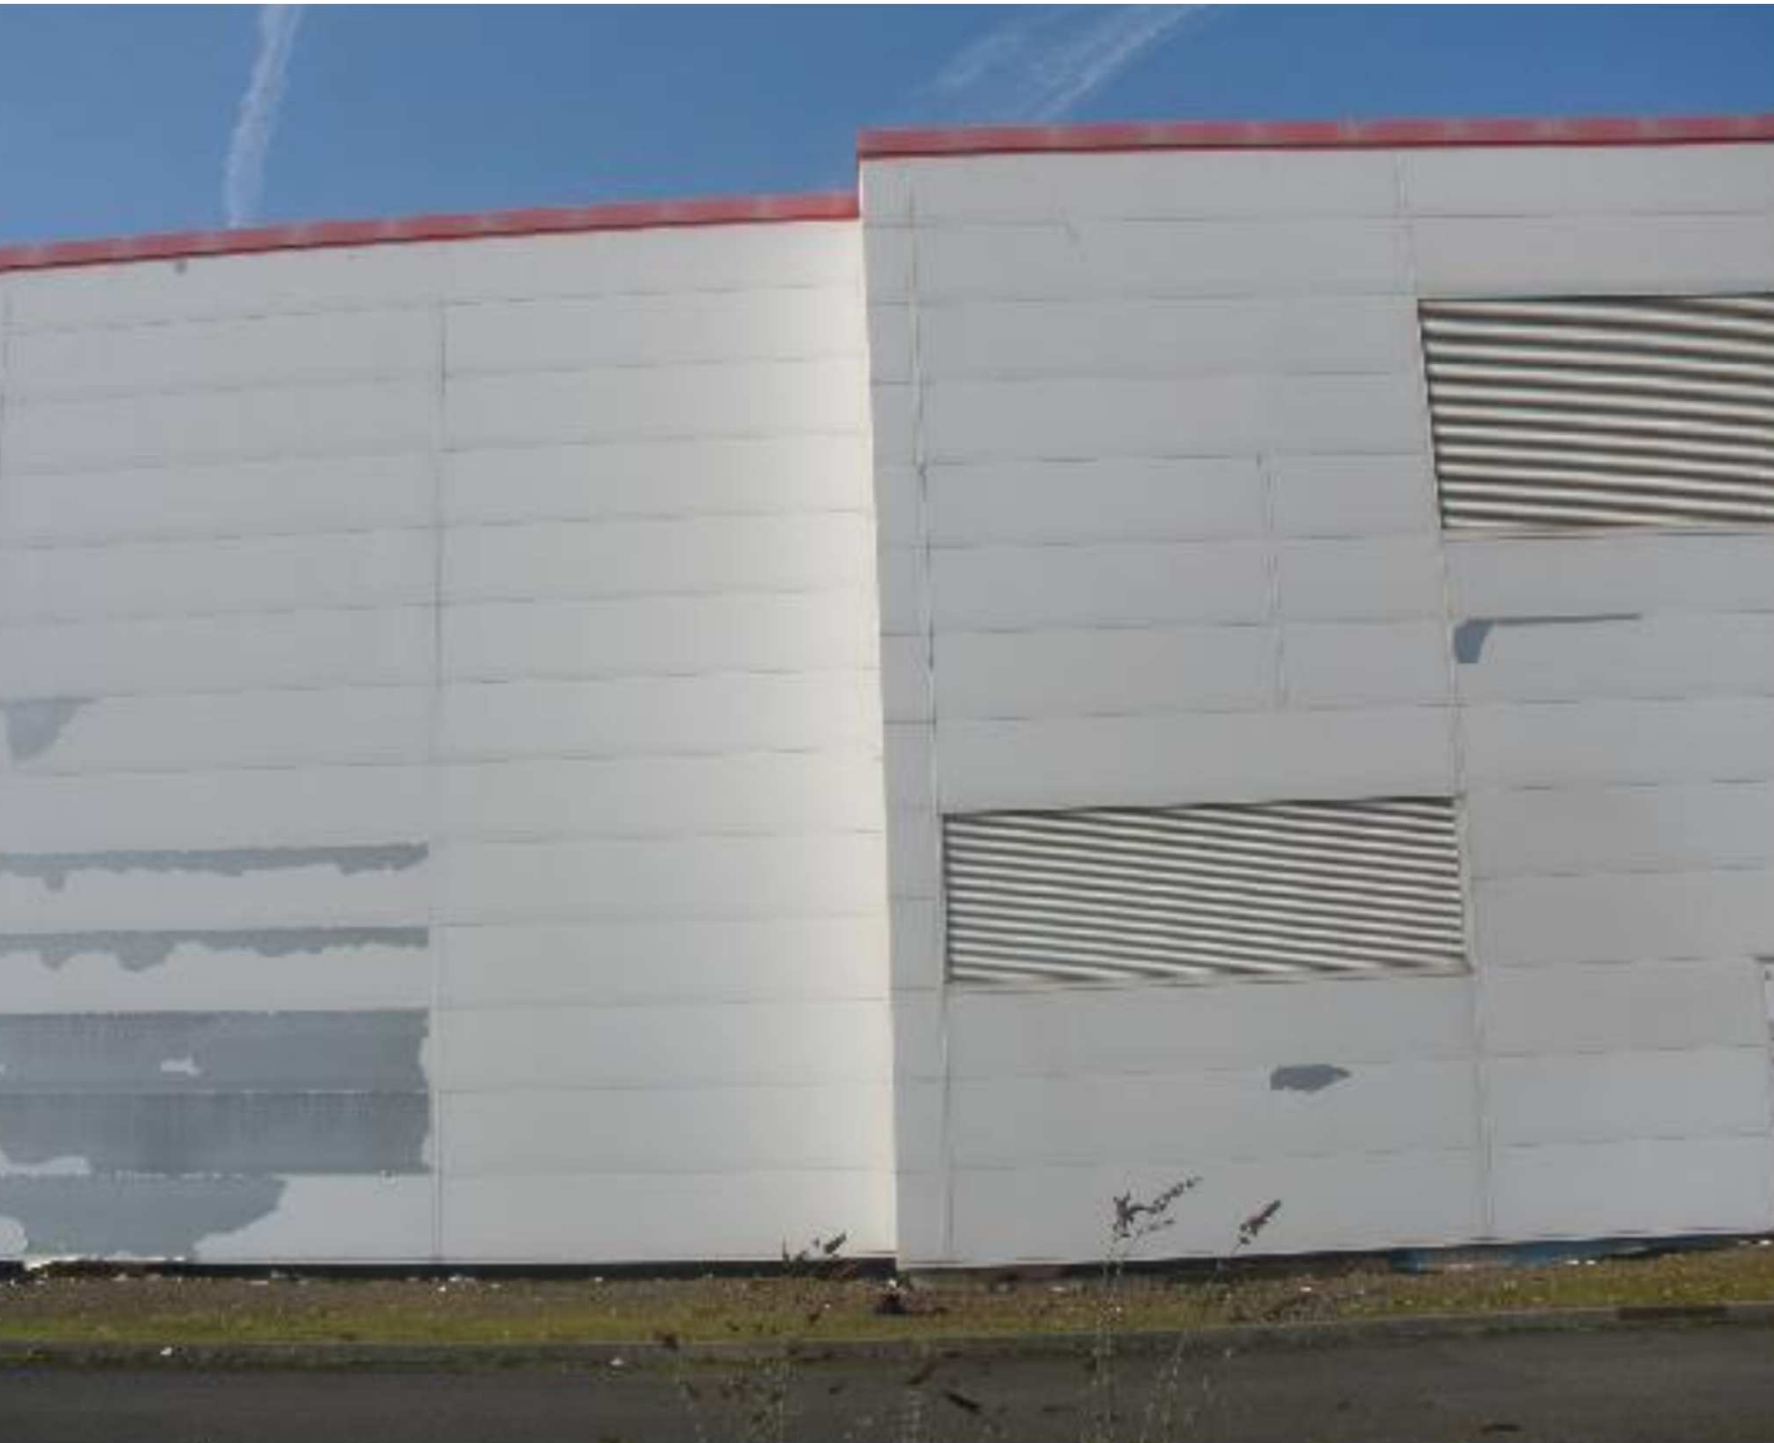
Weather
damage to
external
paintwork on t
side of the
building

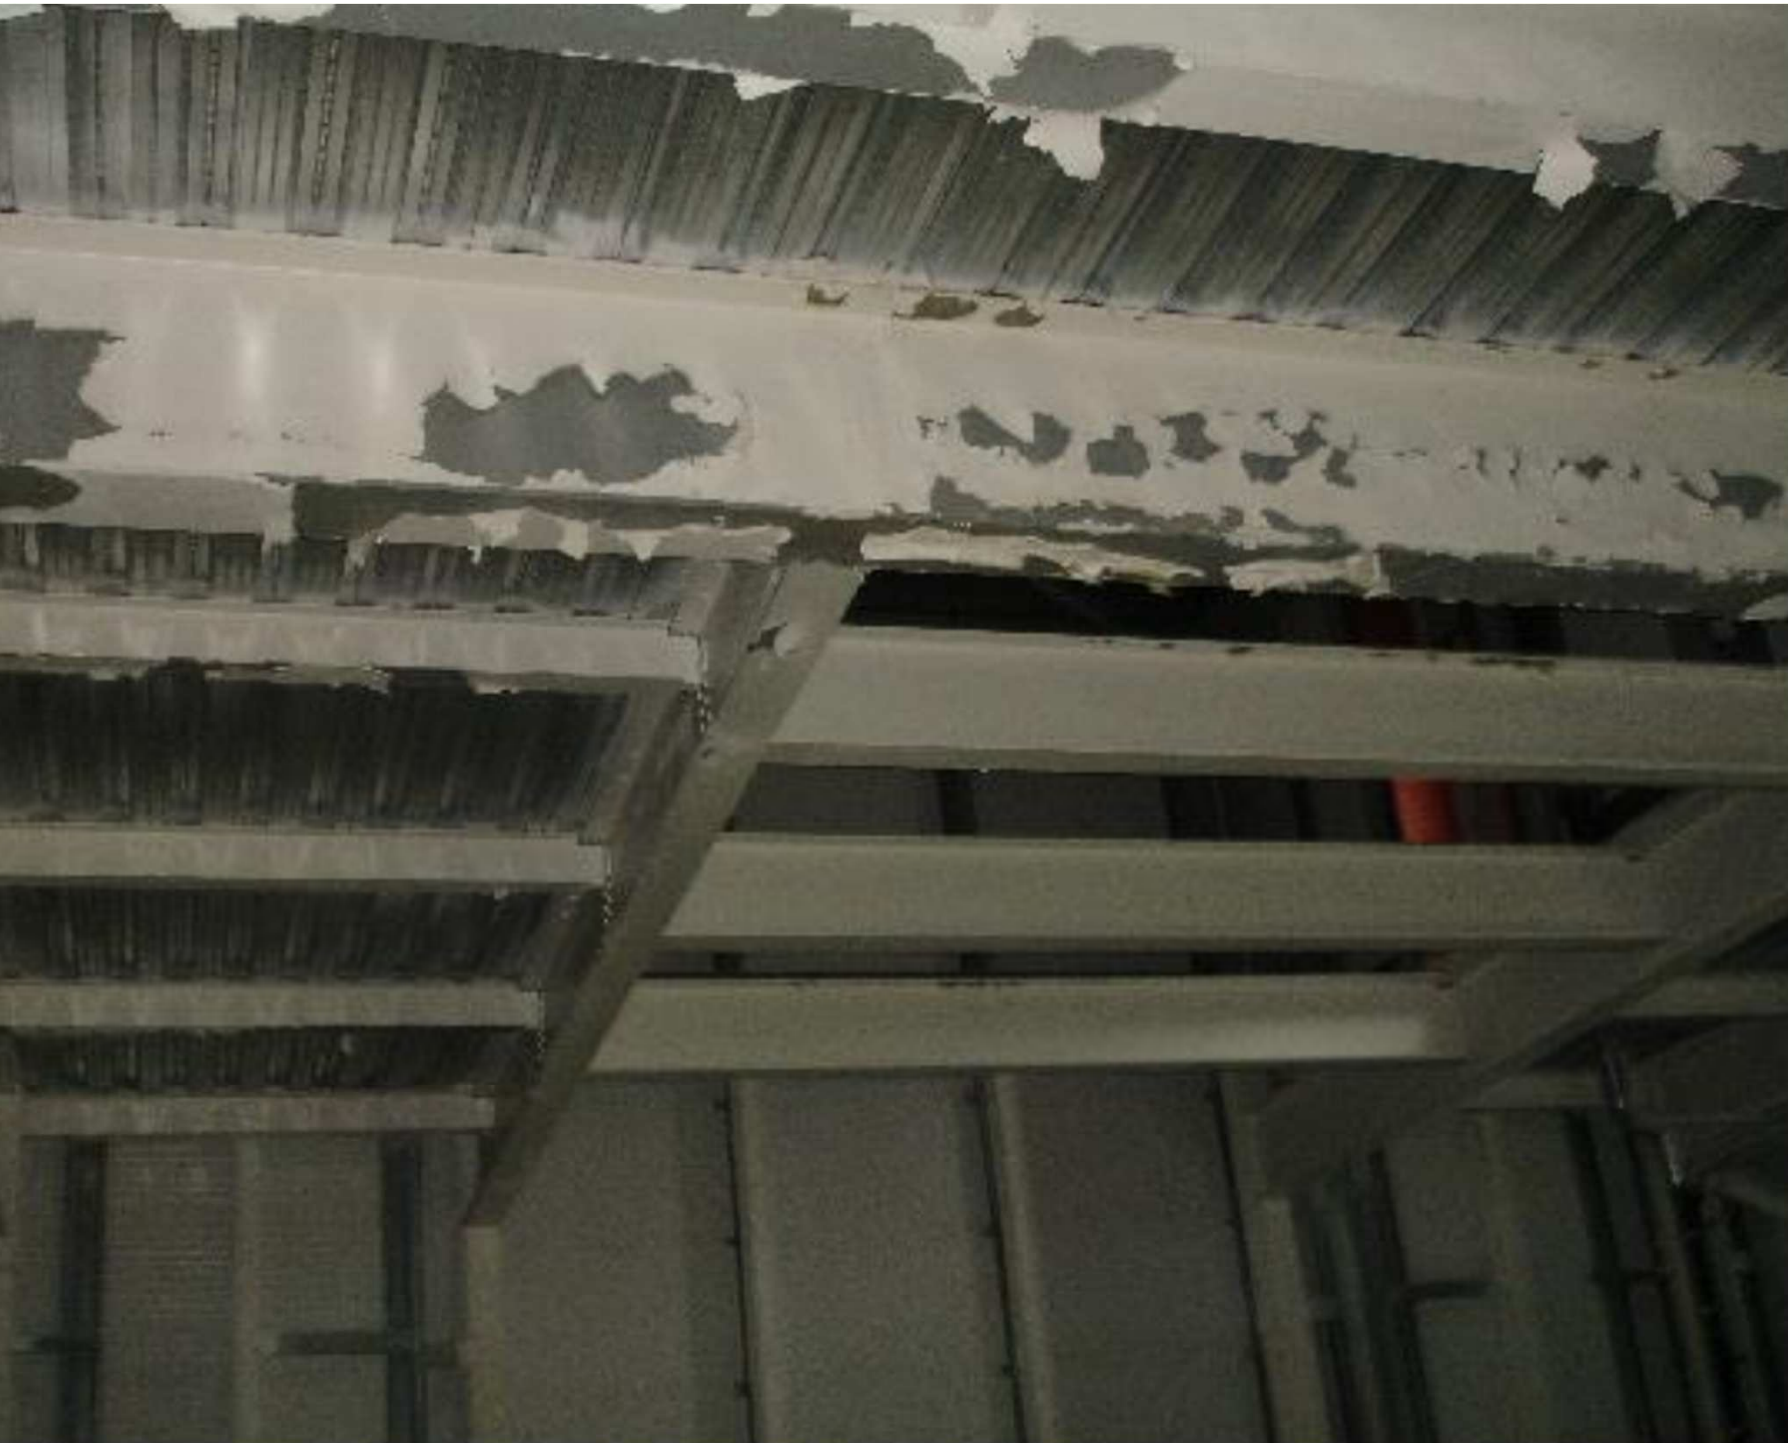
Defective
paintwork on
interior steel
frame

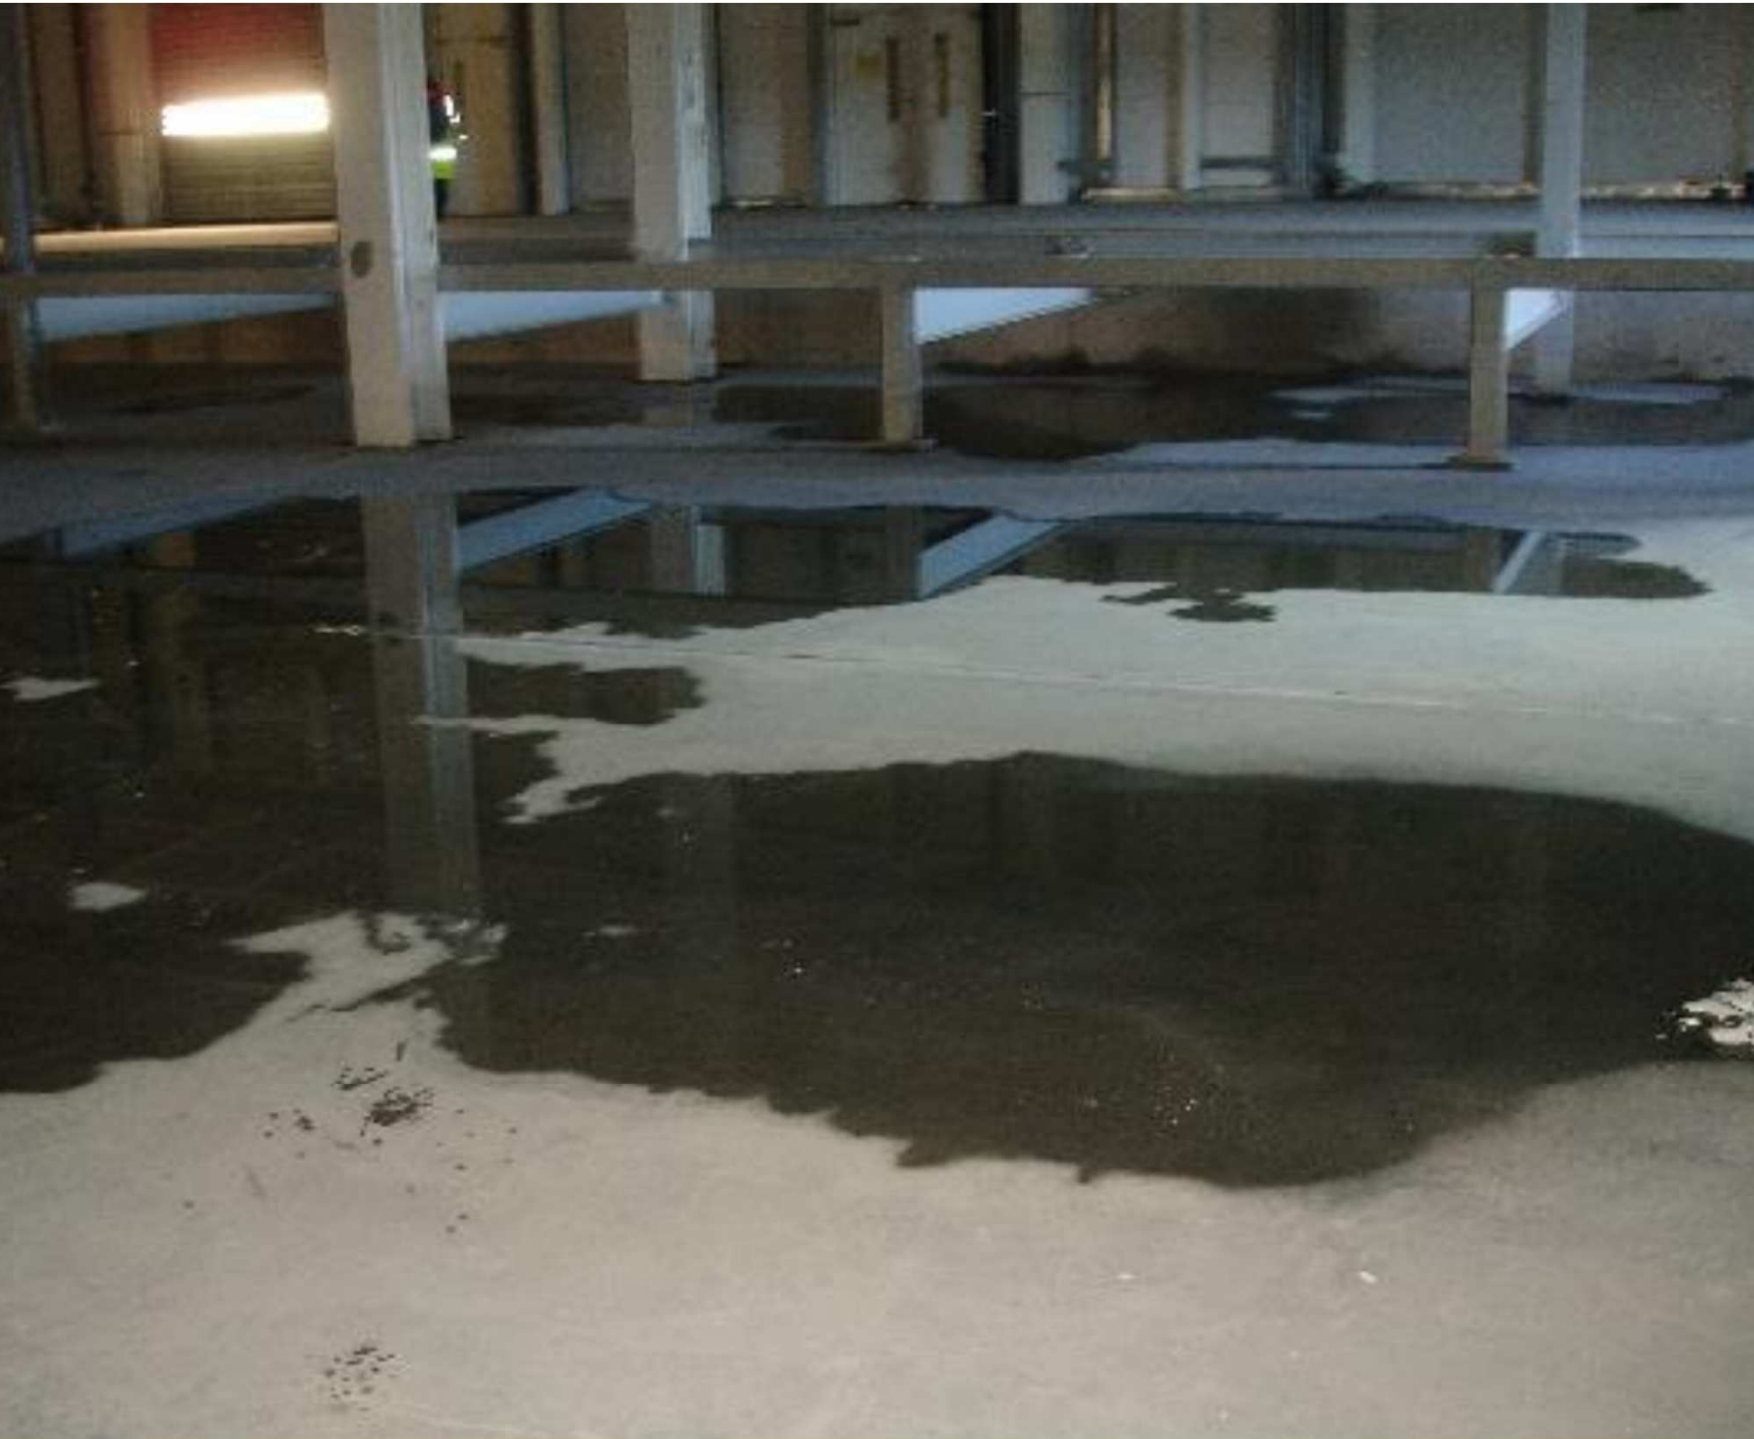
Pools of water
on internal
concrete floors
due to leaks in
the building

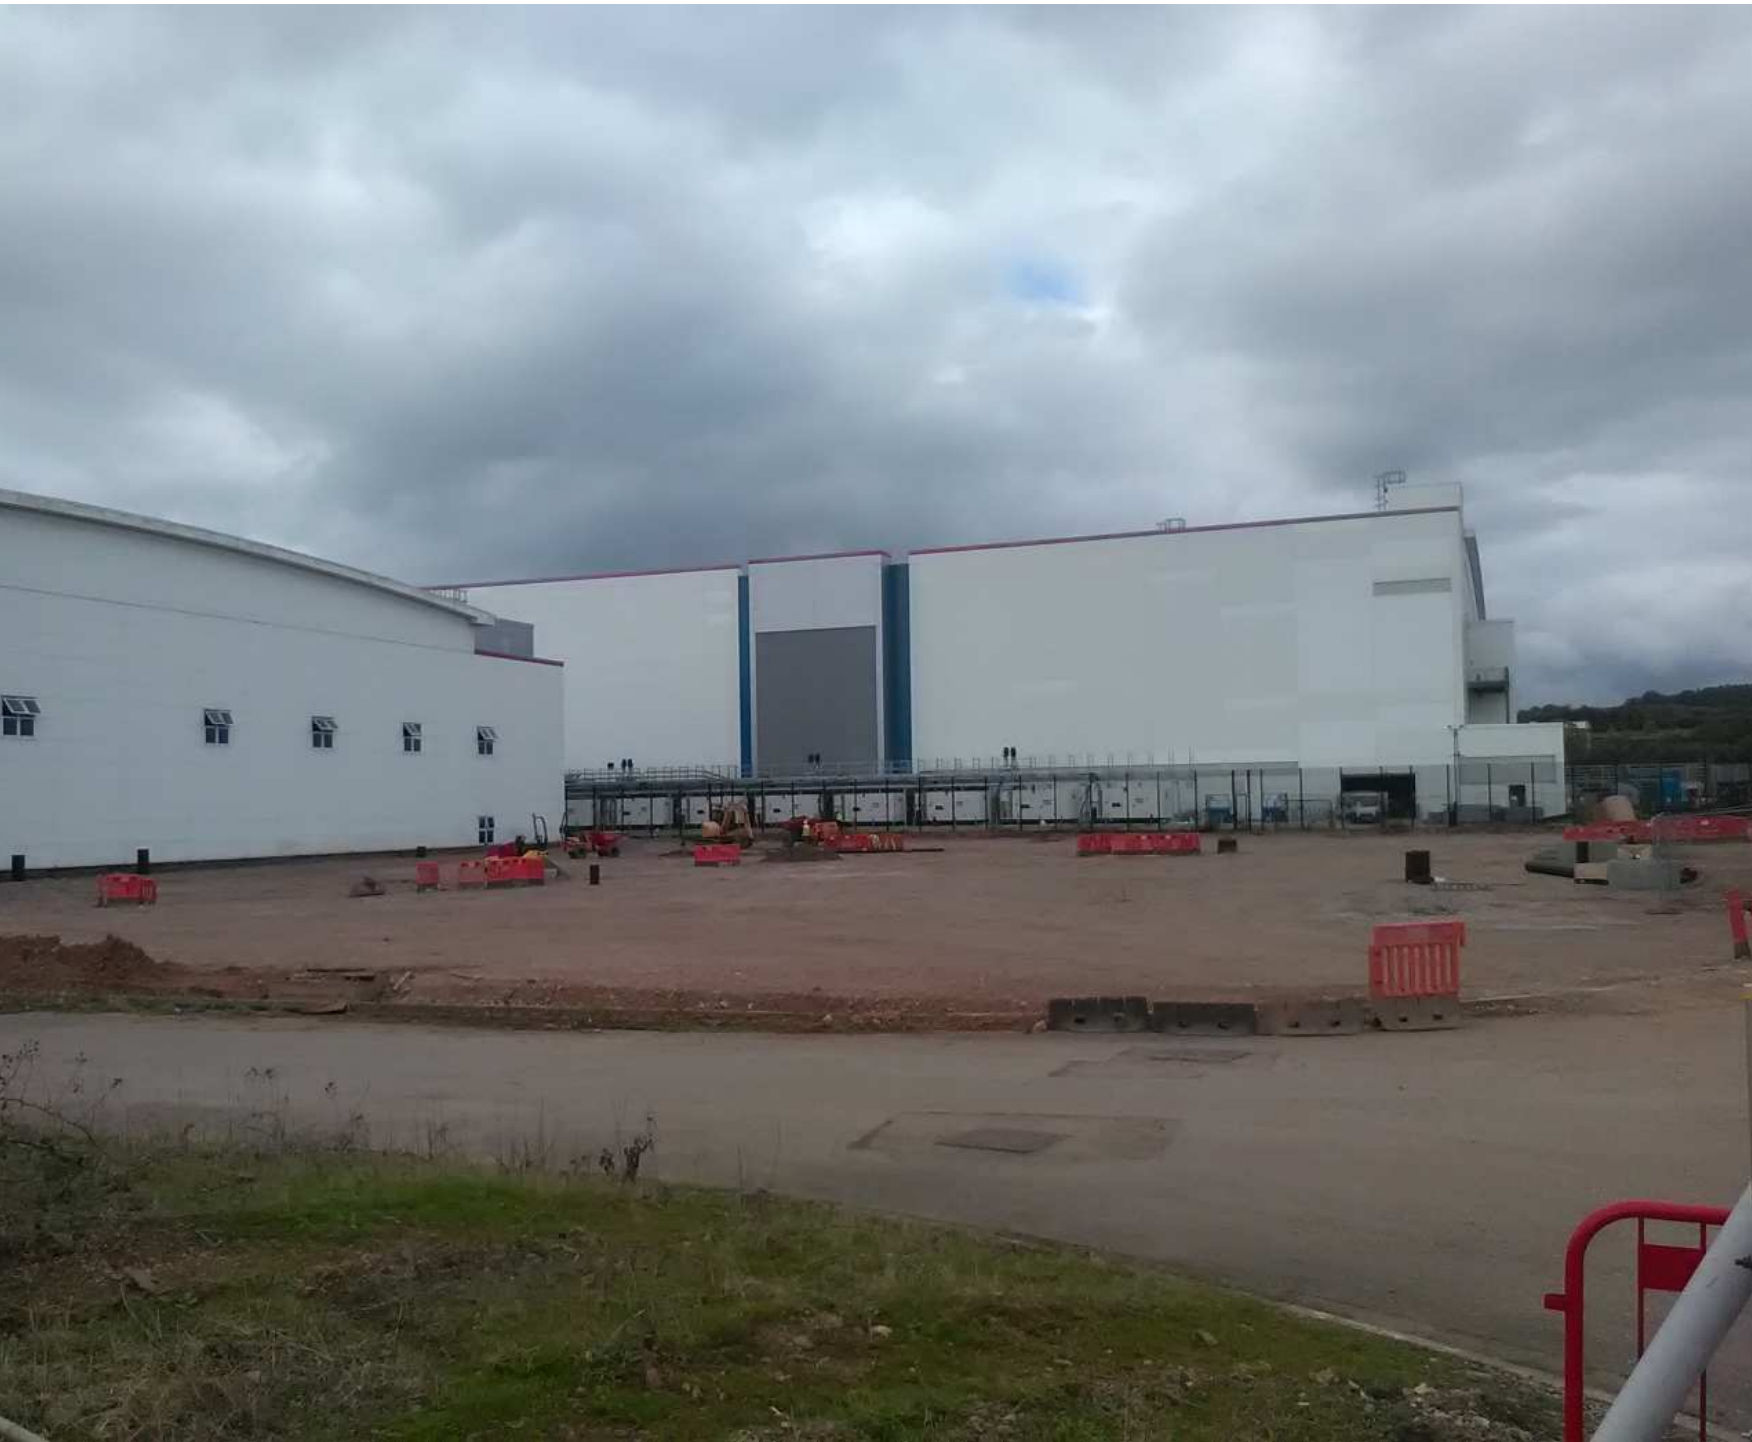
Rear of the building being prepared for significant groundworks to dig attenuation ponds for drainage, create car park, and build gas compound

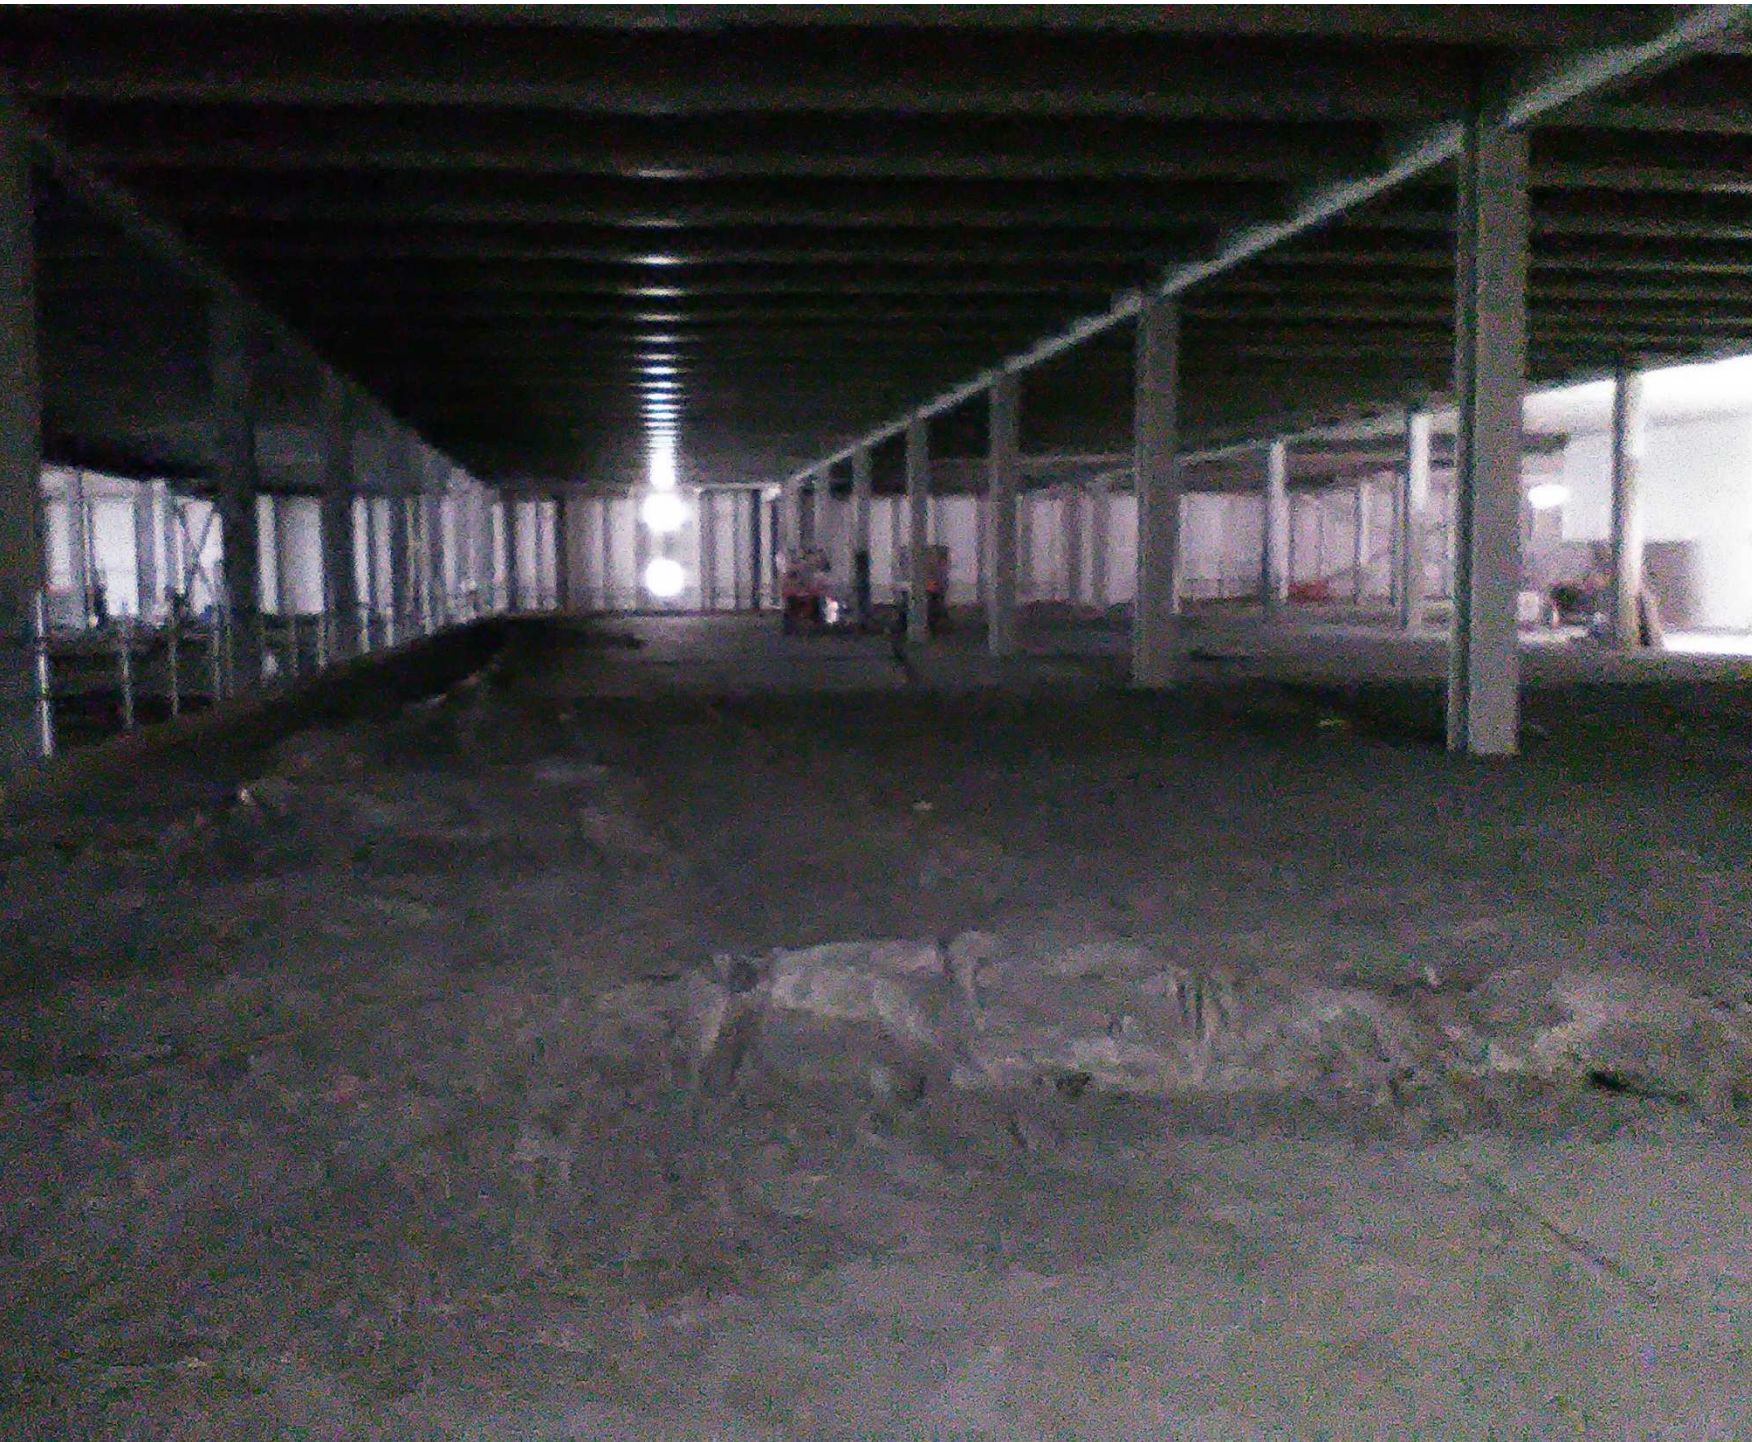
Interior before
the installation
of any stud
walling, wiring,
permanent
lighting or
stairwells

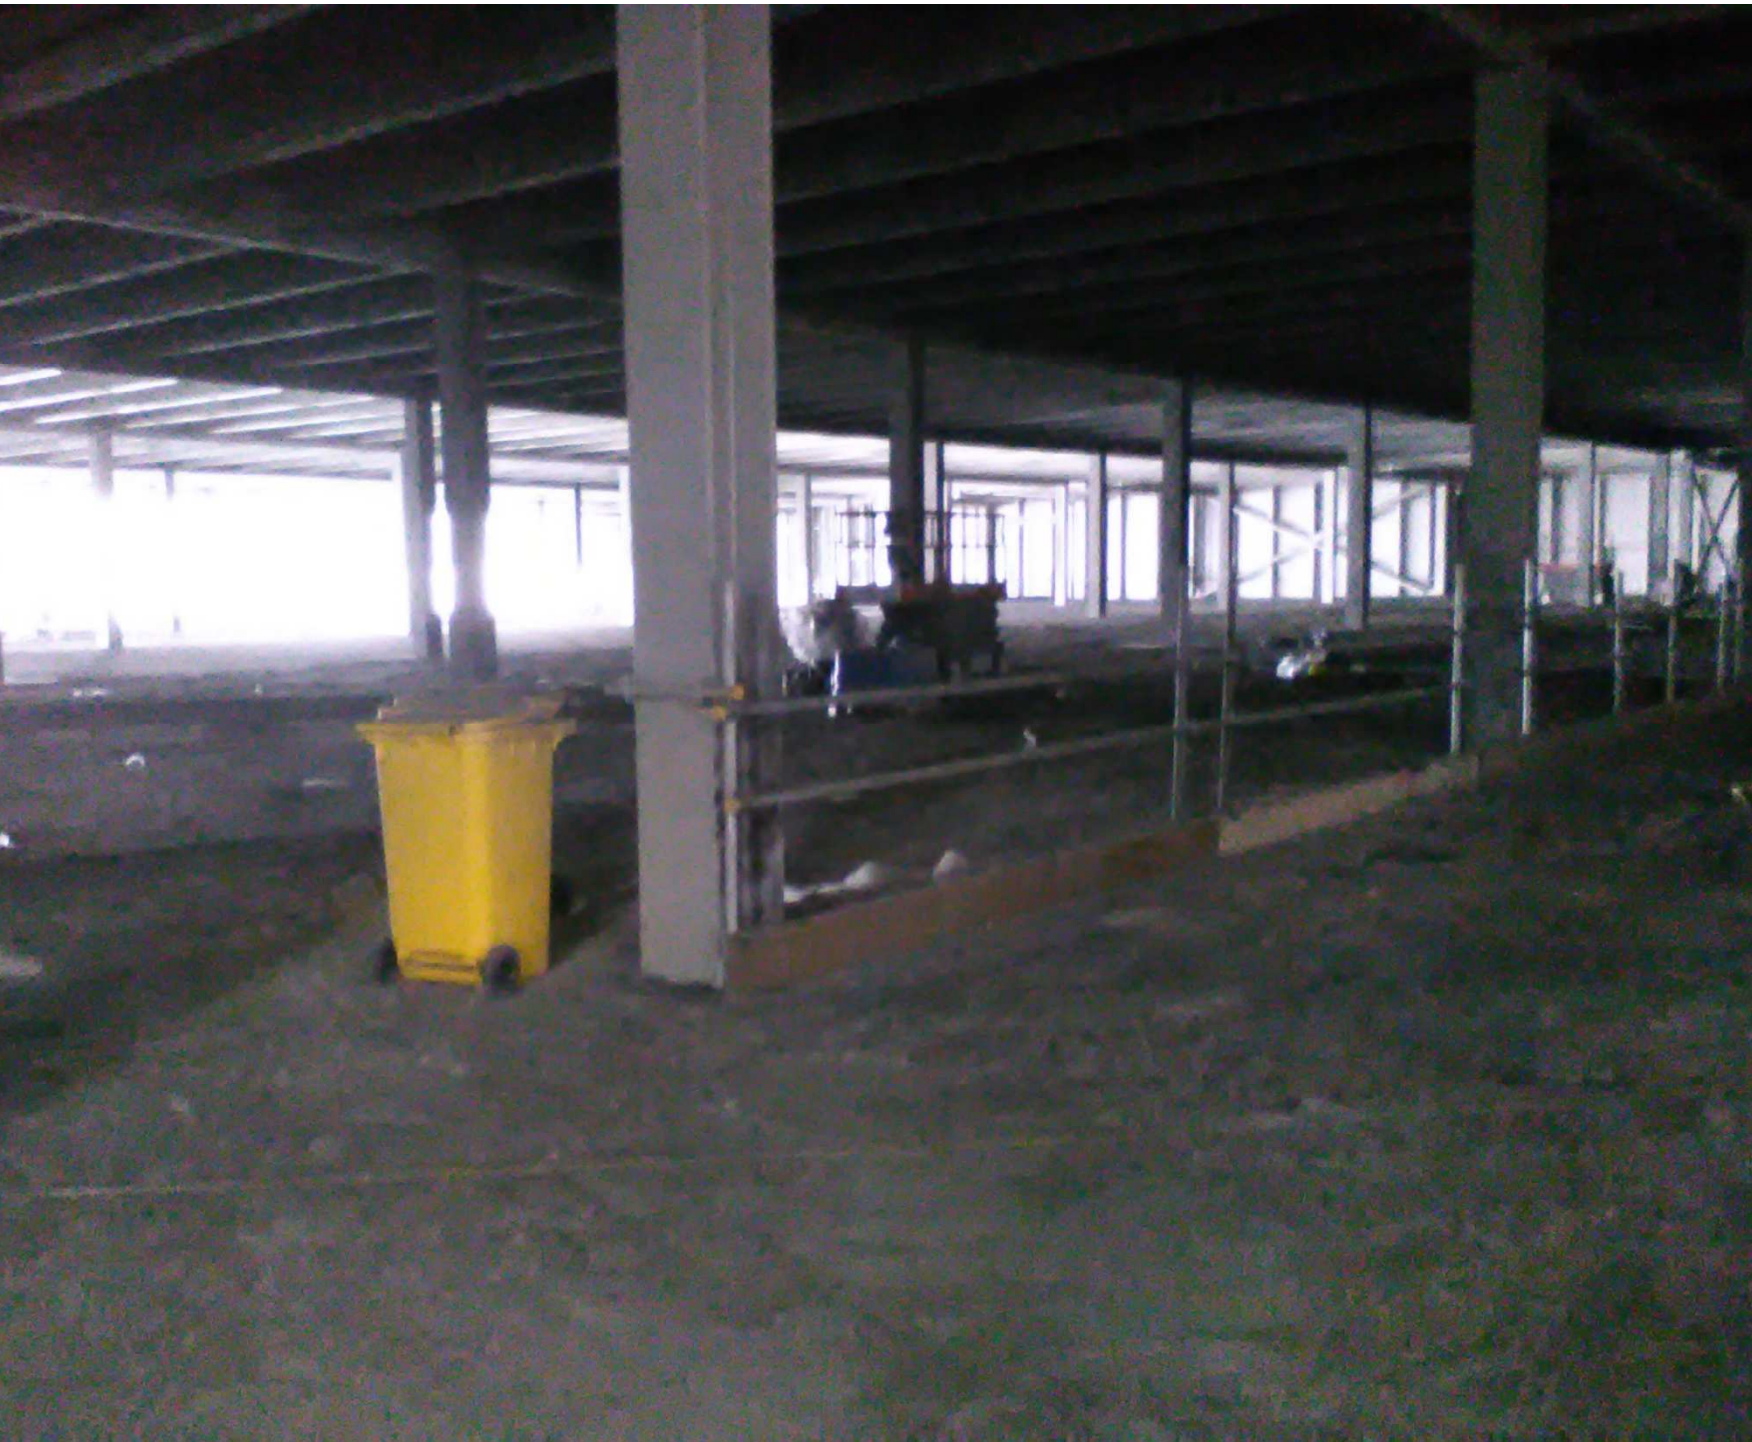
Interior of the building looking towards the front elevation prior to the refurbishing of the internal steel frame

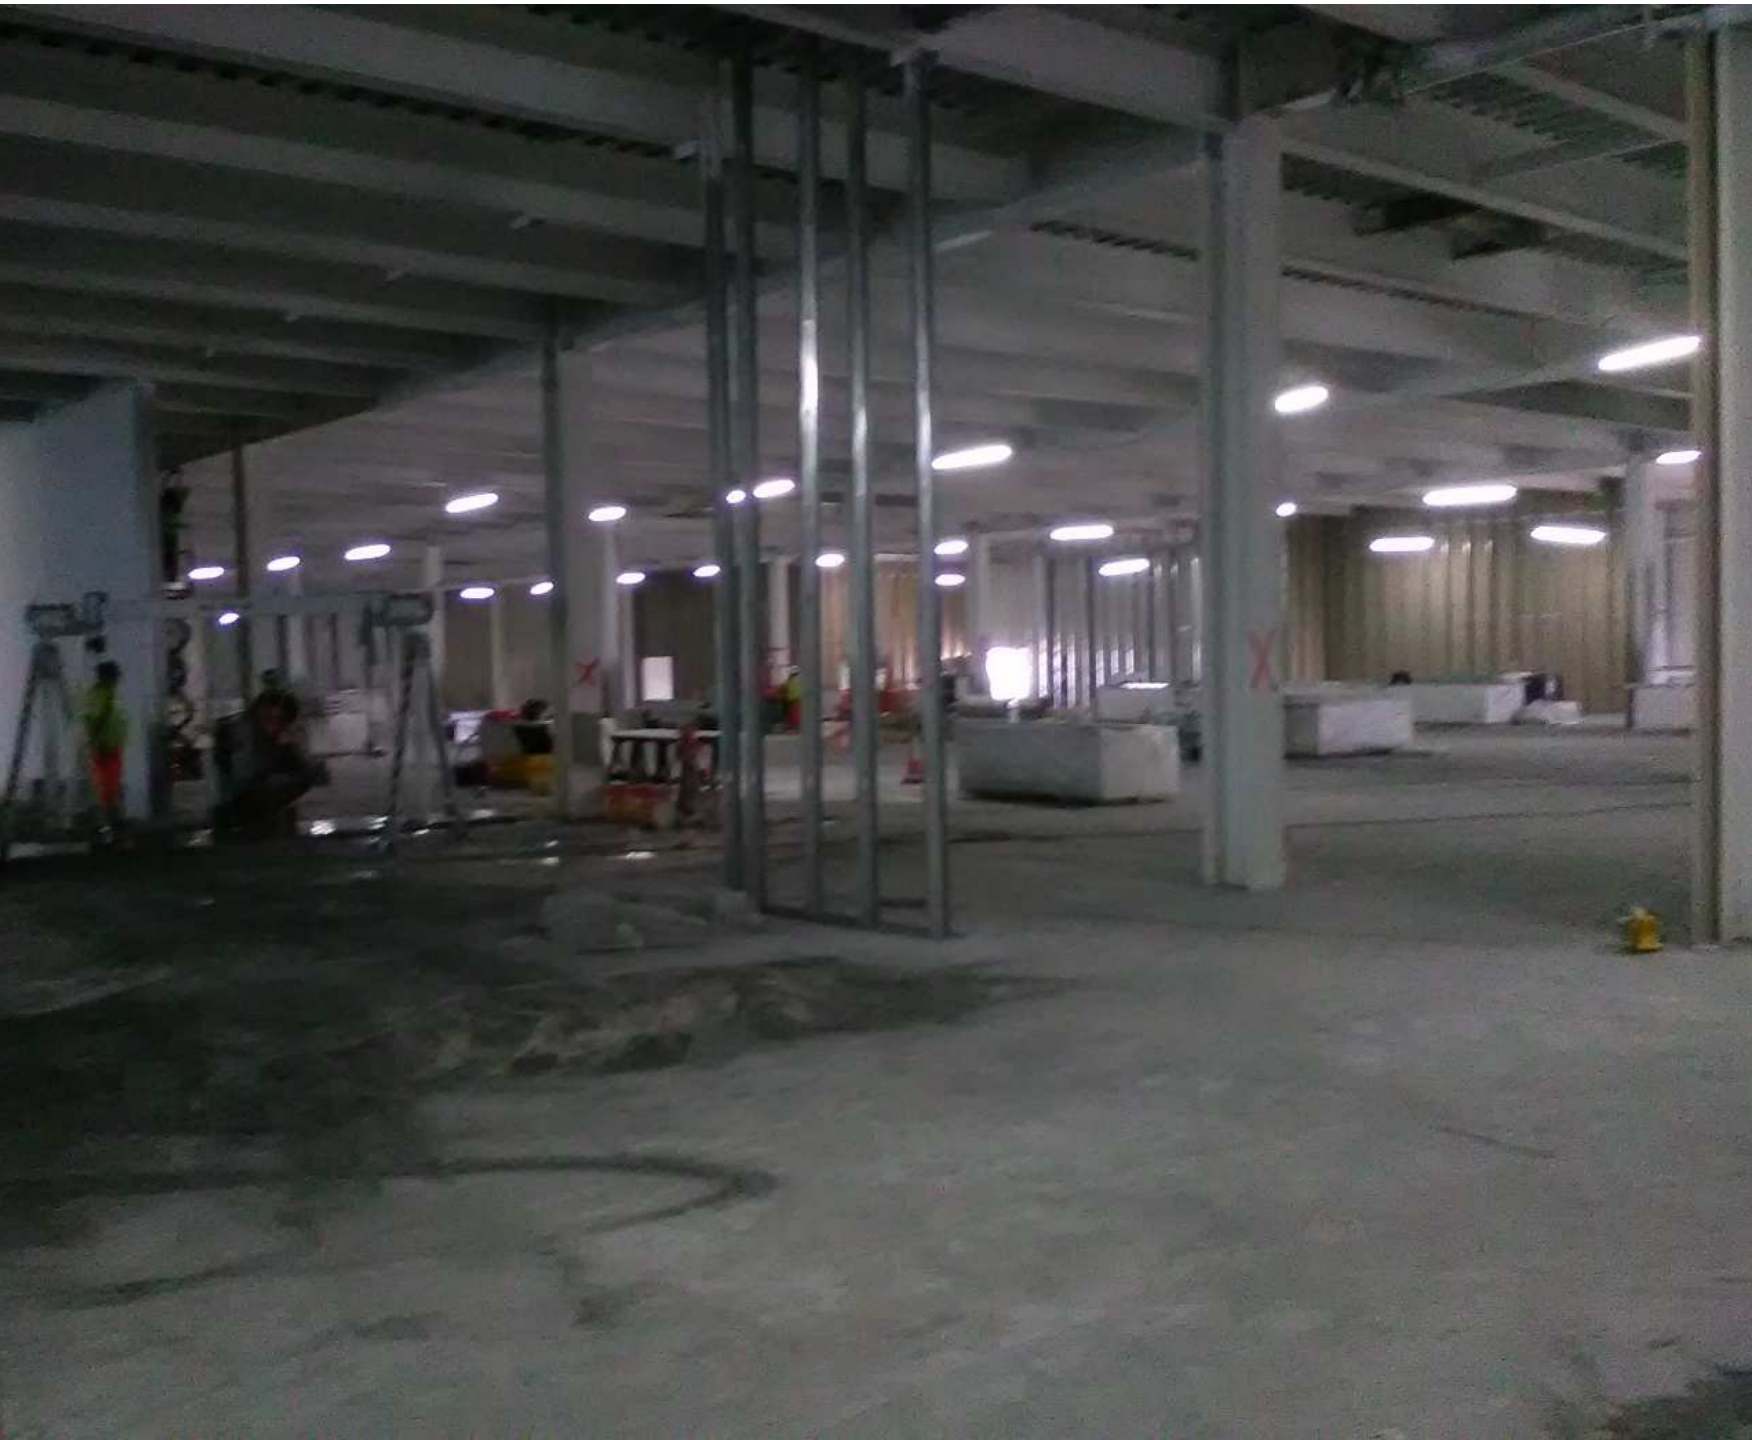
First set of interior stud walls being installed under temporary lighting
