2017 Site Photos

Pre-condition report and project manager's first visit

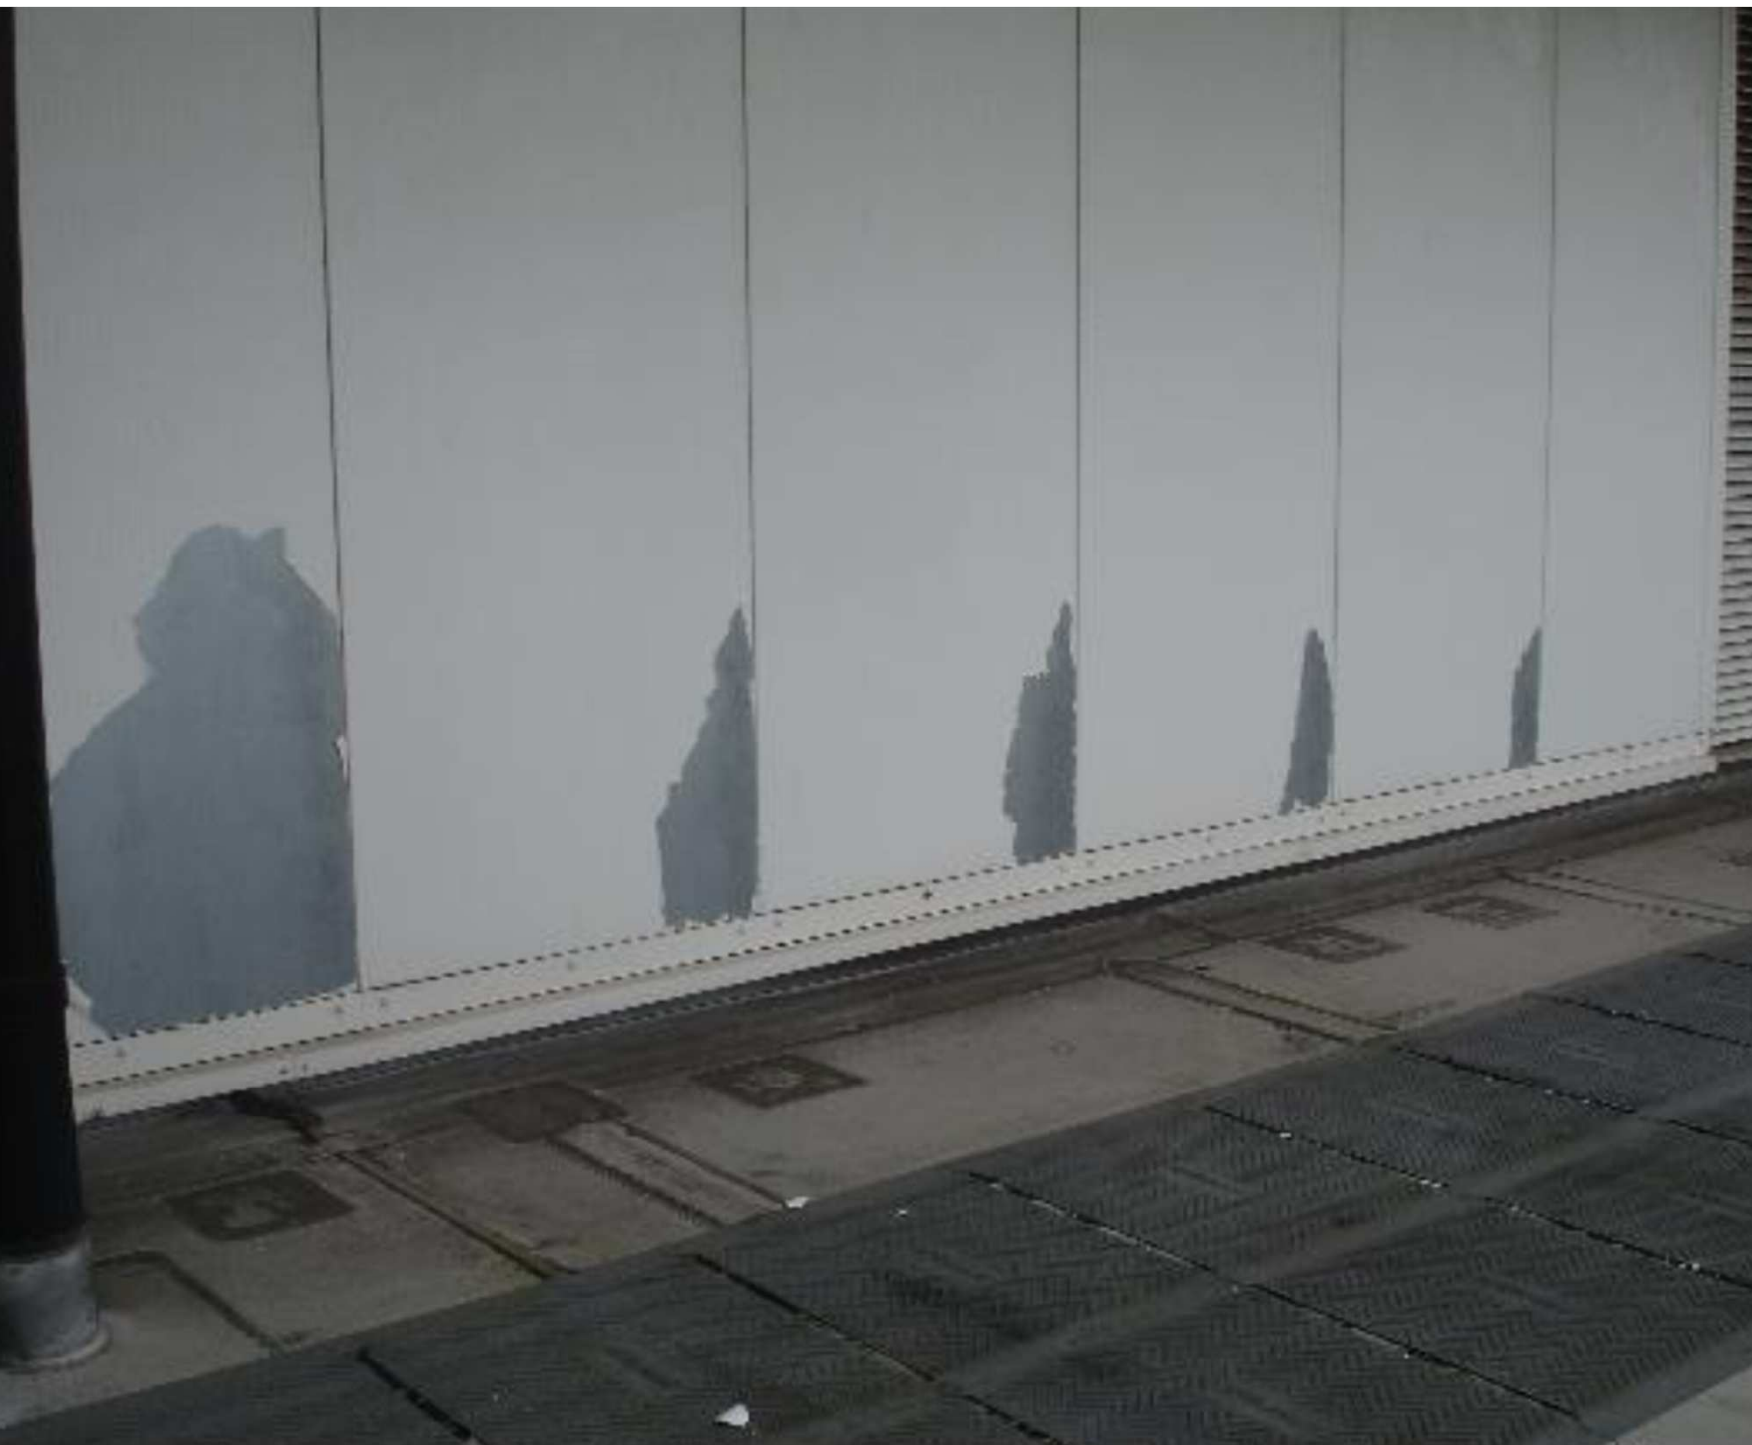
Weather
damage to
external
paintwork above
flat roofing

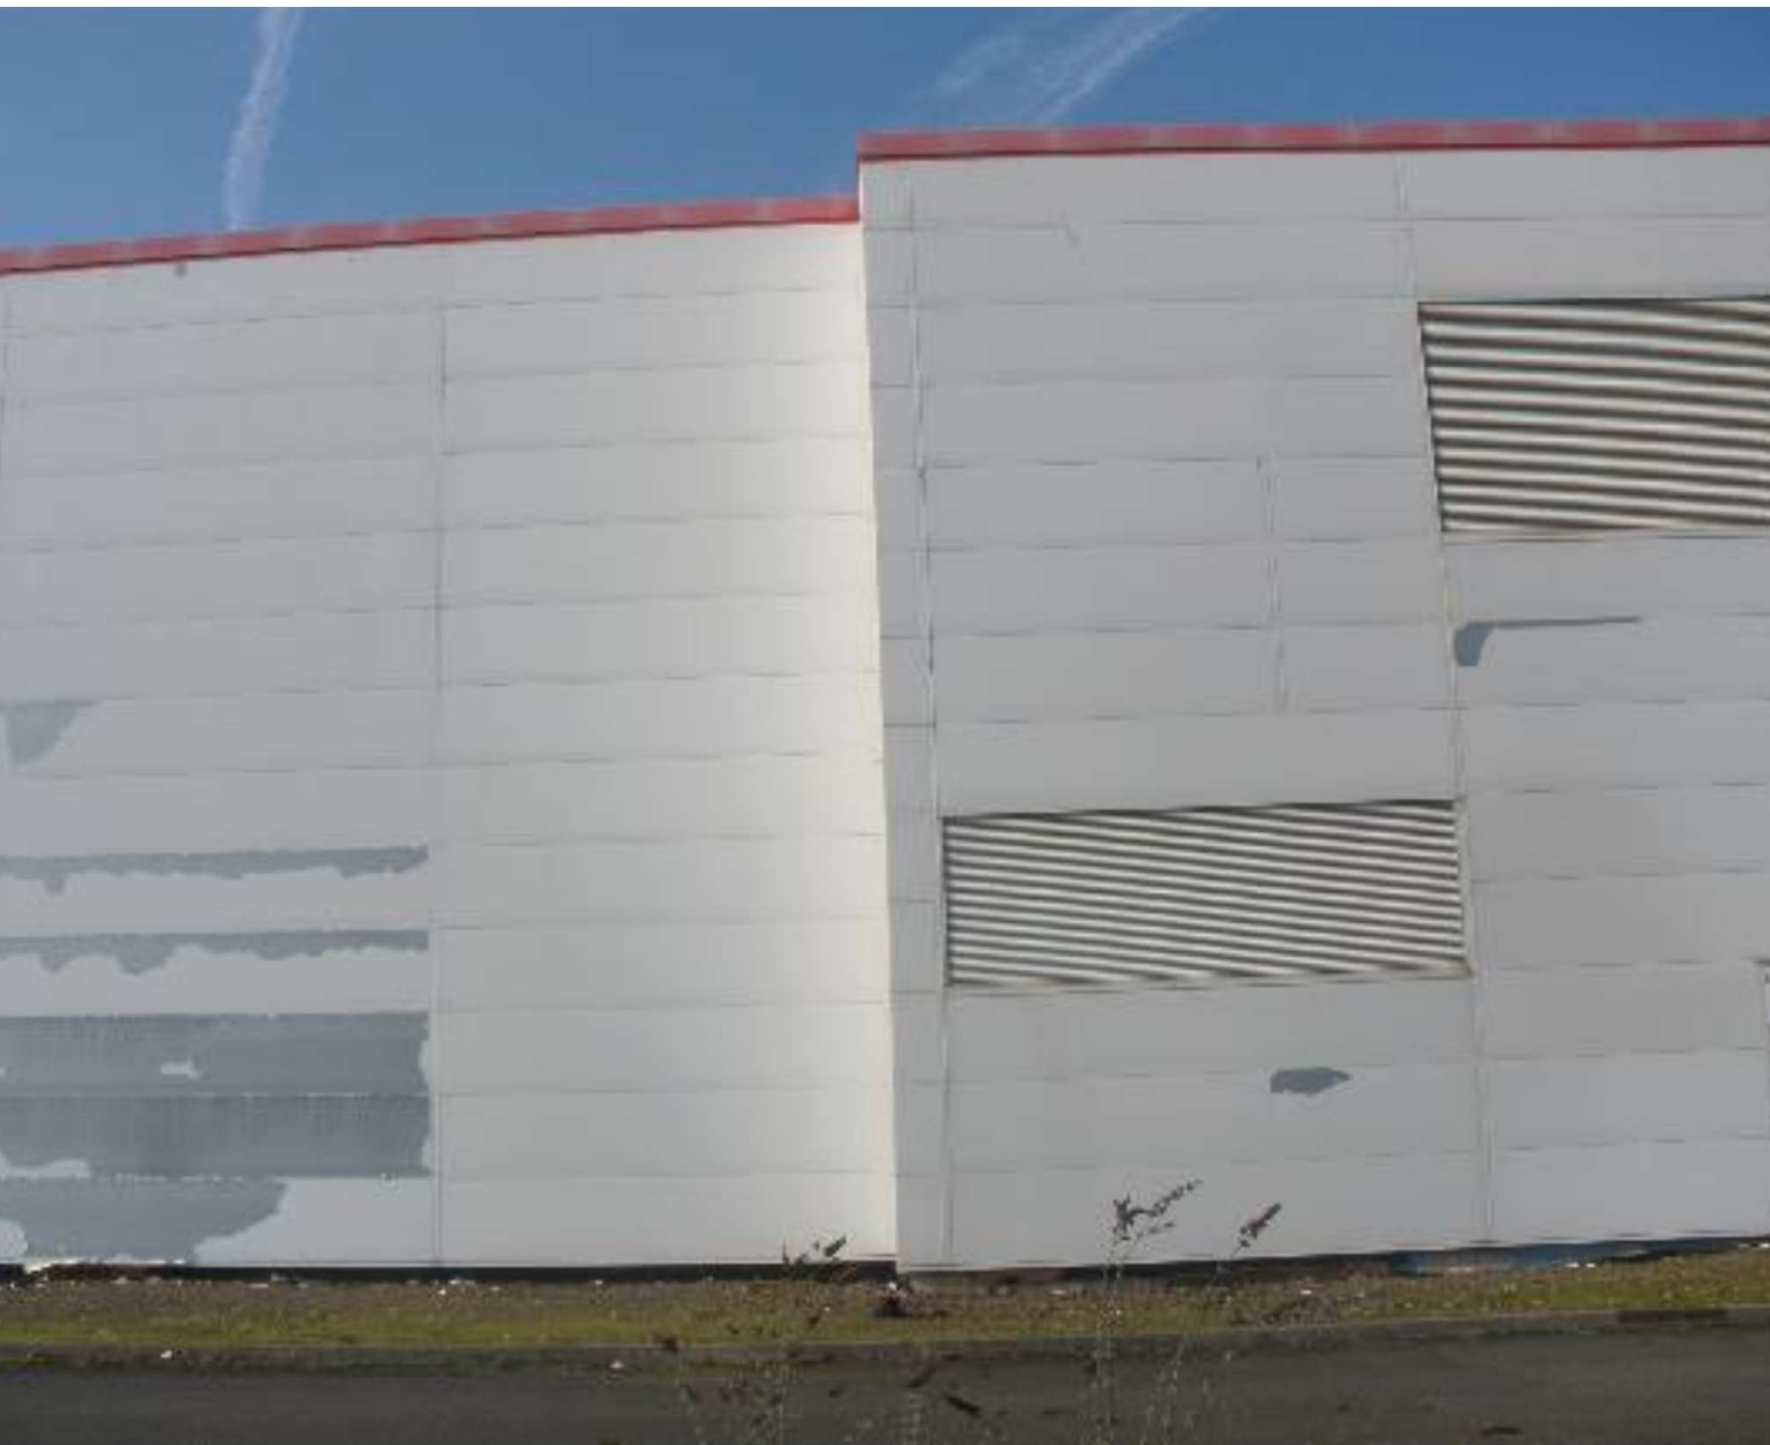
Weather
damage to
external
paintwork on t
side of the
building

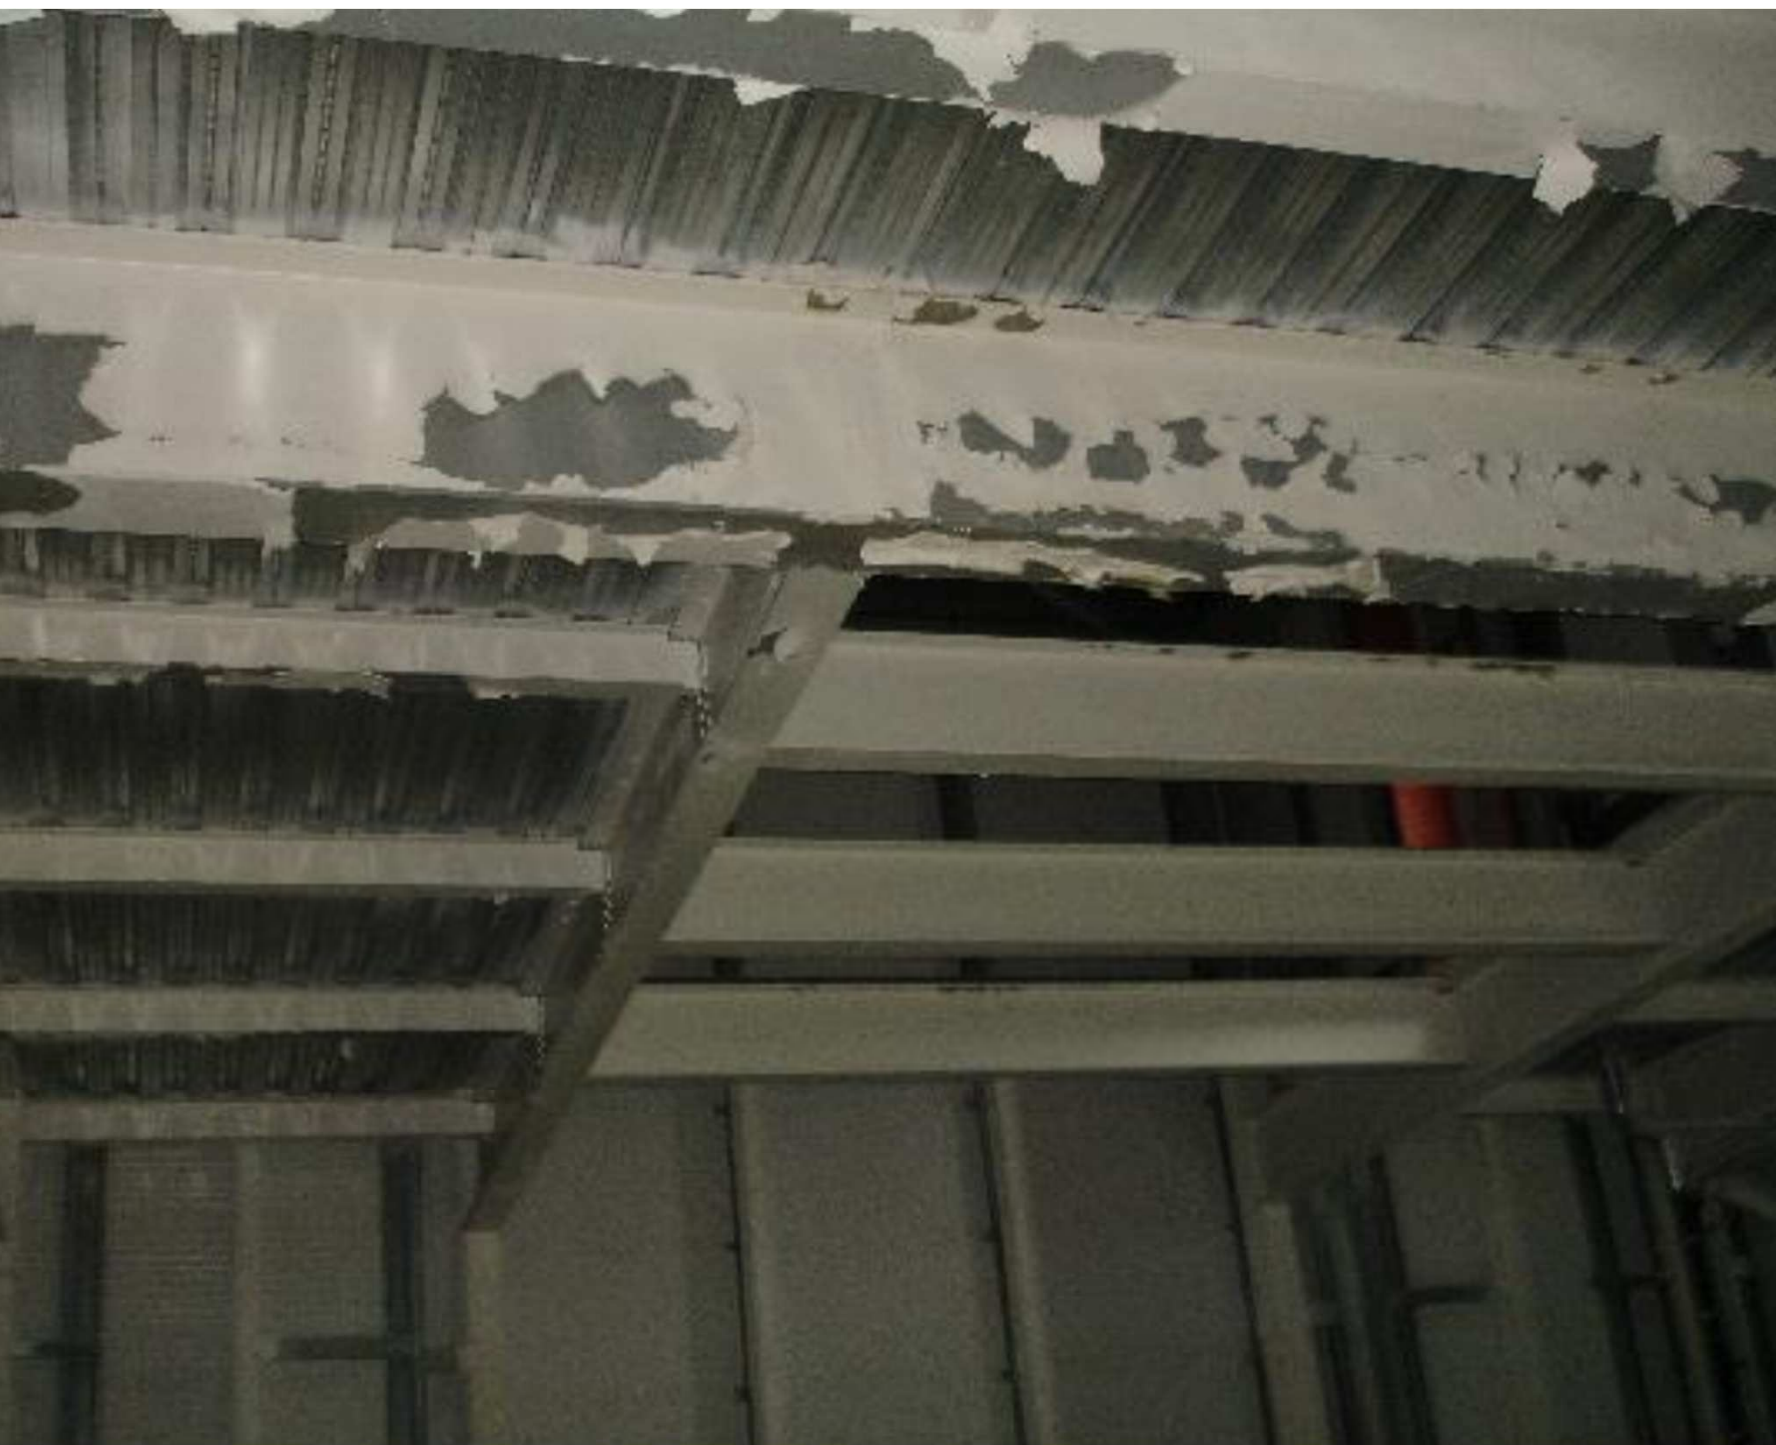
Defective
paintwork on
interior steel
frame

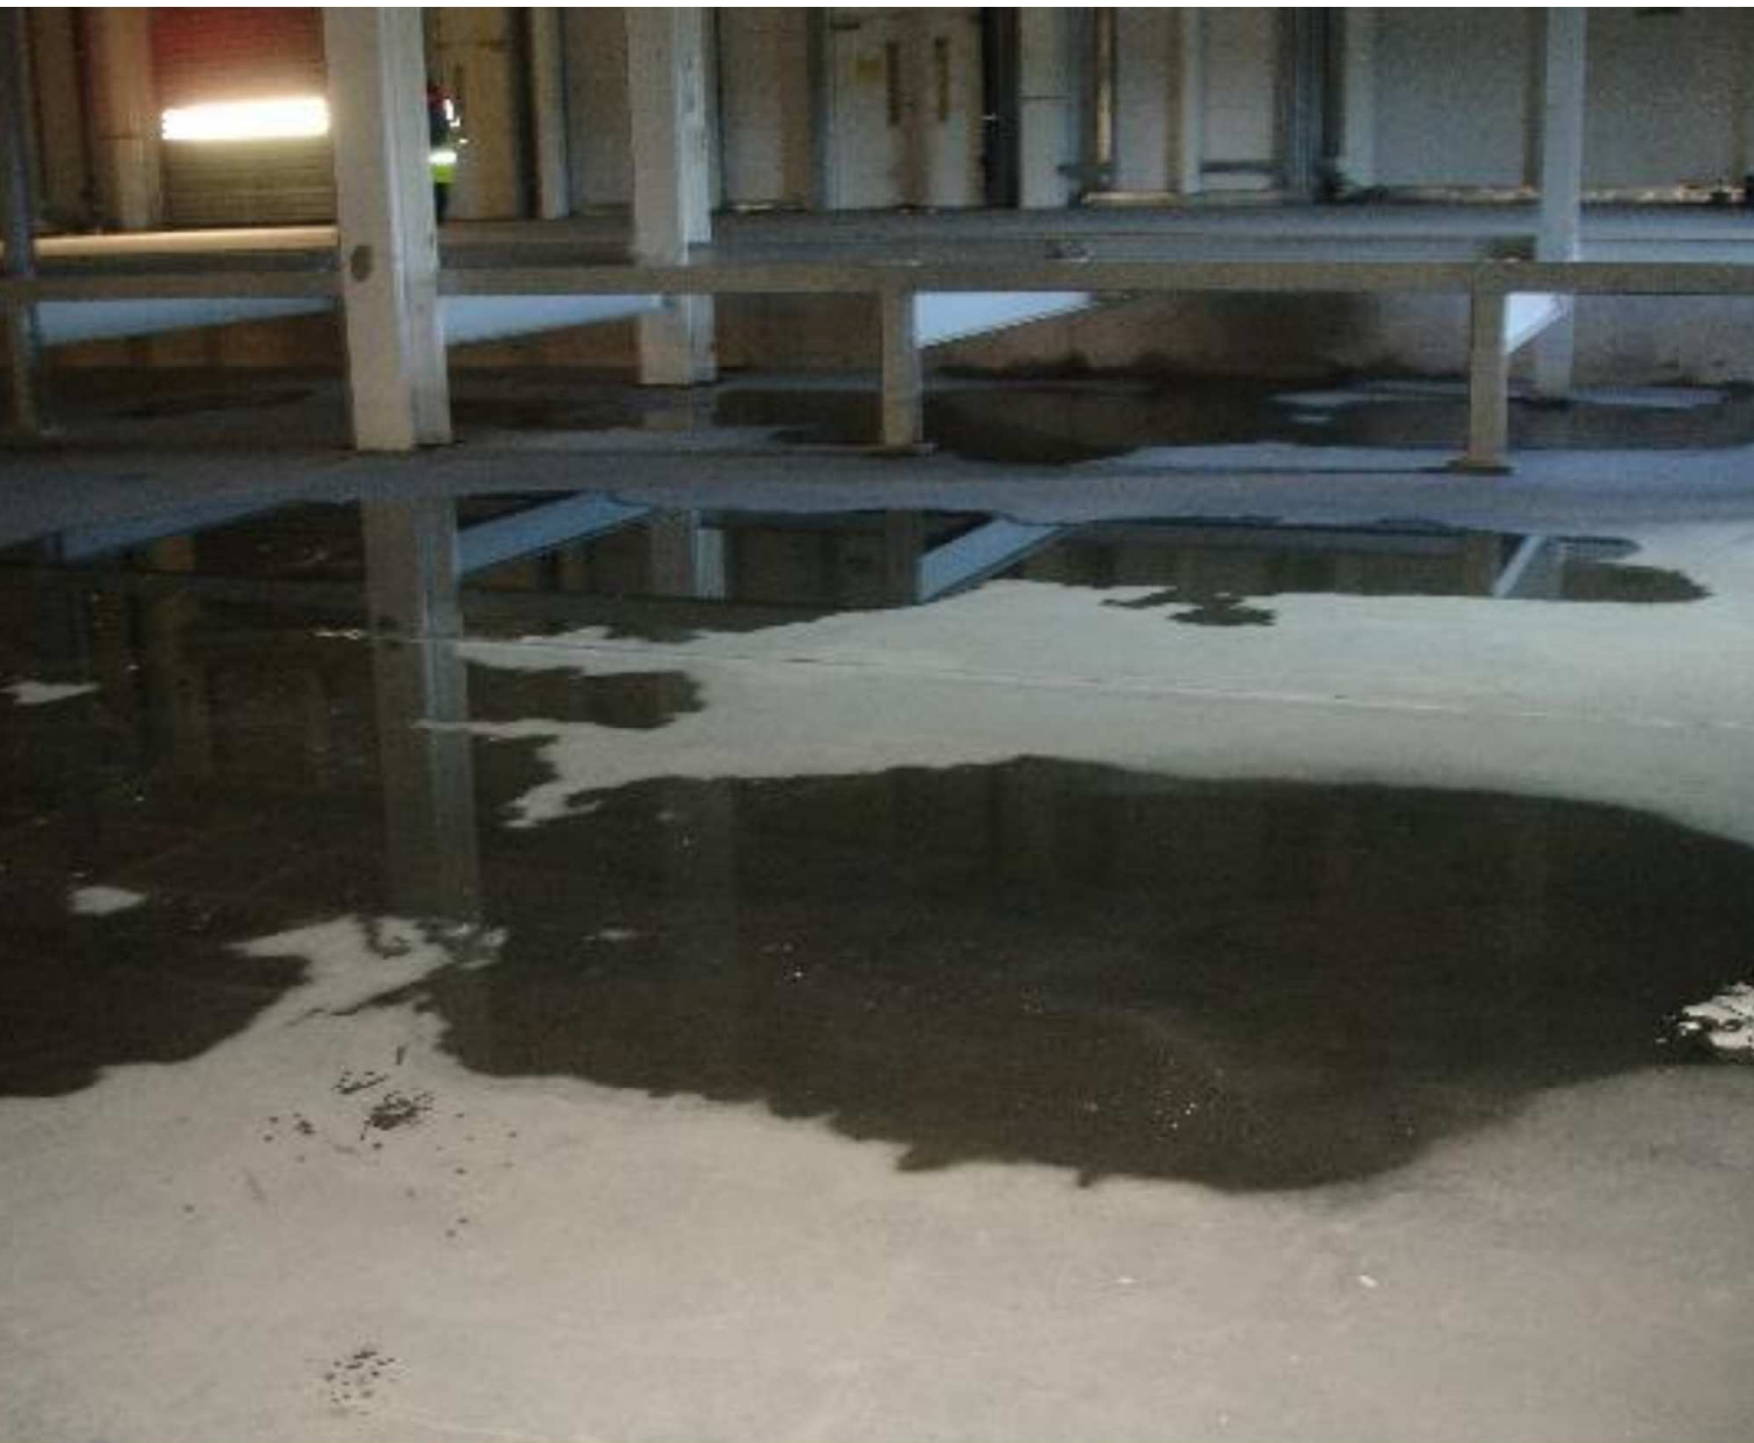
Pools of water
on internal
concrete floors
due to leaks in
the building
