Report on the Evaluation of the ARBED 1 Programme in Caerau

for
Bridgend County Borough Council

Prepared
by
NuVision Energy (Wales) Ltd

Date	July 2020
Revision	1 (Final)

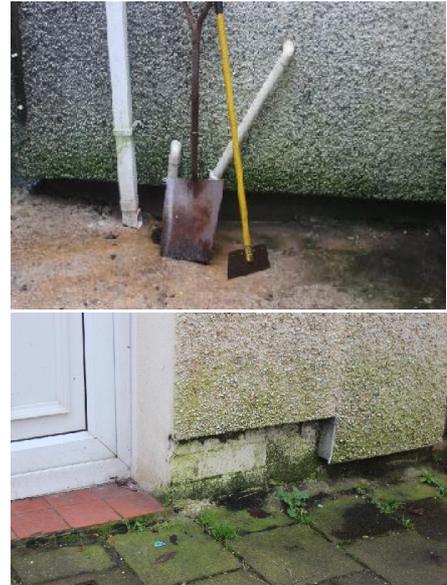
The lack of a DPC between the floor level and the start of the EWI has resulted in excessive damp forming at the lower levels of the walls which has encouraged the growth of green algae. The lack of insulation at the lower levels has also resulted in thermal bridges forming which in turn has caused damp and mould to form on the internal wall surfaces.

Main issue: Lack of a DPC has caused green algae growth to occur on the lower wall levels and lack of insulation at the lower levels has caused thermal bridging to occur within the lower walls.

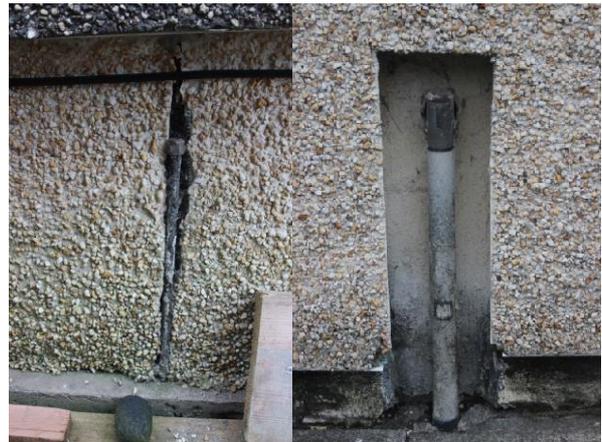
Gas Pipes

In 20 of the 32 homes, the EWI had been cut around existing gas pipes as shown in the adjacent photographs. In one case, no trims were used and hence gaps were evident where damp ingress could occur.

In all cases, there were no PPC aluminium vented cover plates fixed to the EWI to protect the location from water ingress and to make the installation more visually acceptable.

There is no evidence to suggest that the Gas supplier had been contacted to check that the detail was acceptable – this was the responsibility of the installer/main contractor.

Main issue: Thermal bridging occurs where the insulation has been cut around gas pipes which in turn caused damp and mould growth at that location within the property. In addition, where trims have not been installed, there is further risk of damp ingress.

Good practice would have been to move the existing gas pipes but it's acknowledged that this is not always practicable given time constraints and budgets.

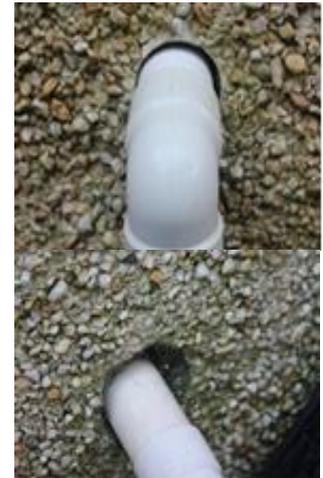
It is essential that opening around pipe protrusions are weathertight to prevent cold and the ingress of water which will compromise the insulation and also increase the risk of interstitial condensation.

Unsealed protrusions will result in water penetration into the insulation and wall, causing the insulation to lose its effectiveness. Interstitial condensation is also more likely to occur as the temperature drops sufficiently for the dew point to be reached within the Wall. Interstitial condensation could cause problems such as mould growth within the wall which would not be visible.

Main issue: Deterioration in the EWI coupled with damp and mould growth on the internal surface of the wall and within the fabric of the wall itself.

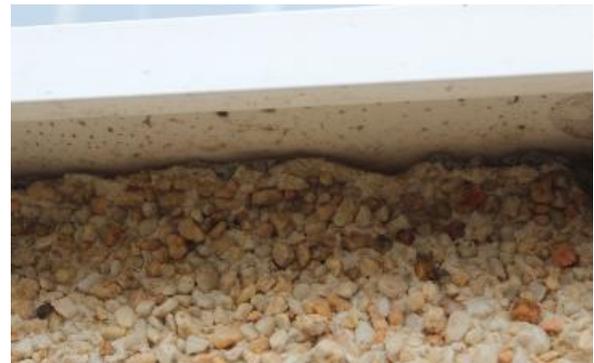
No sealant around window sills

EWI on 11 of the 32 homes surveyed had window sills that had been left unsealed. Whilst the sill overhand will prevent driving rain from entering the insulation, the lack of a sealant will nevertheless enable some water to ingress. In addition draughts can enter through the gap and a thermal bridge will occur, causing damp to form on the internal surfaces of the wall.

Main issue: Unsealed window sills will result in some water ingress and thermal bridging which in turn will lead to damp and mould growth on the surfaces of internal walls.

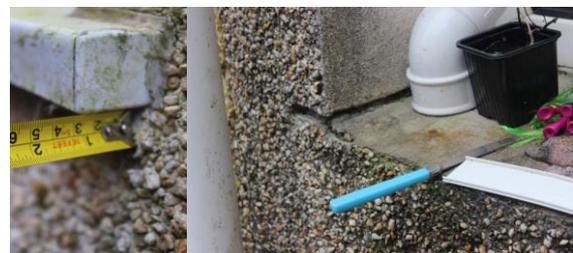
Sills less than 40mm

In 14 of the 32 homes surveyed, it was observed that the overhang on the installed window sills was less than 40mm. In one case there was a window where a sill had not been installed at all. Examples of this defect are shown in the adjacent photographs.

Main issue: The lack of overhang in the sills has resulted in excessive damp areas on the render from water run-off. This has resulted in staining and mould growth on walls.

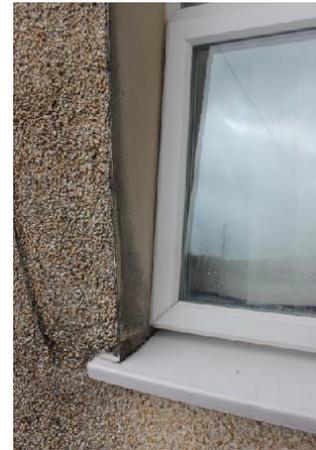
Window sills Poorly installed

Window sills In 11 of the 32 homes had been poorly installed with various unintended outcomes, including sill surface at a very steep angle, bent and loose. An example of a poorly installed sill placed at a steep angle is shown in the adjacent photograph.

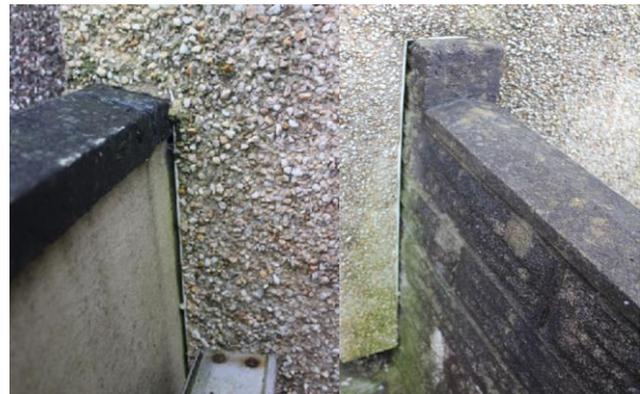
EWI cut around stone walls

15 of the 32 homes surveyed had not addressed the issue of thermal bridging caused by natural obstructions, such as walls, fences and gates connected to the properties. In the 15 properties, EWI had been cut around the walls. This increases the risk of thermal bridging and hence cold damp areas leading to mould growth forming on the surfaces of internal walls.

Main issue: EWI cut around obstructions increases the risk of thermal bridging resulting in cold damp areas and mould growth forming on the surfaces of internal walls.

Good practice to reduce the risk of thermal bridging, would be to cut back the walls so that the EWI could be installed seamlessly along the wall. The wall could then be rebuilt back up to the face of the insulation.

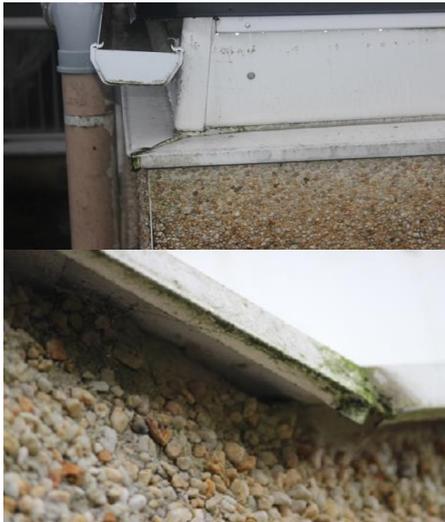
Poor verge trims & sealant detailing

20 of the 32 homes surveyed had poor details produced at roof line and gable end with mastic sealant being used to provide resistance to water penetration. In many cases the sealant had already failed, allowing water to ingress into the EWI and wall of the house. In other cases, there was no sealant visible between the verge trims and EWI resulting in water ingress and thermal bridging problems.

Main issue: Poorly installed verge trims with overreliance on mastic sealant has resulted in damp ingress and thermal bridging problems.

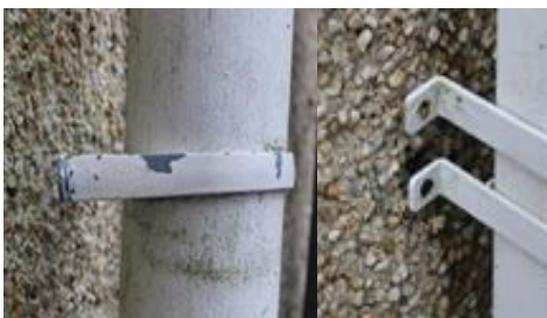
Pipes not fixed to walls

5 of the 32 homes surveyed had downpipes that had not been secured to the walls. This looks unsightly and has resulted in damage to some downpipes with water cascading out through breaks in the jointing.

Main issue: Damage to downpipes due to inadequate wall fixings.

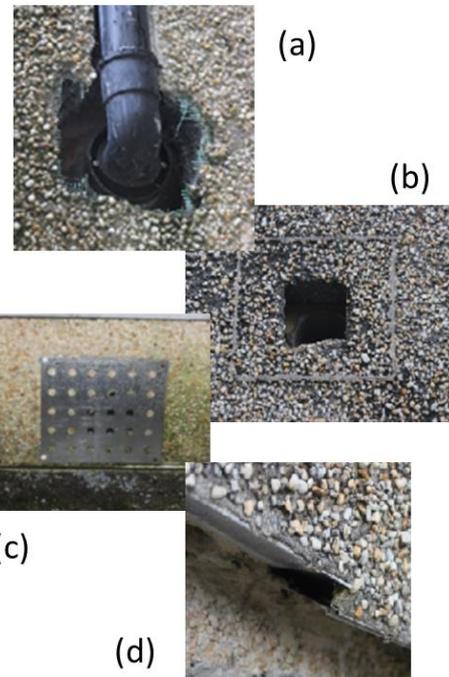
In addition to the defects described in other sections, 25 of the 32 homes exhibited general poor detailing as show in the attached photographs.

Some extract fan grills had been fixed with mastic (b) which had quickly failed, leaving a large hole in the wall.

Some starter tracks had not been fixed properly (d) or left with fence posts protruding through.

Main issue: Miscellaneous poor detailing and insulation causing a variety of opportunities for water to ingress into the property and for thermal bridging to occur. Installing EWI over the boiler flues were particularly concerning.

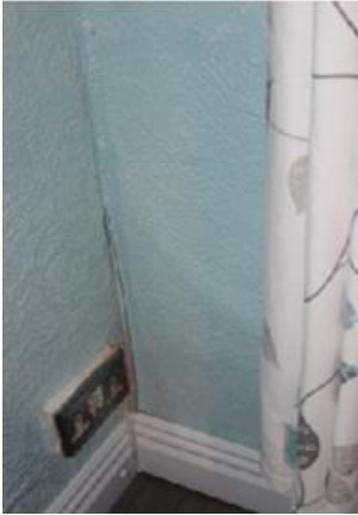
Damp in evidence in Lounge
(front ground floor)

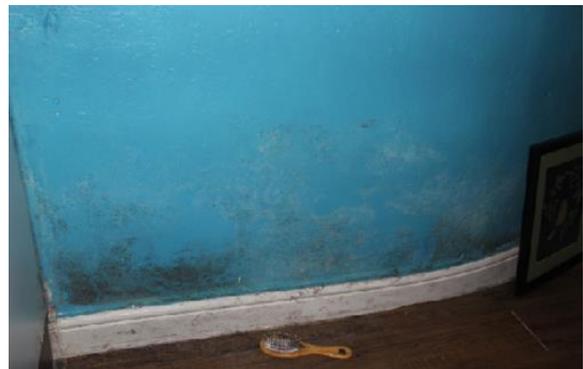
Damp and black mould in evidence
in kitchen (rear ground floor)

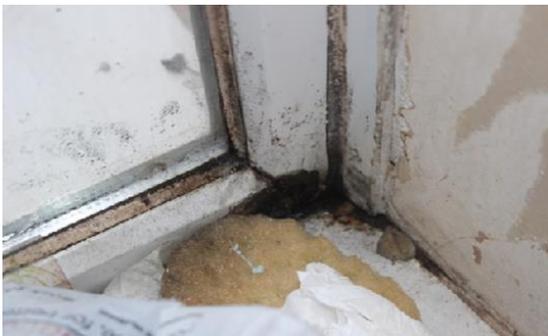
Damp on walls, ceiling and windows
in all three Bedrooms

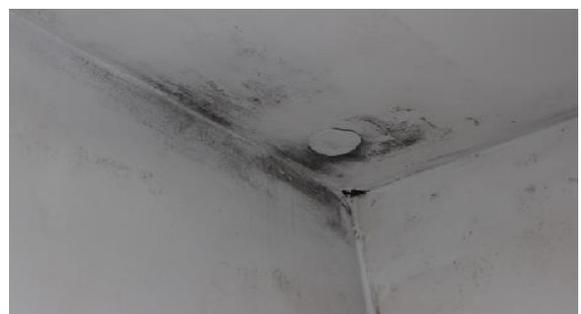
Damp on walls, ceiling and windows
in all three Bedrooms
