Feasibility Report for 4 Winter Sports Pitches at Cefn Cribwr Athletic Club and Cefn Cribwr Boys Club

Mr Peter Watkin Jones BSc MSc MIAgrE
Oolong Sports Pitch Consultancy
February 2020

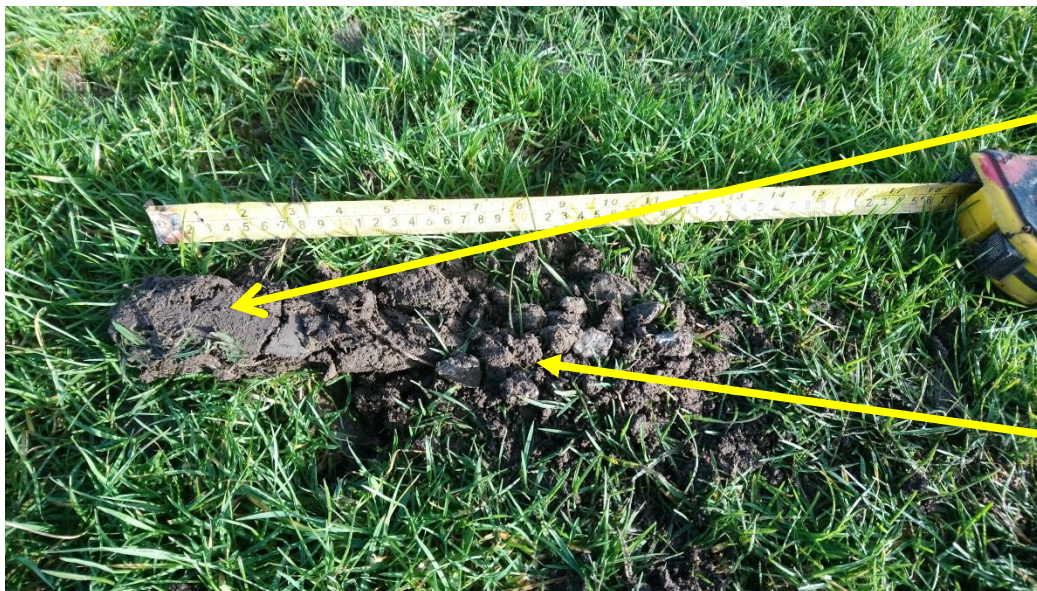
Figure 2 - Typical soil profile for Pitch A

Top 250mm of the profile is soft grey brown Sandy clay loam

Below 250mm is firmer light brown Clay loam with angular stone

Topsoil depths measured in the field were found to be approximately 250mm deep and consistent across the site. The upper 60mm soils were completely de-structured with poor shear strength capacity. Some small fragments of coal were present between 100mm and 250mm.

The entire topsoil profile is without structure and shows signs of being unable to react to rainfall events. The rooting depth is typically 80 - 120mm and within the Mid PQS category. The Clay subsoil below 250mm is compact and will impair drainage.

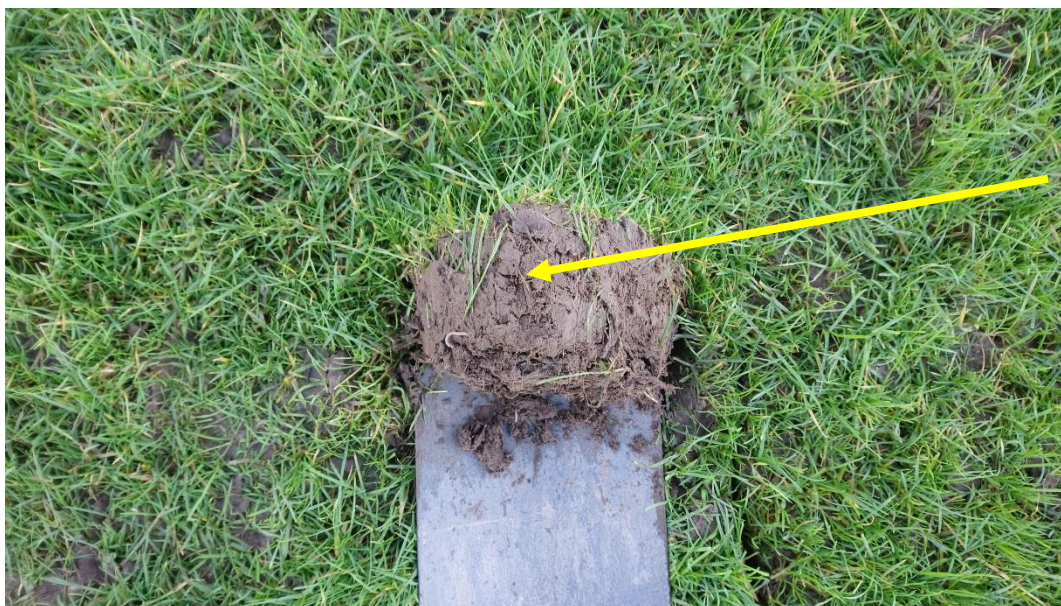
Figure 3 – Typical topsoil structure

Topsoil profile shows complete lack of soil structure and poor shear strength capacity

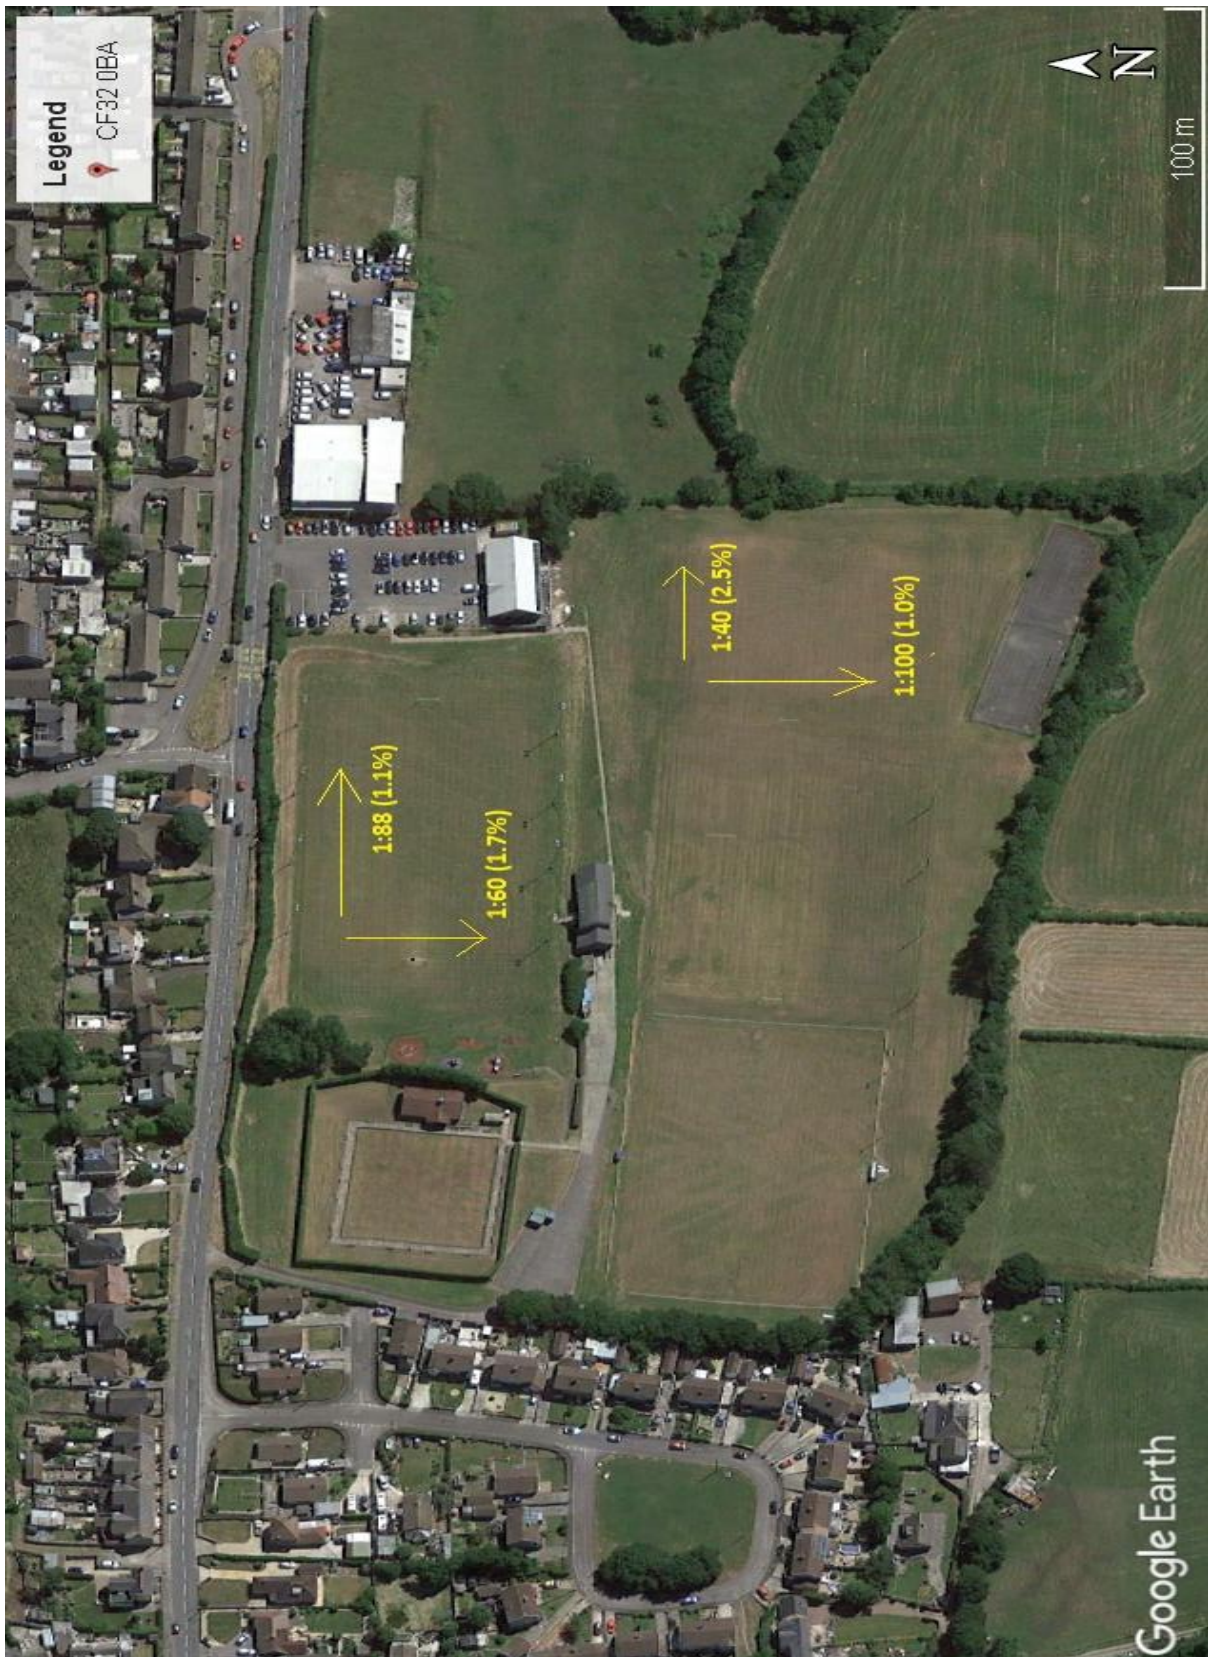
Figure 4 – General ground slopes

The site can be viewed as two distinct levels. The main pitch A is situated on an upper bench or plateau previously created by re-grading the existing slope, the pitch gradients are highlighted in **Figure 4** below. Pitches B to D are located at the lower part of the site where the original ground levels shallow out, the gradients of pitch D being most significant. In general the pitch gradients assessed against the standards bench marked by the Institute of Groundsmanship (IOG) Performance Quality Standards (PQS) suggest that all pitches meet the basic standard. If a higher standard is required some minor releveling work will be needed which might be addressed through cultivation operations rather than larger earthmoving operations.

The surface gradients can be addressed if needed during improvement operations by re-profiling the topsoil and reducing the pitch slopes.

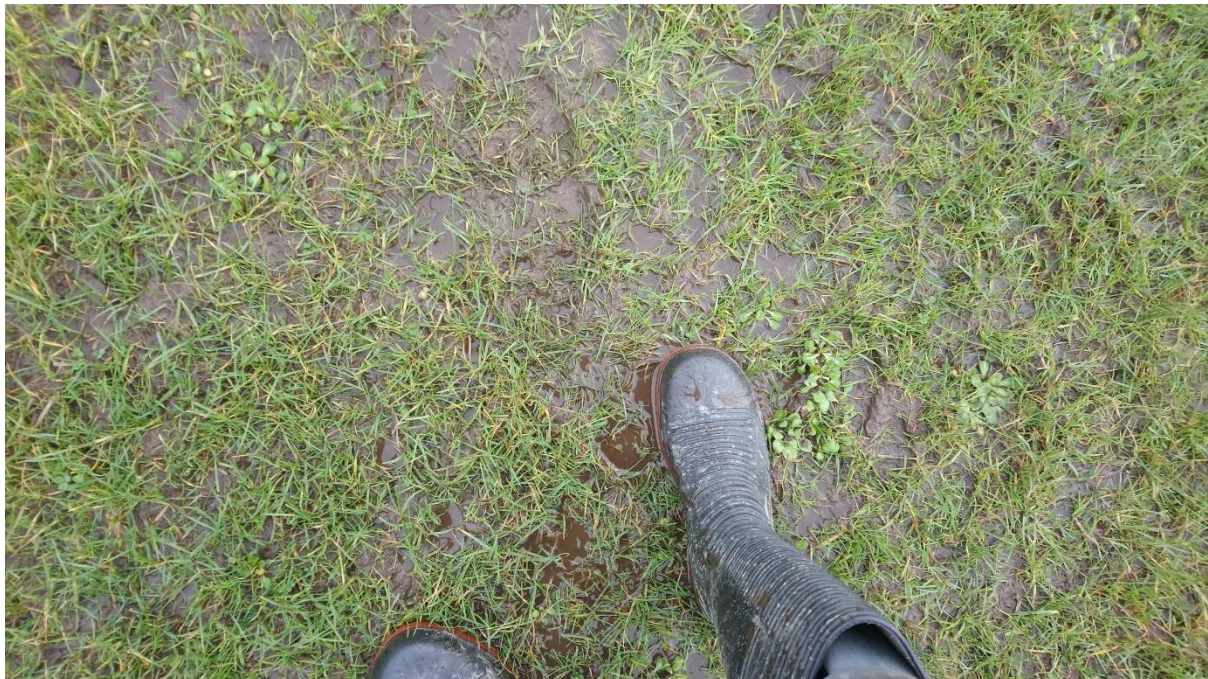
Figure 5 – Pitch A showing areas of poor grass coverage, some broadleaved weeds and saturated conditions

The main rugby pitch shows several characteristics of surface drainage problems. Visually the ground was very muddy underfoot with areas of surface ponding. The grass density was patchy and poor in many areas contributing to unstable surface conditions and lack of traction. Even if the existing primary pipe system is functioning (i.e. pipes remain undamaged and running freely) it is evident that there is a problem with removing surface water through the system (soil profile) to a suitable outfall. Installation of a secondary drainage system and management of the upper soil profile would address these problems.

1. Further investigate the status of the existing primary drainage system and renew if required
2. Install a new secondary drainage scheme
3. Surface establishment of a suitable grass sward and improve the soil chemistry
4. Re-profile the surface

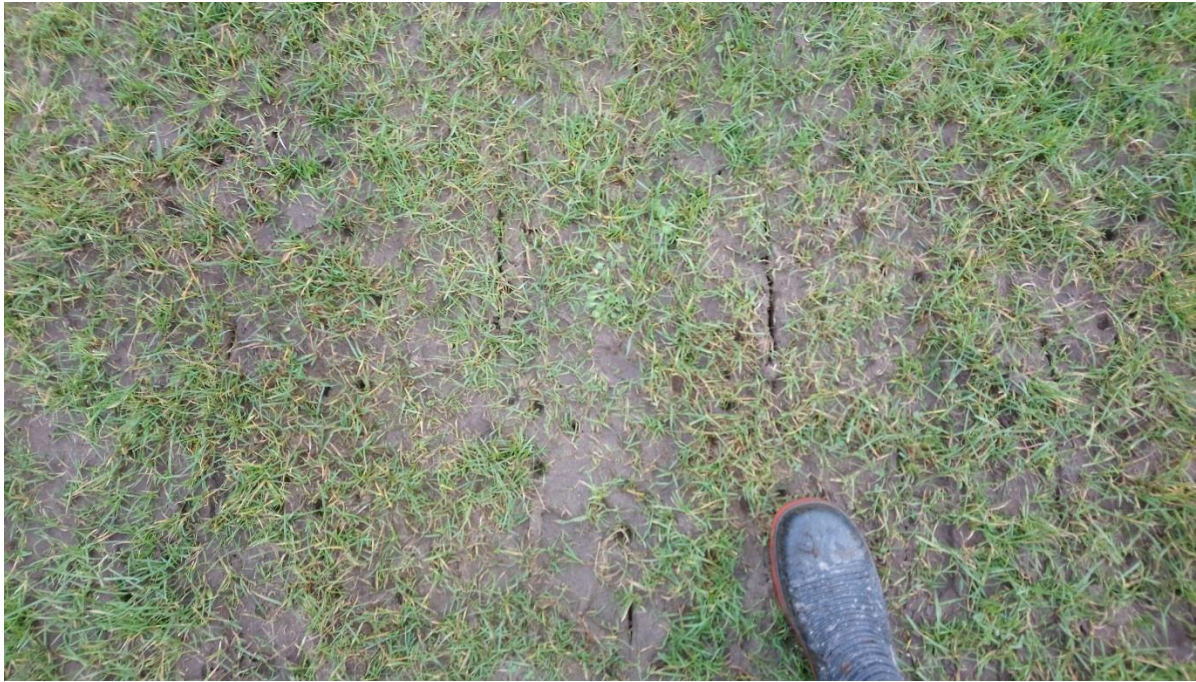
Figure 6 – Pitch A showing evidence of some maintenance operations

Currently only basic and limited maintenance work is undertaken which include grass cutting, line marking and occasional light aeration operations (which are visible on pitch A in the form of tine aeration and shallow slit operations). Site staff currently arranges and manages pitch maintenance operations.

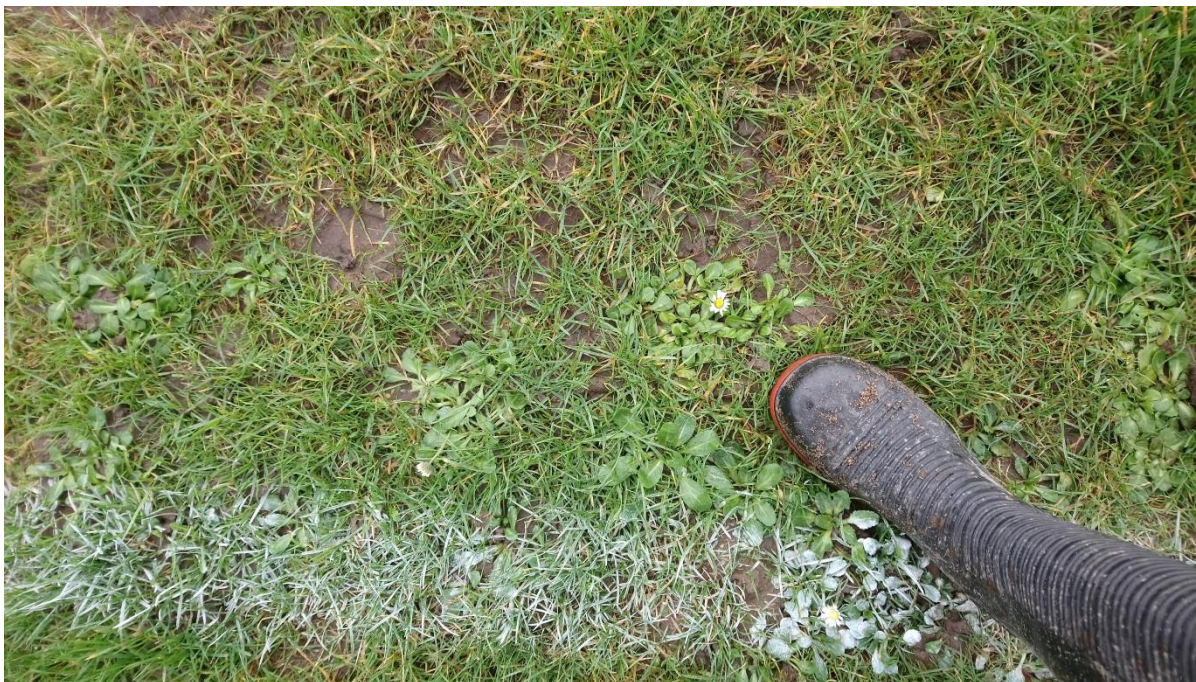
Undesirable grass species and broadleaved weeds cause competition between themselves and the essential grass cultivar species present and should be eliminated. Annual meadow grass (*Poa annua*) is considered a weed grass within the sports turf industry, although it remains present in a large percentage of sports surfaces all over the UK.

Figure 7 - Broadleaved weeds

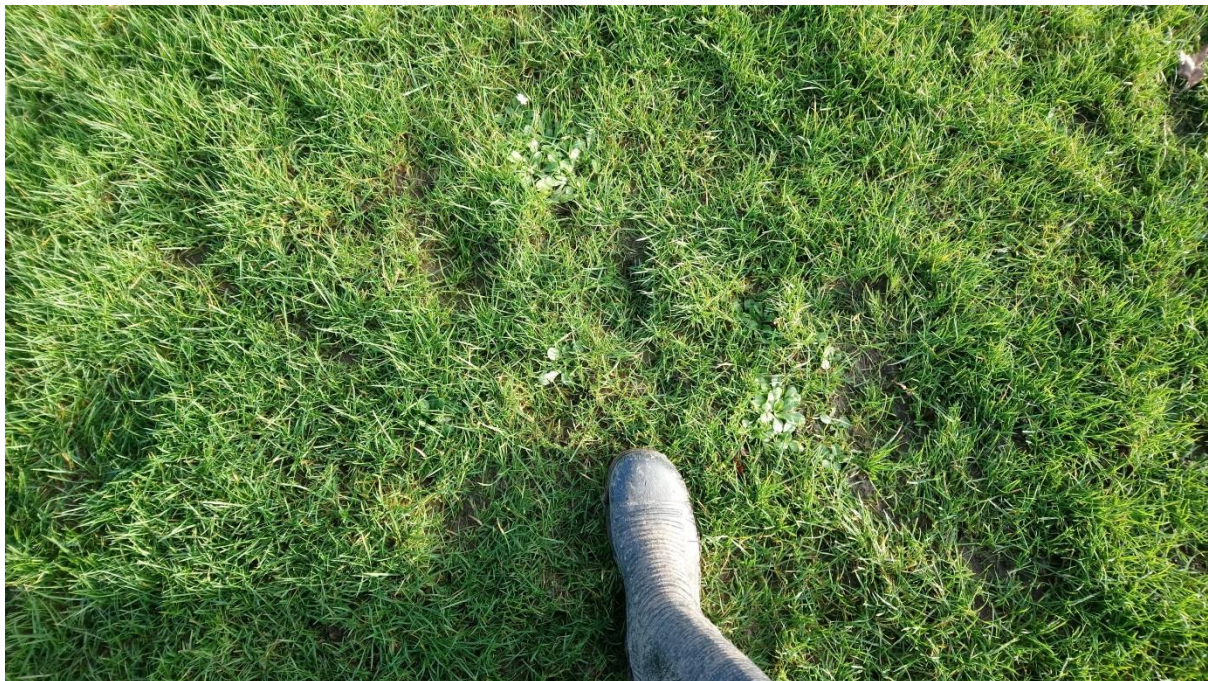
Figure 8 – Pitch C showing reasonable grass coverage and some weeds

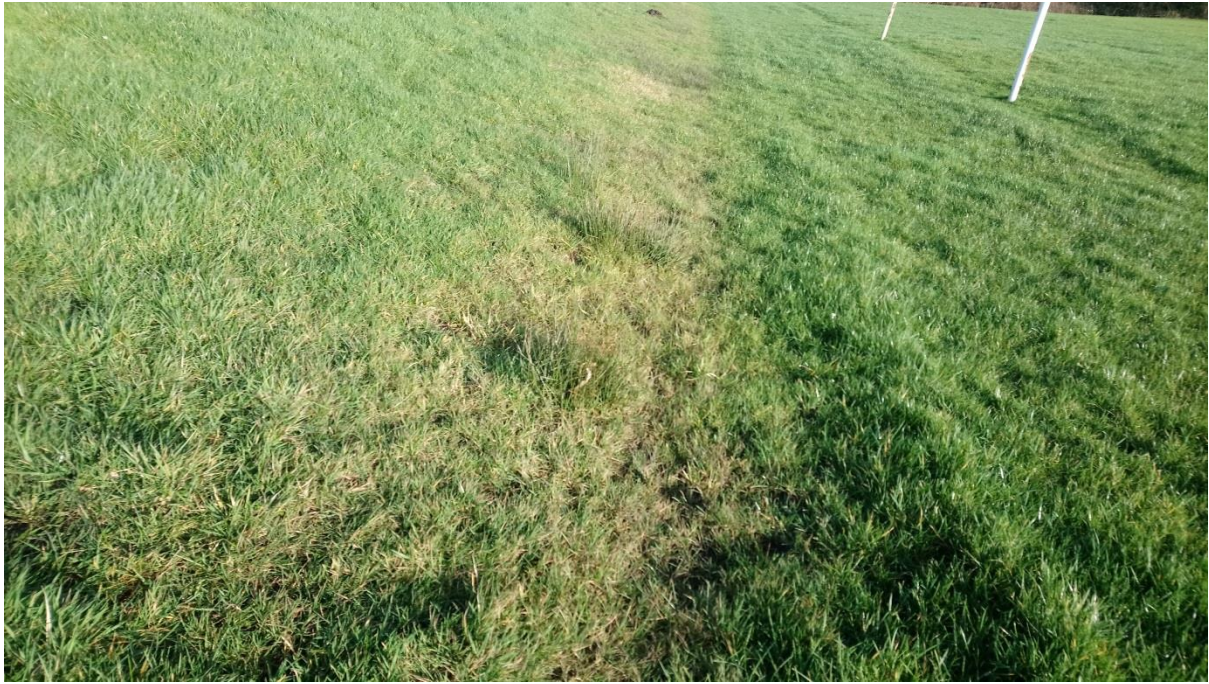
Sedge plants possibly Compact Rush was evident in areas of ground prone to waterlogging and particularly found on the fringes of pitch D.

Figure 9 - Area of sedge around pitch D

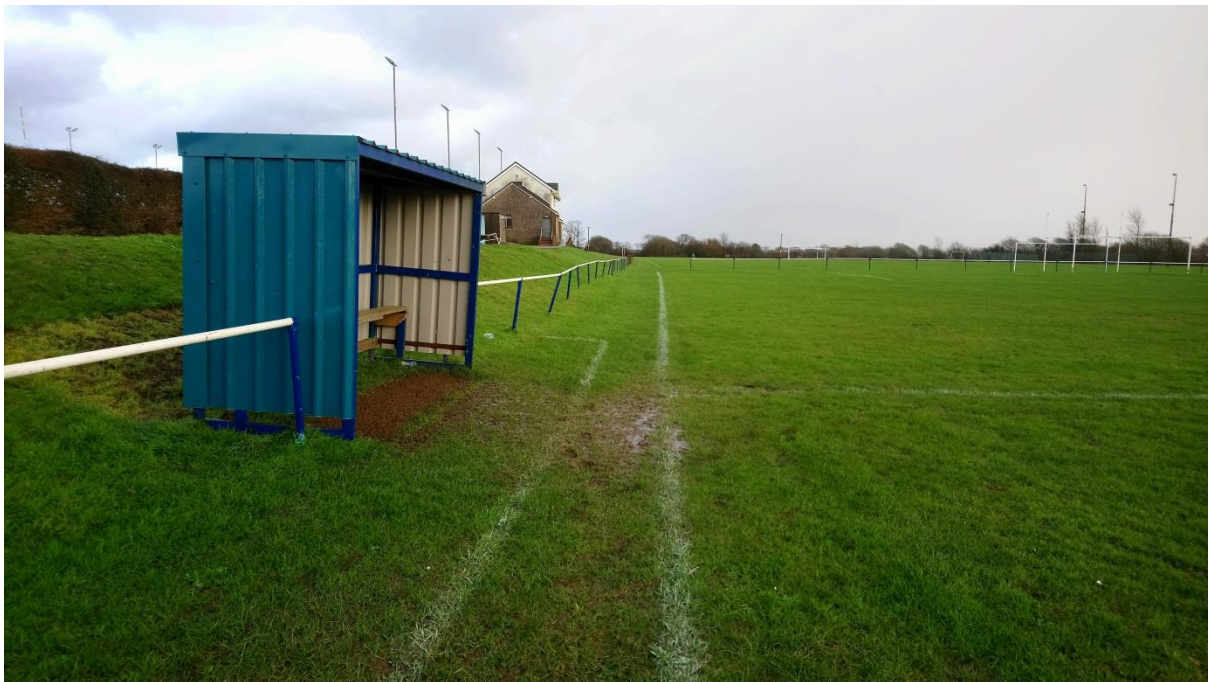
Figure 10 - View of the main football pitch B

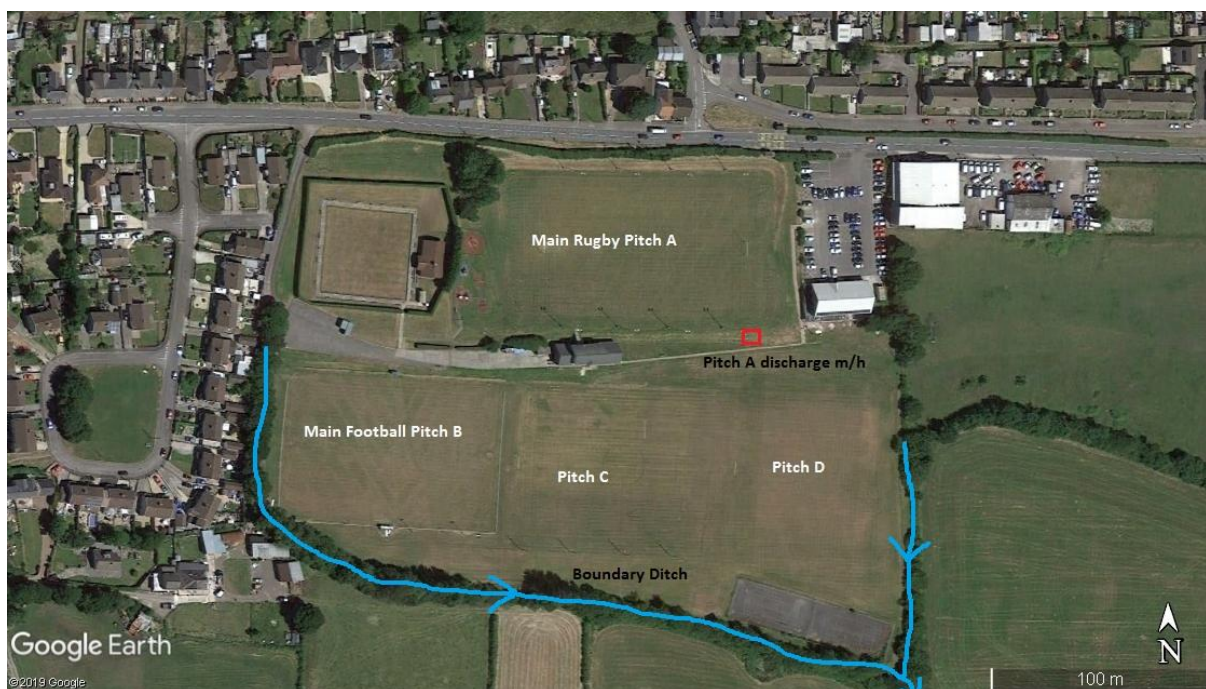
Information provided at the site visit indicates the existence of an old underdrainage pipe system within the main rugby pitch (pitch A) with the outfall on the southern pitch boundary and is assumed to discharge to some form of soakaway. Due to the potential age and nature of the existing primary underdrainage system and the observed ground conditions it must be assumed that the drainage system may not function efficiently and some form of remediation works are likely required.

There is a drainage ditch situated around the boundary as shown in **Figure 11** which discharges to the south east corner and away through agricultural land. This could be a useful outfall for any drainage system considered in the future.

Figure 11 - Likely discharge point for pitch A, also shows the boundary ditch
Other observations
