Bridgend Estates Surveys

Llangynwyd Summary Report

Bridgend County Borough Council

17/03/2020

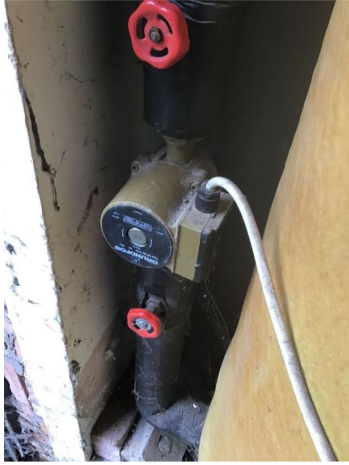
<p>Room 0.14</p> <p>Location Store</p> <p>Item Mechanical Services - Pumping - HWS Pump</p>

Block 1	LTHW Calorifier	C	2	2	2	Nr	3634.4	£7268.80	Hot water storage cylinders with electrical immersion heaters appear in poor condition and at the end of anticipated life cycle. Renew
Block 1	DHWS/ CWS	B	3	7	50 PA	M2	51.92	£6362.80	
Block 1	LTHW Calorifier	B	3	7	2	Nr	3634.4	£7268.80	
Block 1	HWS Pump	C	2	2	2	Nr	1869.12	£3738.24	HWS pumps at the end of serviceable life. Renew
Block 1	HWS Pump	B	3	10	1	Nr	1869.12	£1869.12	
Block 1	Unvented Storage Heater	B	3	6	1	Nr	623.04	£623.04	
Block 1	Radiator (m2)	B	3	10	90 PA	M2	30.73664	£6780.20

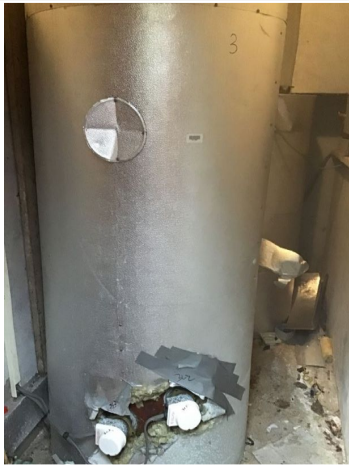
<p>Room 0.21</p> <p>Location Store</p> <p>Item Mechanical Services - Calorifiers Heat Exchangers - LTHW Calorifier</p>

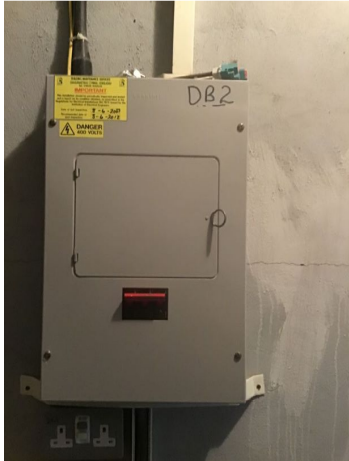
Power is provided to the building via the main isolator to a number of sub isolators and distribution boards which generally appear in satisfactory condition; however, one distribution board is approaching the end of anticipated life cycle and is recommended for replacement in the medium term.

<p>Room 0.21</p> <p>Location Store</p> <p>Item Electrical Services - Sub Main Dist - Distribution Board</p>

Block 1	Distribution Board	C	2	2	1	Nr	986.48	£986.48	Distribution board at the end of anticipated life cycle. Renew
Block 1	Luminaires	C	2	2	30 PA	M2	20.768	£1527.07	Luminaires appear in poor condition and at the end of anticipated life cycle. Renew
Block 1	Luminaires	A	4	11	70 PA	M2	5.192	£890.79	
Block 1	Earth Bonding - Primary	B	3	20	30 PA	M2	5.192	£381.77	
Block 1	Earth Bonding - Secondary	B	3	20	30 PA	M2	10.384	£763.54

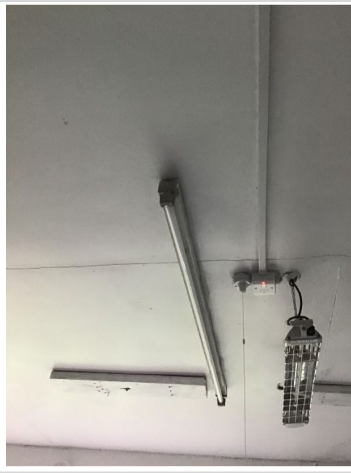
<p>Room ALL</p> <p>Location ALL</p> <p>Item Electrical Services - Lighting System Inc. Switches Wiring Luminaries - Luminaires</p>

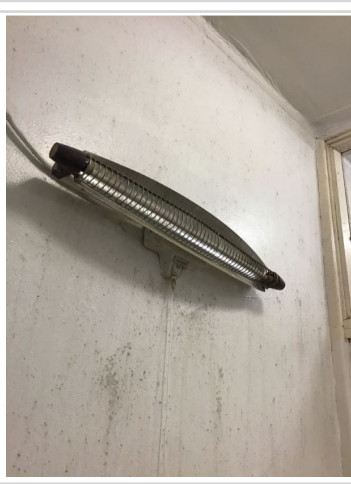
<p>Room ALL</p> <p>Location ALL</p> <p>Item Mechanical Services - Heating LTHW Electrical - Radiator (m2)</p>

Block Element	Condition	Rating	RSL	Measurement	Unit	Unit Rate	Cost	Comments
Block 1 Radiator (m2)	C	2	1	10 PA	M2	30.73664	£753.36	Electrical bar heater in poor condition and at the end of useful life. Renew
Block 1 Extract (Local)	C	2	1	10	Nr	415.36	£4153.60	Local extract fans appear in poor condition and at the end of anticipated life cycle. Renew

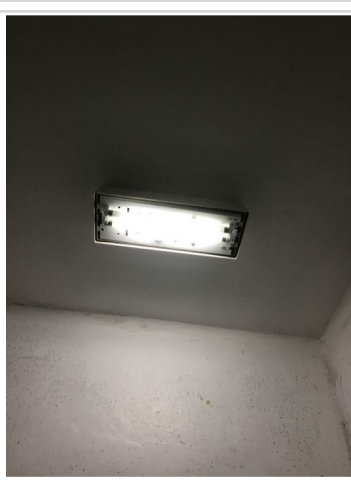
<p>Room ALL</p> <p>Location ALL</p> <p>Item Electrical Services - Emergency Lighting - Luminaires</p>

Block Element	Condition	Rating	RSL	Measurement	Unit	Unit Rate	Cost	Comments
Block 1 Isolator	B	3	20	1	Nr	903.408	£903.41	
Block 1 Distribution Board	B	3	10	1	Nr	986.48	£986.48	
Block 1 Isolator	B	3	7	2	Nr	903.408	£1806.82	
Block 1 Luminaires	C	2	1	30 PA	M2	5.192	£381.77	Emergency luminaires appear in poor condition and at the end of anticipated life. Renew
Block 1 Luminaires	A	4	24	70 PA	M2	20.768	£3563.17	
Block 1 Lighting Wiring & Accessories	A	4	24	70 PA	M2	33.2288	£5701.07	
Block 1 Small Power Wiring & Accessories	A	4	24	100 PA	M2	25.96	£6362.80	
Block 1 Bulkhead Fitting	B	3	5	4	Nr	311.52	£1246.08

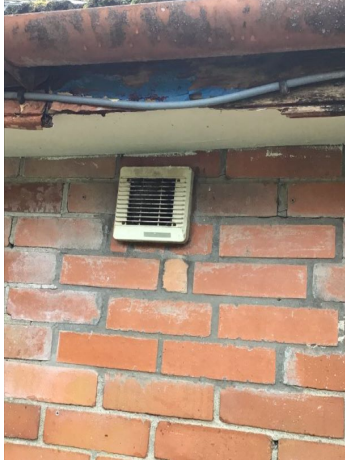
<p>Room ALL</p> <p>Location ALL</p> <p>Item Mechanical Services - Fan - Extract (Local)</p>

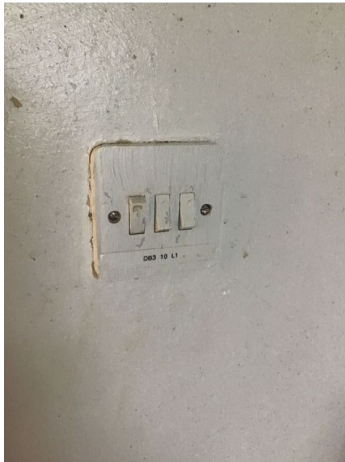
<p>Room ALL</p> <p>Location ALL</p> <p>Item Electrical Services - Sub Main Dist - Lighting Wiring & Accessories</p>

Block Element	Condition	Rating	RSL	Measurement	Unit	Unit Rate	Cost	Comments	
Block 1	Lighting Wiring & Accessories	C	2	2	30 PA	M2	33.2288	£2443.31	Lighting wiring and accessories appear in poor condition. Renew

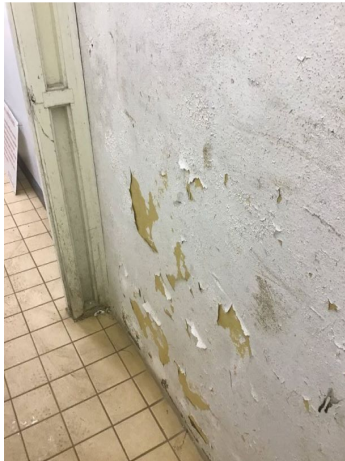
<p>Room ALL</p> <p>Location ALL</p> <p>Item Redecoration - Internal - Walls & internal joinery, windows & doors - Finished</p>

Block 1 Finished	C	2	1	25 PA	m2	17.23	£1055.77	Flaking paint visible to areas
Block 1 Finished	B	3	3	20	m2	17.23	£844.61	
Block 1 Finished	A	4	5	30	m2	17.23	£1266.92	
Block 1 Finished	B	3	4	30	m2	17.23	£1266.92	
Block 1 Finished	A	4	5	80	m2	17.23	£3378.46

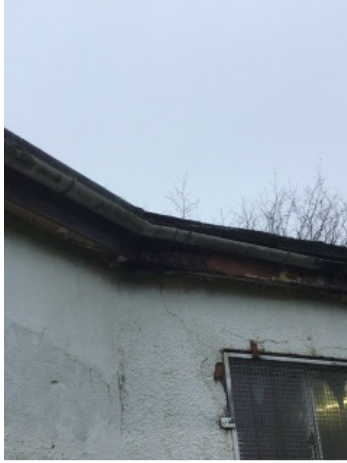
<p>Room ALL</p> <p>Location ALL</p> <p>Item Roofs - Roof Coverings - Built-Up Felt Roof - Double</p>

Block 1	Built-Up Felt Roof - Double	C	2	1	10 PA	m2	120	£980.40	The built up felt flat roof is in poor condition and nearing the end of its serviceable life.
Block 1	UPVC Gutters and downpipes	C	2	2	100 PP	lm	45	£2250.00	The UPVC (with isolated aluminium downpipes) guttering and downpipes are in poor condition with several areas missing and / or damaged.
Block 1	Timber Fascia/Soffit	C	2	2	100 PP	lm	56.4	£2820.00	The timber fascias and soffits are in poor condition with rot and deterioration visible.
Block 1	Concrete Tiles	B	3	10	90 PA	m2	40	£8823.60

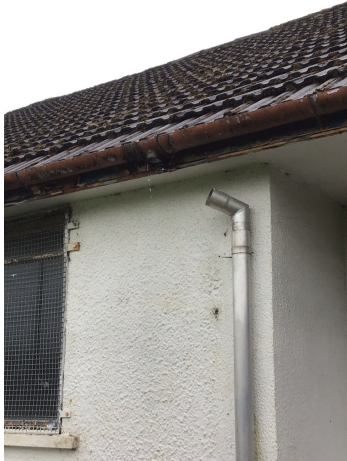
<p>Room ALL</p> <p>Location ALL</p> <p>Item Roofs - Roof Drainage - UPVC Gutters and downpipes</p>

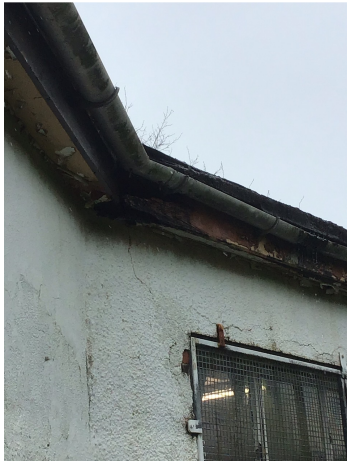
<p>Room ALL</p> <p>Location ALL</p> <p>Item Roofs - Roof Coverings - Timber Fascia/Soffit</p>

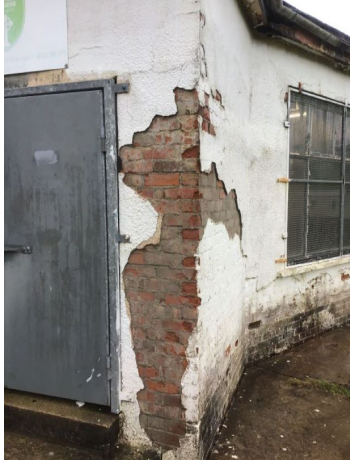
Sections of the external render are blown and require repair, particularly to the front elevation. The single glazed crittal framed window are also beyond their serviceable life and require replacement.

<p>Room ALL</p> <p>Location ALL</p> <p>Item External Walls, Windows & Doors - External Walls - Render</p>

Block 1	Softwood Casement	B	3	5	5 PA	m2	450	£4500.00	
Block 1	Brick	B	3	30	20 PA	m2	90	£3600.00	
Block 1	Render	C	2	3	15 PA	m2	25	£750.00	Several sections of loose / damaged render to the external walls.
Block 1	Steel unglazed	B	3	25	4	nr	1099.8	£4399.20	
Block 1	Render	B	3	12	60 PA	m2	25	£3000.00	
Block 1	PVC	A	4	20	2	nr	282	£564.00

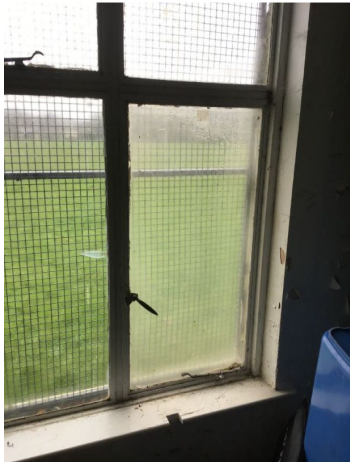
<p>Room ALL</p> <p>Location ALL</p> <p>Item External Walls, Windows & Doors - External Windows - Steel Casement</p>

Block Element	Condition	Rating	RSL	Measurement	Unit	Unit Rate	Cost	Comments	
Block 1	Steel Casement	C	2	5	10 PA	m2	1057.5	£21150.00 0	The single glazed crittal framed external windows are in poor condition and nearing the end of their serviceable life.
