Bridgend Estates Surveys

Llangeinor Pavillion Summary Report

Bridgend County Borough Council

28/02/2020

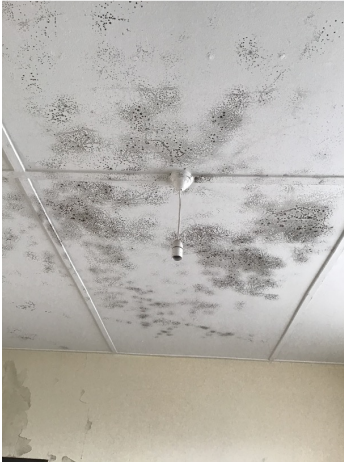
<p>Block / Element Block 1 - Finished</p> <p>Description Ceilings in a poor condition throughout.</p> <p>Ref Photo 27-02-2020 11.02.27.jpg</p>

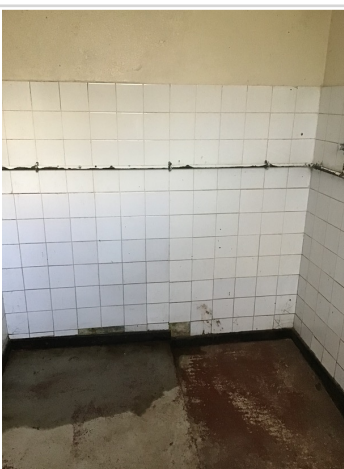
<p>Block / Element Block 1 - Ceramic Tiles</p> <p>Description Tiles are in a poor condition. Several areas have been repaired/replaced</p> <p>Ref Photo 27-02-2020 11.08.09.jpg</p>

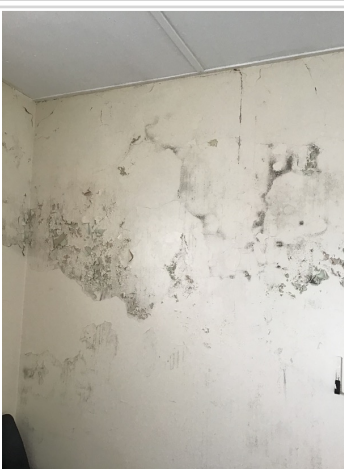
<p>Block / Element Block 1 - Finished</p> <p>Description Walls throughout are in a poor condition with flaking or marked paintwork throughout.</p> <p>Ref Photo 27-02-2020 11.08.44.jpg</p>

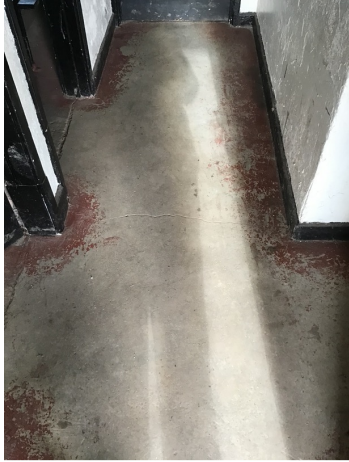
<p>Block / Element Block 1 - Other</p> <p>Description Screed finish has worn away to rooms to the right half of the block</p> <p>Ref Photo 27-02-2020 11.04.37.jpg</p>

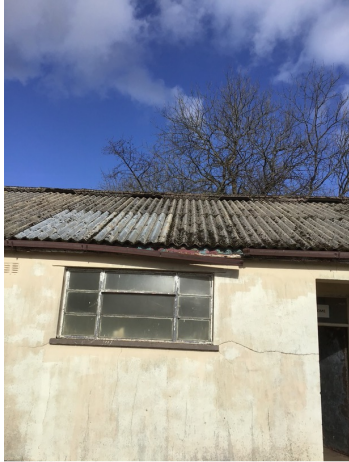
<p>Block / Element Block 1 - Fibre Cement</p> <p>Description Asbestos containing material in a poor condition</p> <p>Ref Photo 27-02-2020 11.14.07.jpg</p>

Block 1 - Fibre Cement	D	1	1	100	PA	m2	60	£9,582.00	Photo 27-02-2020 11.14.07.jpg	Asbestos containing material in a poor condition
Block 1 - UPVC Gutters and downpipes	C	3	1	100	PP	lm	45	£2,250.00	Photo 27-02-2020 11.14.59.jpg	All rainwater goods in a poor condition throughout.
Block 1 - Timber Fascia/Soffit	C	2	1	100	PP	lm	56.4	£2,820.00	Photo 27-02-2020 11.16.06.jpg	Fascias and soffits in a poor condition throughout

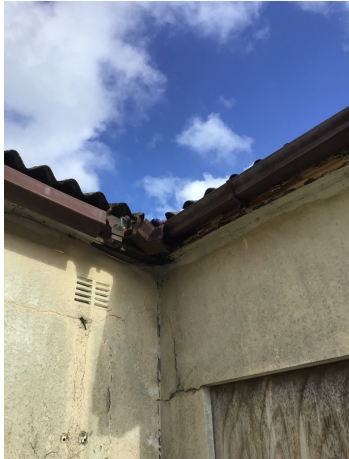
<p>Block / Element Block 1 - UPVC Gutters and</p> <p>Description All rainwater goods in a poor condition throughout.</p> <p>Ref Photo 27-02-2020 11.14.59.jpg</p>

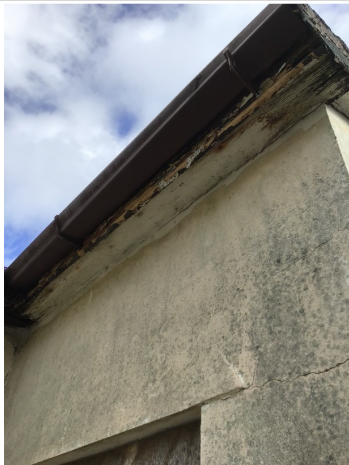
<p>Block / Element Block 1 - Timber Fascia/Soffit</p> <p>Description Fascias and soffits in a poor condition throughout</p> <p>Ref Photo 27-02-2020 11.16.06.jpg</p>

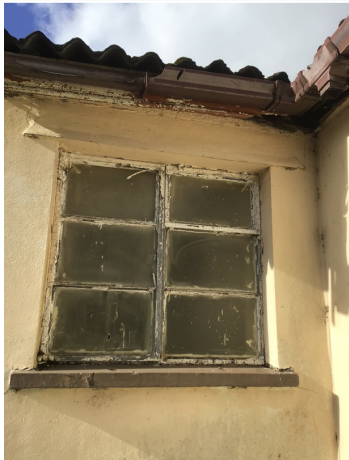
<p>Block / Element Block 1 - Steel Casement</p> <p>Description Windows throughout are in a very poor condition. Windows appear original.</p> <p>Ref Photo 27-02-2020 11.17.22.jpg</p>

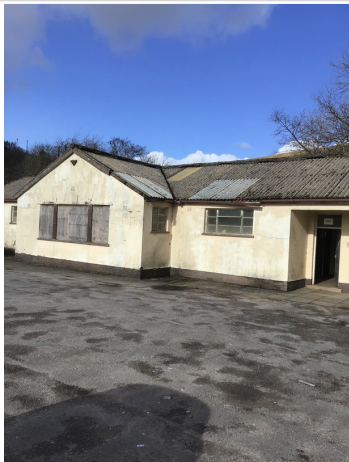
<p>Block / Element Block 1 - Solid Core Timber Steel</p> <p>Description Doors are in a poor condition</p> <p>Ref Photo 27-02-2020 11.35.21.jpg</p>

Block 1 - Solid Core Timber Steel Plated	C	3	1	4	COUNT	nr	1128	£4,512.00	Photo 27-02-2020 11.35.21.jpg	Doors are in a poor condition
Block 1 - Render	C	2	1	60	PF	m2	25	£2,025.00	Photo 27-02-2020 11.36.22.jpg	Render has blown in several places with cracks to the remaining.

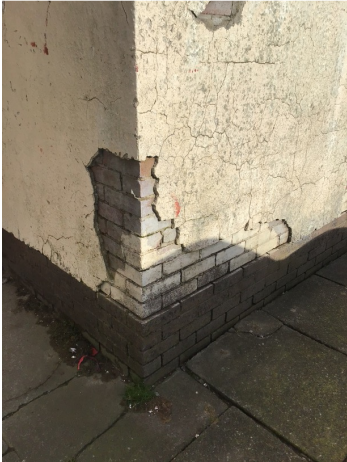
<p>Block / Element Block 1 - Render</p> <p>Description Render has blown in several places with cracks to the remaining.</p> <p>Ref Photo 27-02-2020 11.36.22.jpg</p>

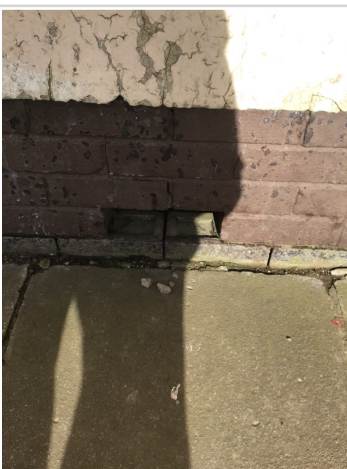
<p>Block / Element Block 1 - Brick</p> <p>Description Repairs to brickwork where bricks have been removed.</p> <p>Ref Photo 27-02-2020 11.37.56.jpg</p>

Block 1 - Brick	B	3	15	15	PF	m2	90	£1,822.50	Photo 27-02-2020 11.37.56.jpg	Repairs to brickwork where bricks have been removed.
Floors and Stairs										Identified item total: £11,258.85 Backlog cost total (C/D): £5,629.43
Block 1 - Other	B	3	3	50	PA	m2	70.5	£5,629.43		
Block 1 - Other	C	2	1	50	PA	m2	70.5	£5,629.43	Photo 27-02-2020 11.04.37.jpg	Screed finish has worn away to rooms to the right half of the block
Internal Walls and Doors										Identified item total: £11,788.43 Backlog cost total (C/D): £3,832.80
Block 1 - Ceramic Tiles	C	2	1	30	PA	m2	80	£3,832.80	Photo 27-02-2020 11.08.09.jpg	Tiles are in a poor condition. Several areas have been repaired/replaced
Block 1 - Render/Plaster	B	3	10	85	PA	m2	25	£3,393.63		
Block 1 - Timber Skirting	B	3	8	60	PP	m	20	£600.00		
Block 1 - Hollow Core Timber	B	3	3	14	COUNT	nr	283	£3,962.00		
Mechanical Services										Identified item total: £11,941.60 Backlog cost total (C/D): £11,941.60

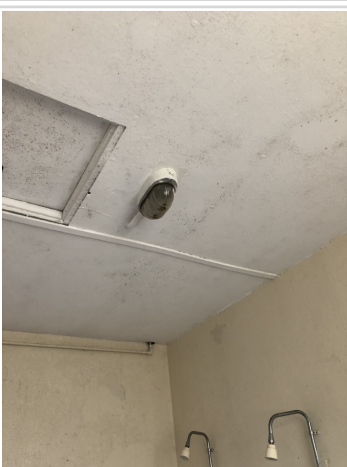
<p>Block / Element Block 1 - Luminaires</p> <p>Description Original luminaires beyond anticipated life cycle. Renew in the short term</p> <p>Ref IMG_4423.JPG</p>

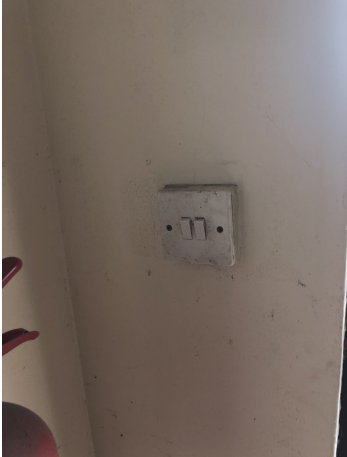
<p>Block / Element</p> <p>Block 1 - Lighting Wiring &</p> <p>Description</p> <p>Original lighting wiring and accessories at the end of anticipated life cycle. Renew in the short term</p> <p>Ref</p> <p>IMG_4409.JPG</p>

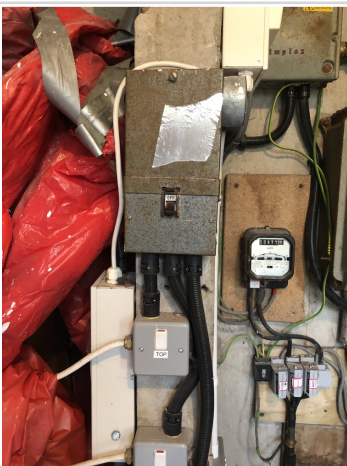
<p>Block / Element</p> <p>Block 1 - Small Power Wiring &</p> <p>Description</p> <p>Original small power wiring and accessories at the end of anticipated life cycle. Renew in the short term</p> <p>Ref</p> <p>IMG_4397.JPG</p>

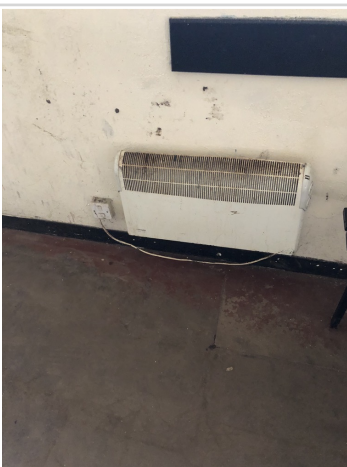
<p>Block / Element</p> <p>Block 1 - Electric Heater</p> <p>Description</p> <p>Electrical convector heaters beyond anticipated life cycle. Renew in the short term</p> <p>Ref</p> <p>IMG_4421.JPG</p>

Block 1 - Electric Heater	C	1	1	2	COUNT	Nr	1038.4	£2,076.80	IMG_4421.JPG	Electrical convector heaters beyond anticipated life cycle. Renew in the short term
Block 1 - LTHW Calorifier	C	2	1	2	COUNT	Nr	3634.4	£7,268.80	IMG_4400.JPG	Calorifiers at the end of anticipated life cycle. Renew
Block 1 - Cold Water Tank	C	2	1	1	COUNT	Nr	2596	£2,596.00	IMG_4401.JPG	Cold water storage tank at the end of anticipated life cycle. Renew in the short term
Redecoration										Identified item total: £4,265.03 Backlog cost total (C/D): £4,265.03
Block 1 - Finished	C	2	1	100	PA	m2	17.23	£2,751.63	Photo 27-02-2020 11.02.27.jpg	Ceilings in a poor condition throughout.
Block 1 - Finished	C	2	1	55	PA	m2	17.23	£1,513.40	Photo 27-02-2020 11.08.44.jpg	Walls throughout are in a poor condition with flaking or marked paintwork throughout.
Roofs										Identified item total: £14,652.00 Backlog cost total (C/D): £14,652.00

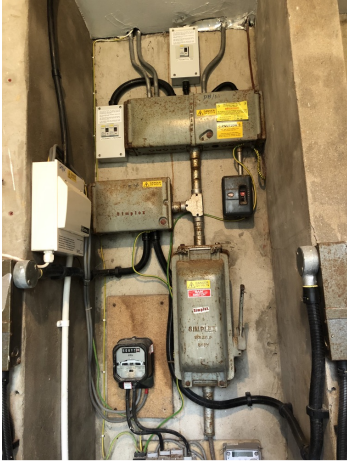
<p>Block / Element</p> <p>Block 1 - Isolator</p> <p>Description</p> <p>Main and sub main isolators beyond anticipated life cycle. Renew in the short term</p> <p>Ref</p> <p>IMG_4396.JPG</p>

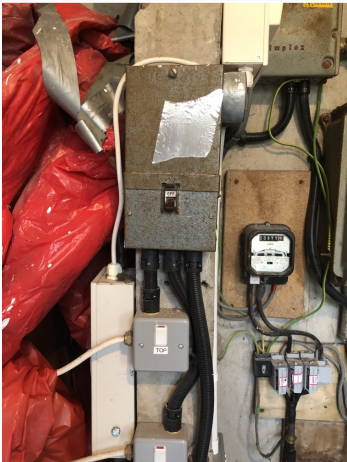
<p>Block / Element</p> <p>Block 1 - Mains Cabling</p> <p>Description</p> <p>Original main cable beyond anticipated life cycle. Renew in the short term</p> <p>Ref</p> <p>IMG_4397.JPG</p>

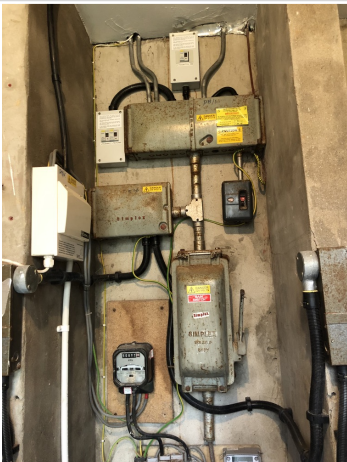
<p>Block / Element</p> <p>Block 1 - Distribution Board</p> <p>Description</p> <p>Original HRC type distribution boards beyond anticipated life cycle. Renew</p> <p>Ref</p> <p>IMG_4396.JPG</p>

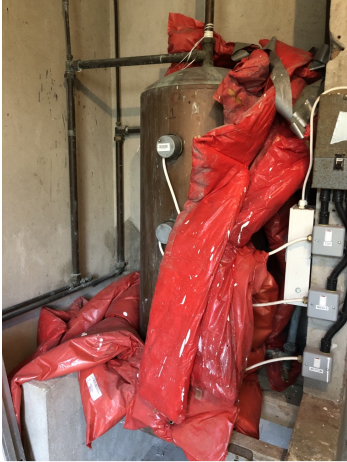
<p>Block / Element Block 1 - LTHW Calorifier</p> <p>Description Calorifiers at the end of anticipated life cycle. Renew</p> <p>Ref IMG_4400.JPG</p>

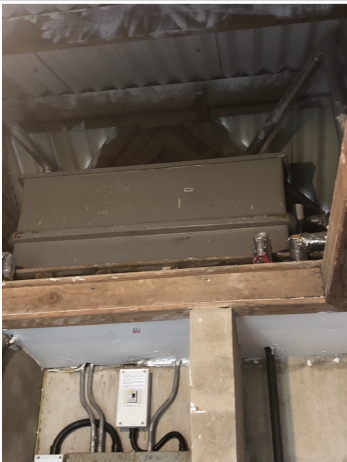
<p>Block / Element Block 1 - Cold Water Tank</p> <p>Description Cold water storage tank at the end of anticipated life cycle. Renew in the short term</p> <p>Ref IMG_4401.JPG</p>
