In Respect Of:-

**Llangeinor Football Club, Bettws Road,
Bridgend CF32 8PG**

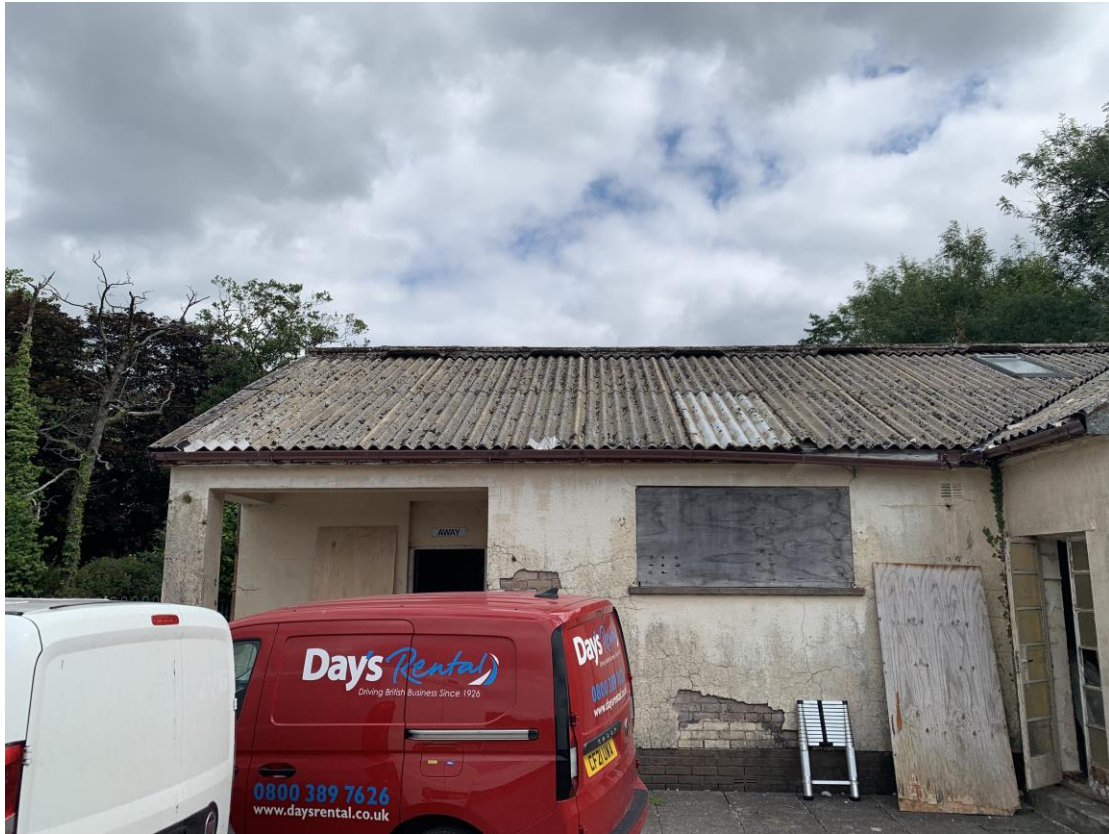
Photograph showing part view of the left hand side front roof slope. Impact damage along with previous patch repairs noted.

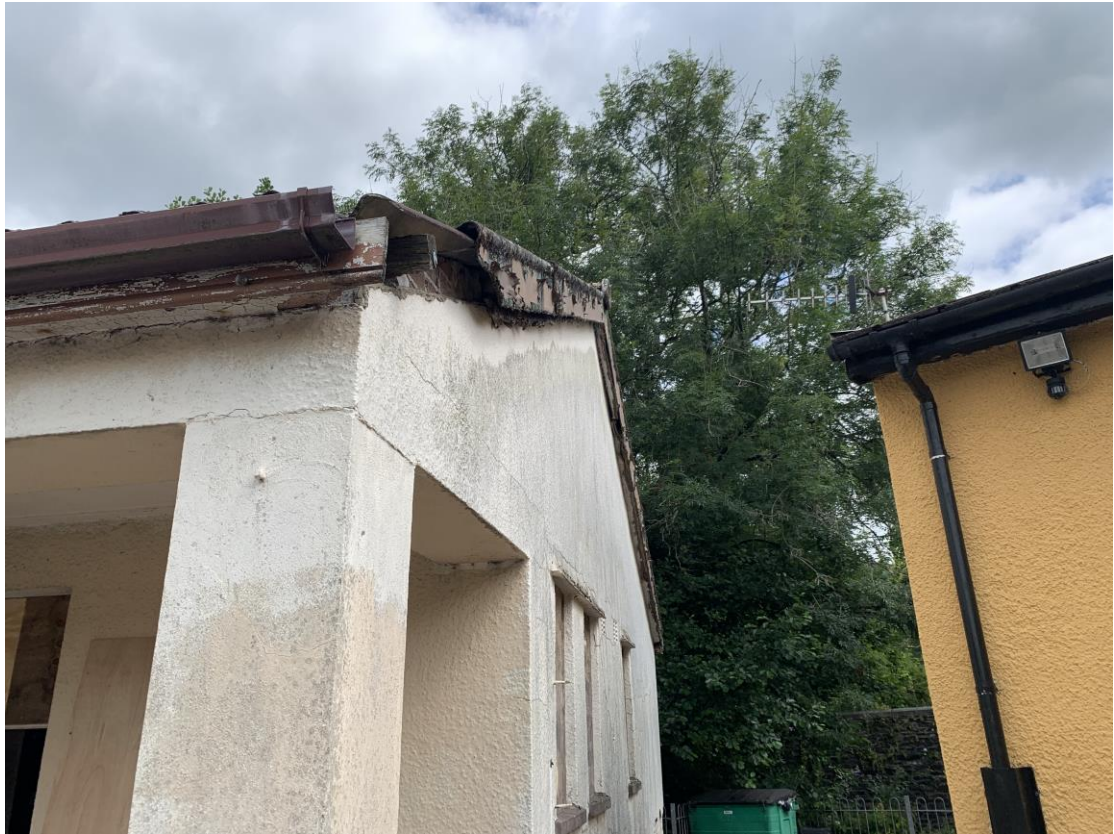
Photograph showing view of the front right corner gable where the fibre cement trim to eaves has been removed/missing.

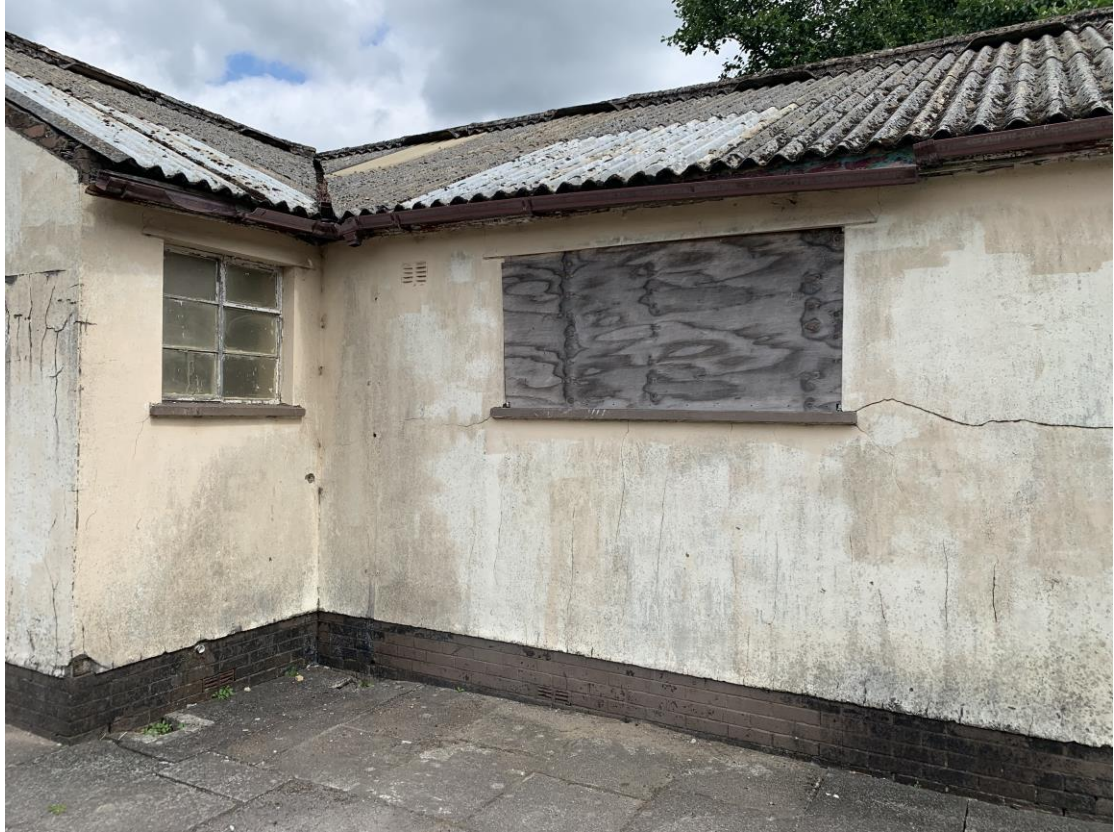
Photograph showing part view of the right side of roof to front. Previous patch repairs and impact damage noted.

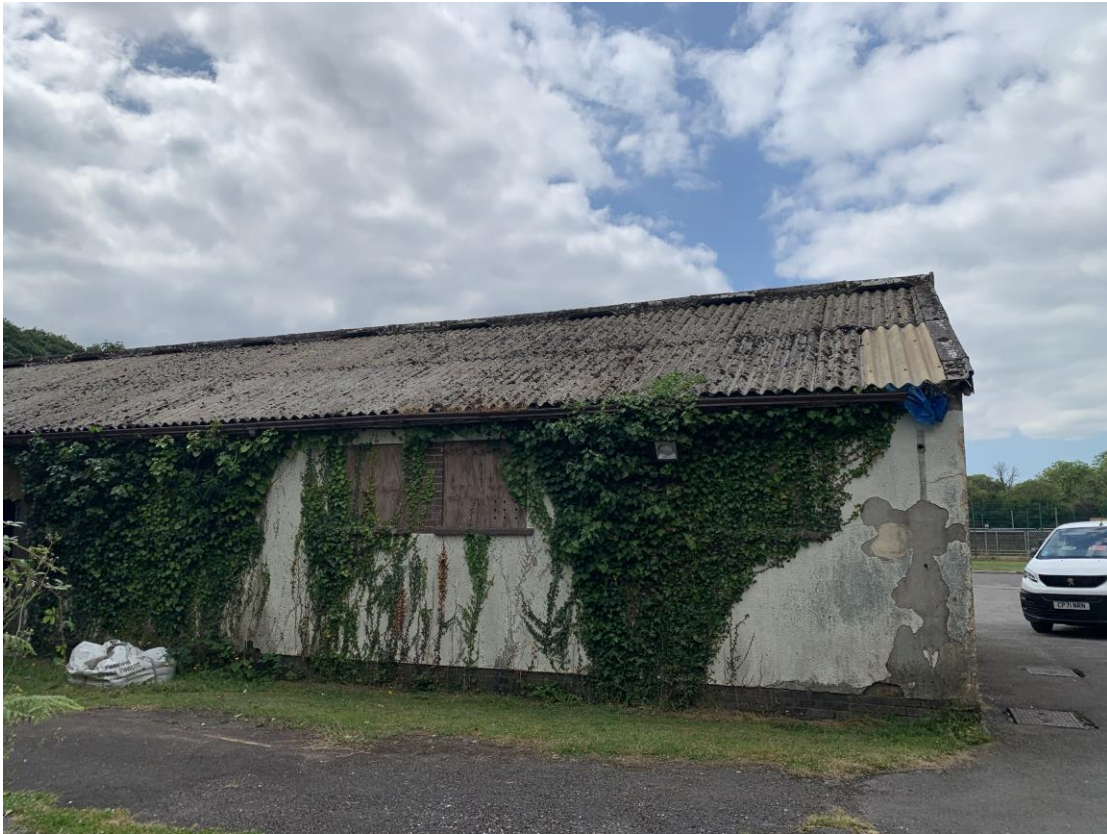
Photograph showing part view of the rear left corner roof. Previous patch repairs undertaken with a GRP sheet covering. Moss growth and scaling of the roof covering noted.

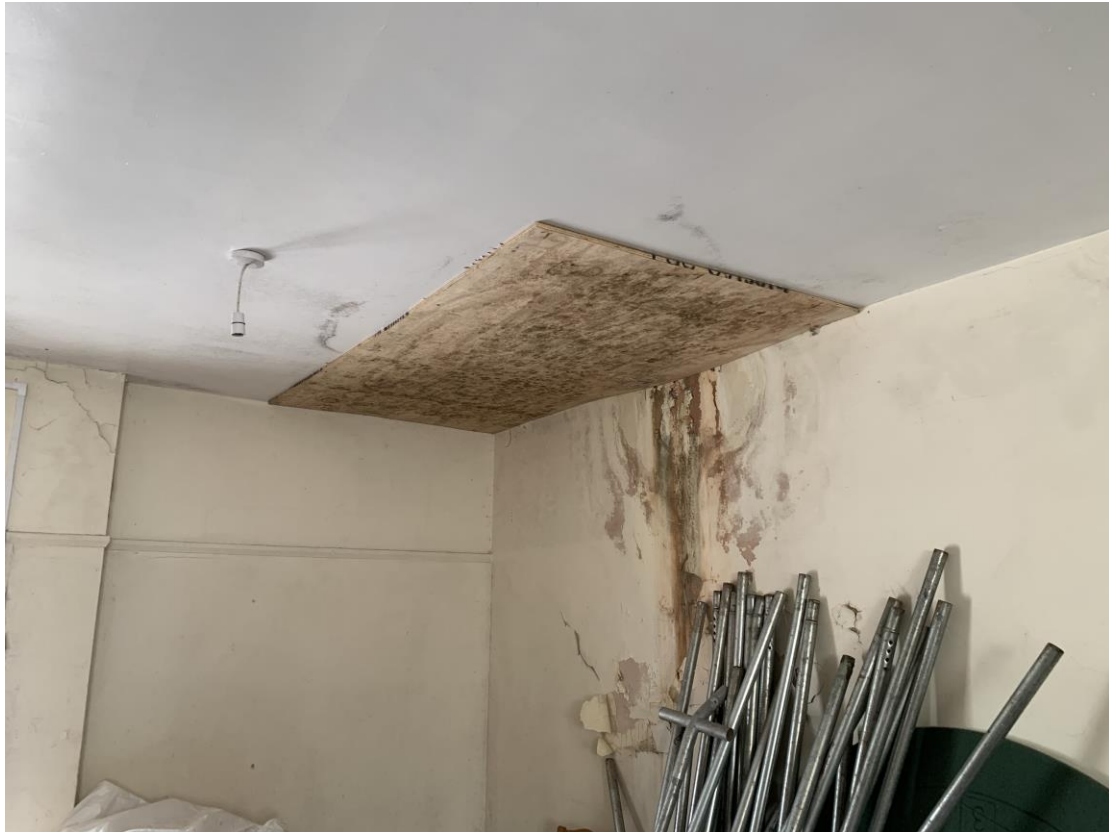
Photograph showing one area where water ingress was noted to the front reception room.

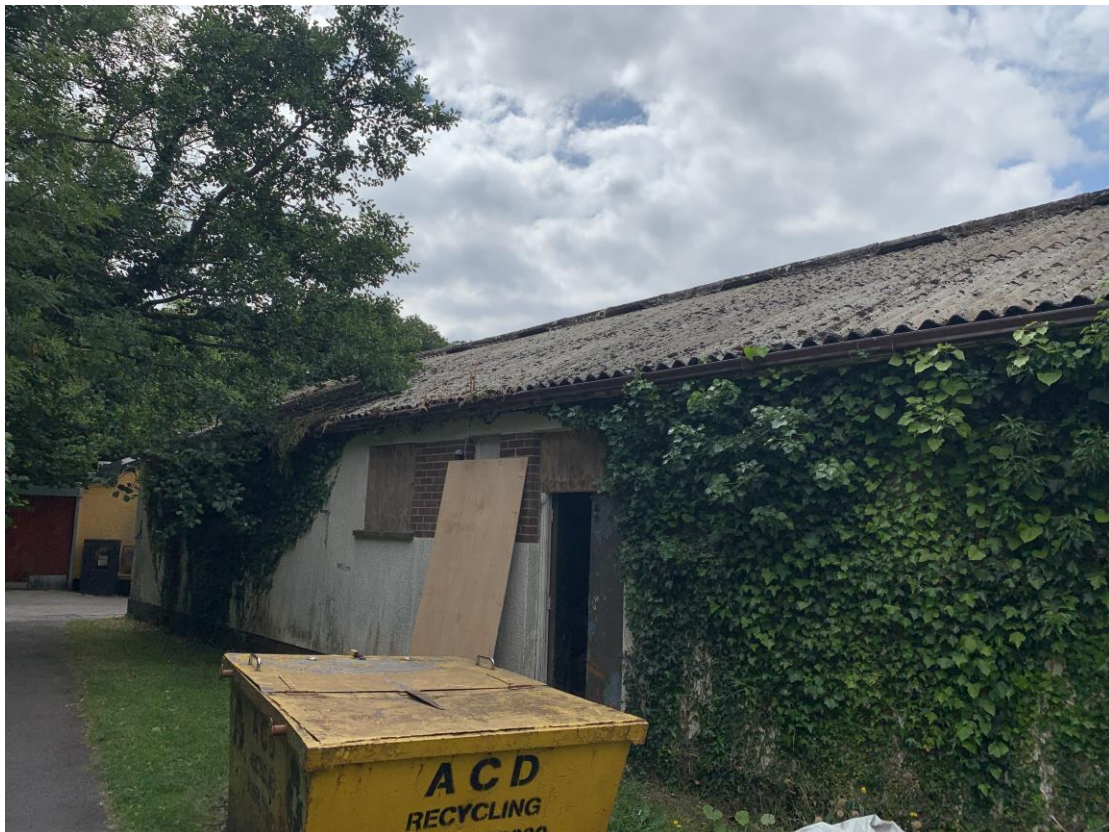
Photograph showing part view of rear elevation where UPVC guttering was noted subject to extensive debris and vegetation growth.

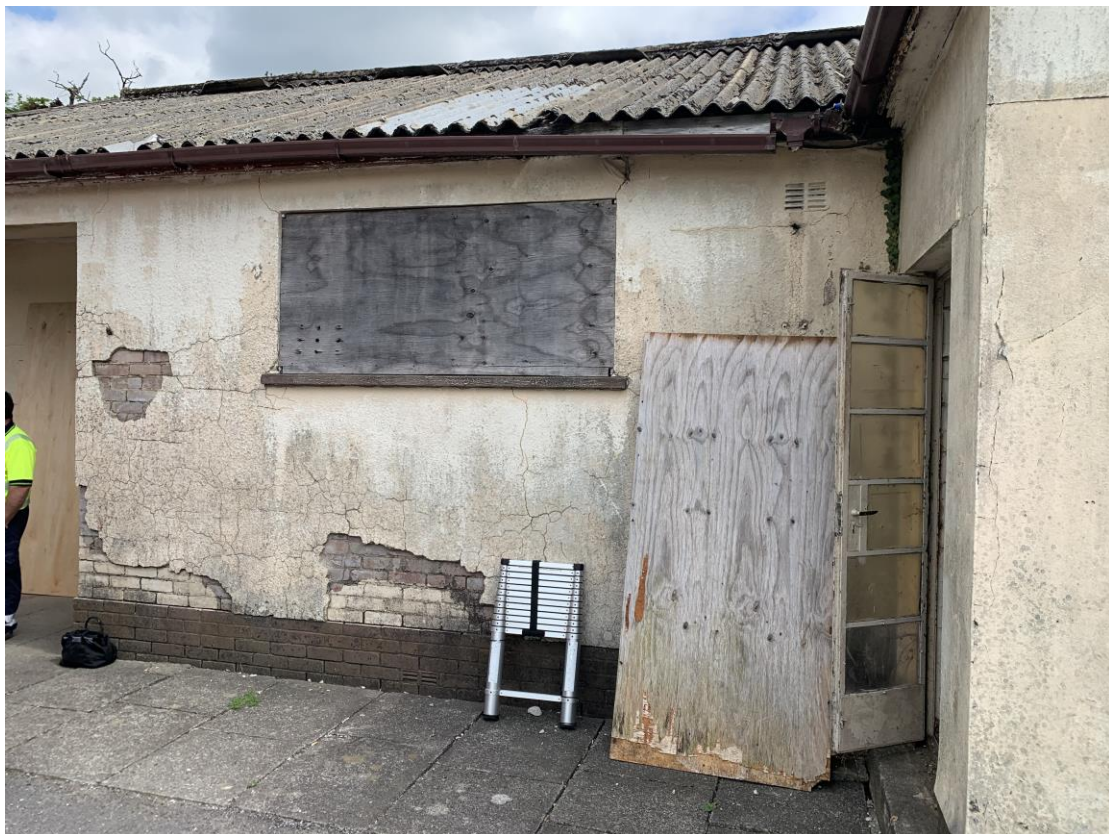
Photograph showing part view of the front elevation to left side. Cracking noted around structural members forming openings and also extensive cracking, de-bonding of the render finishes.

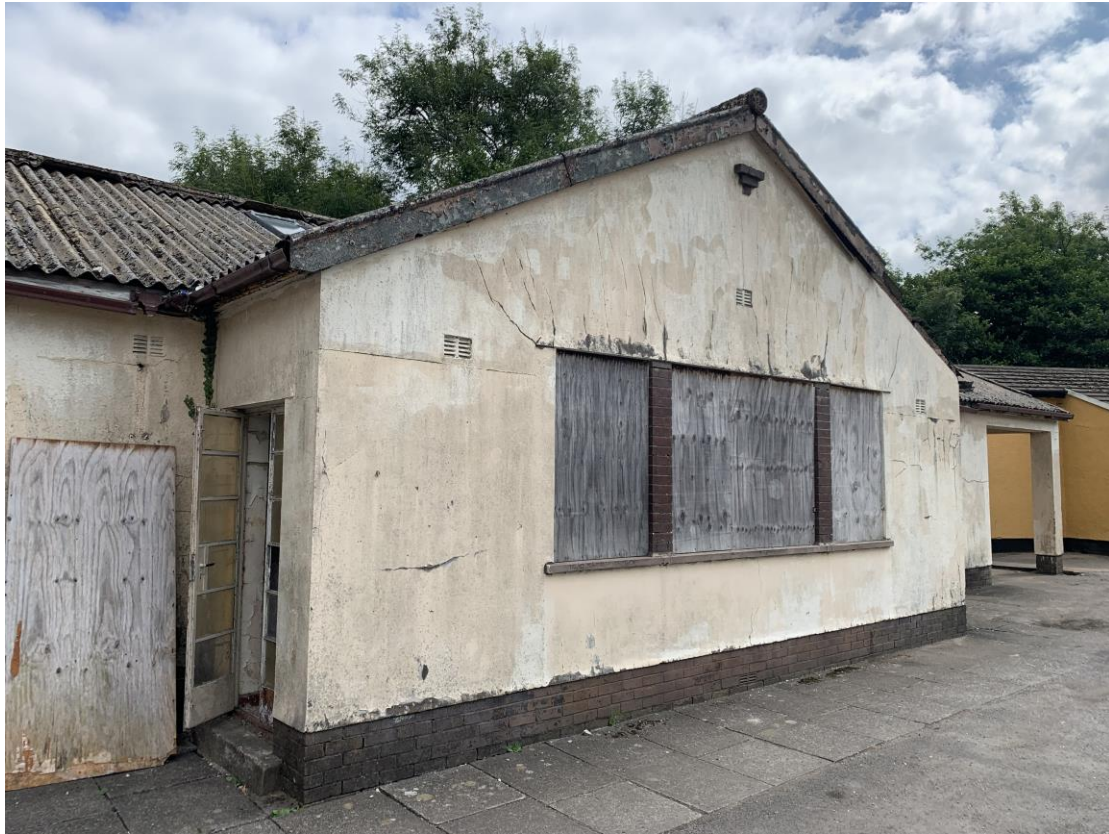
Photograph showing part view of front elevation where extensive cracking/de-bonding of the render was noted above windows.

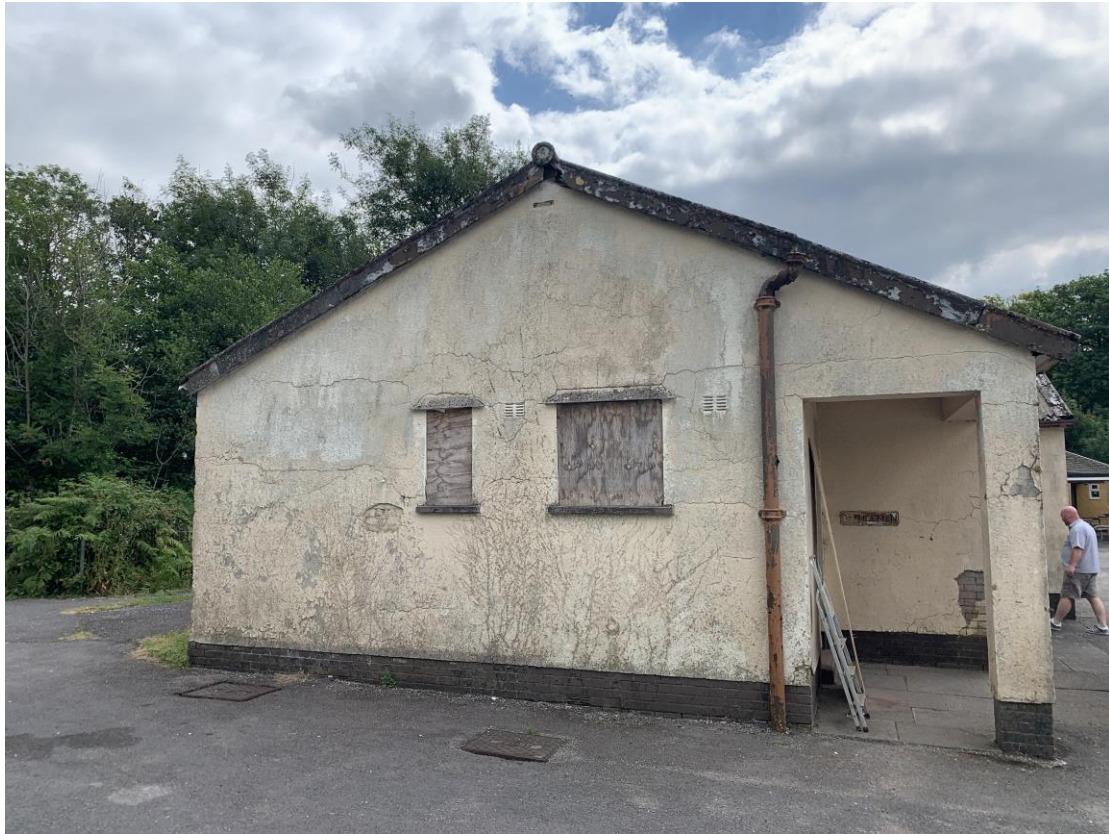
Photograph showing view of the left side gable elevation. Extensive cracking and de-bonding of render noted in several locations.

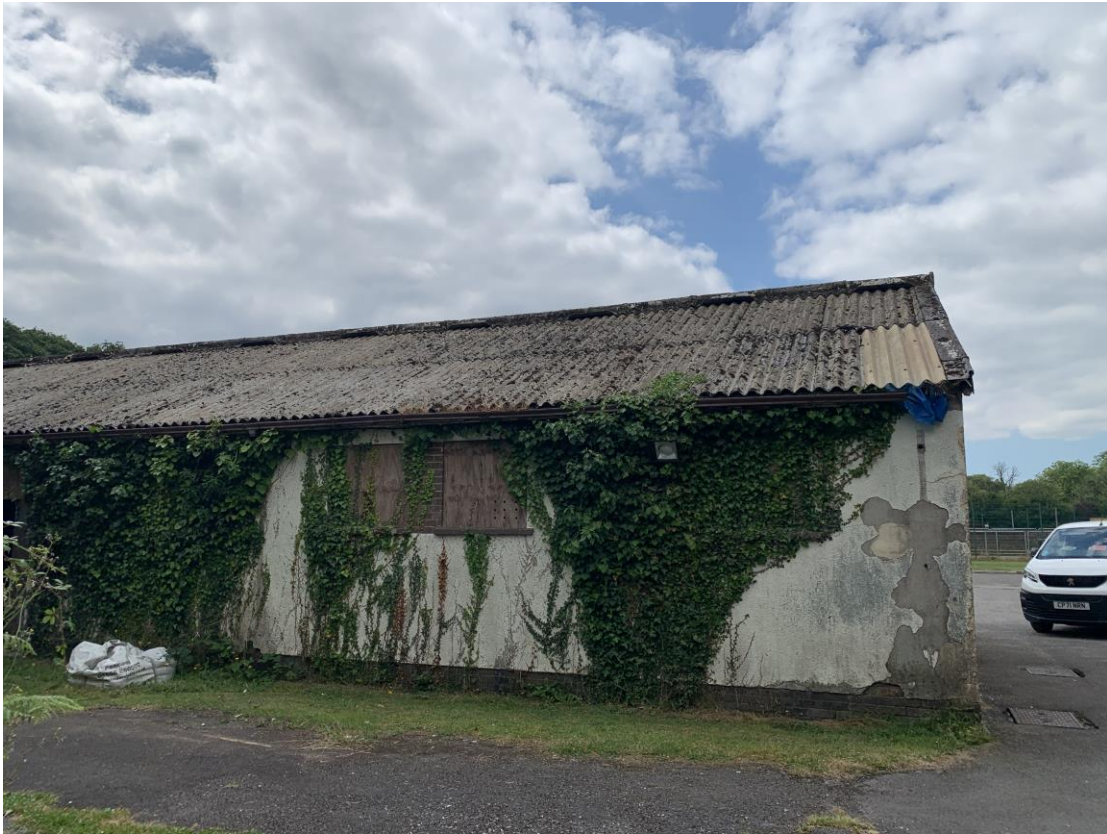
Photograph showing extensive vegetation growth to rear elevation. Also cracking, hollow and de-bonded sections of render noted.

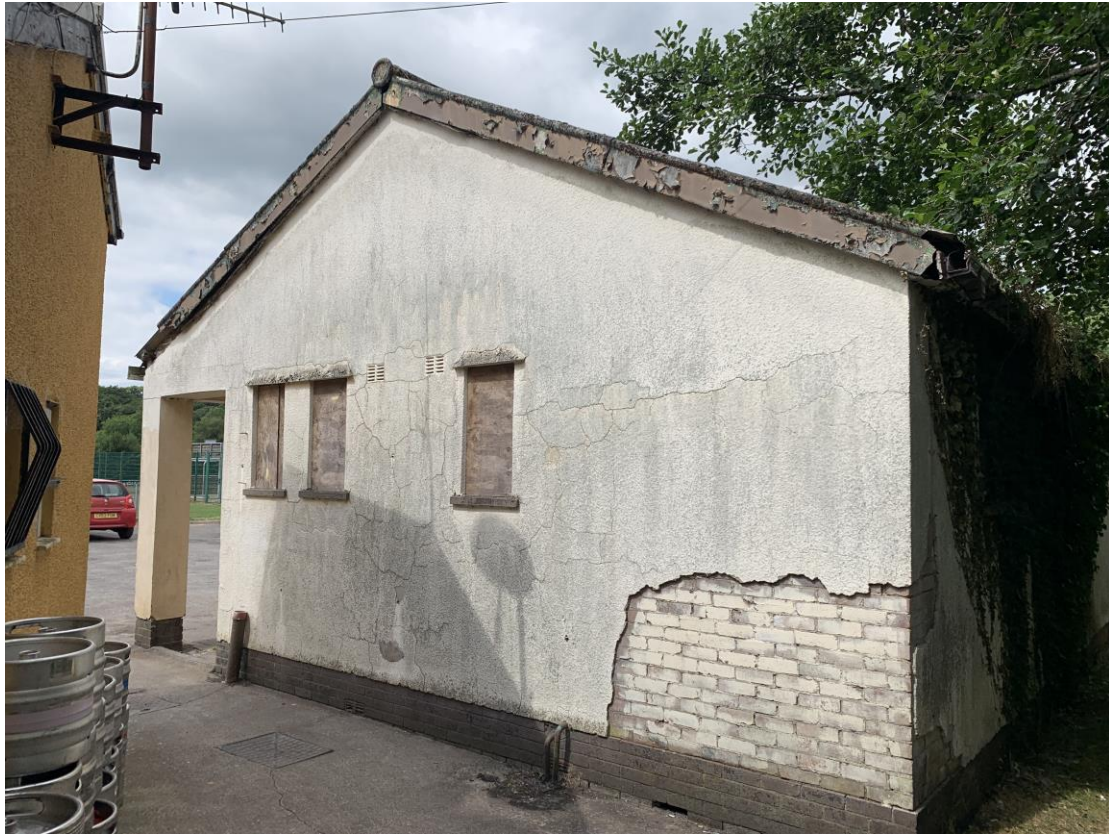
Photograph showing view of the right side gable elevation. Extensive cracking, hollow and de-bonded sections of render noted.

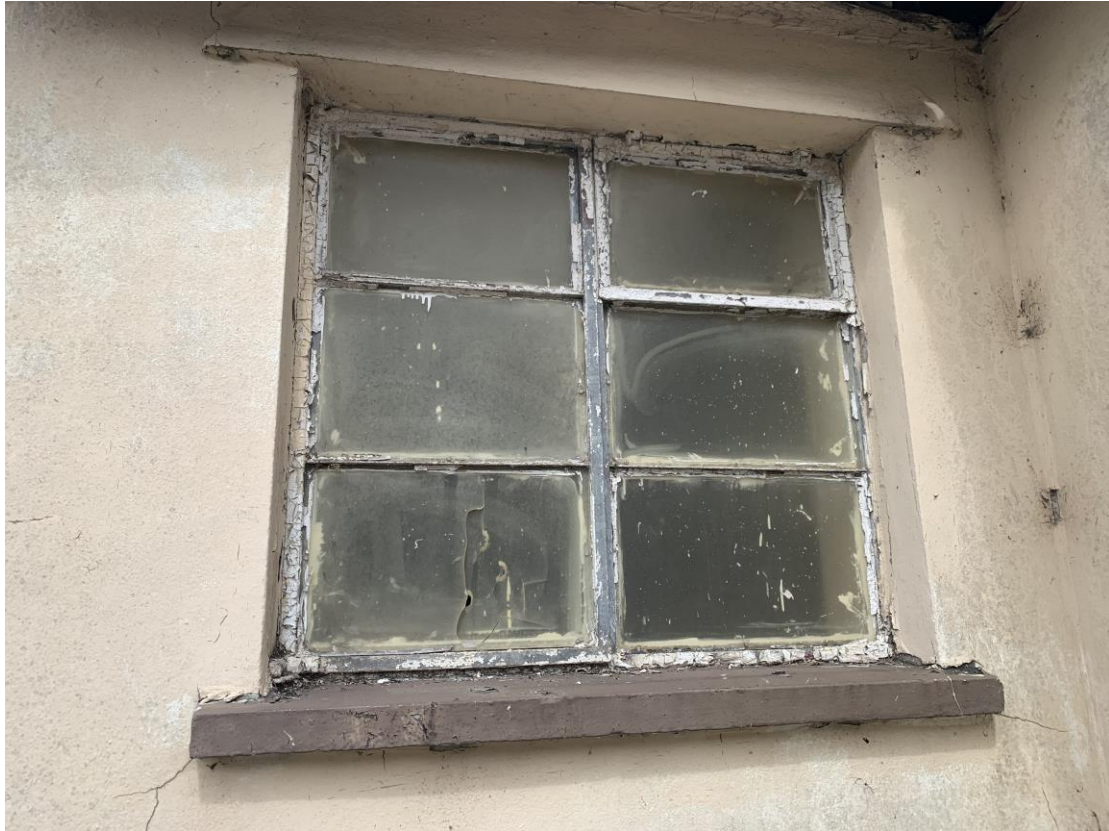
Photograph showing typical example of the window condition.

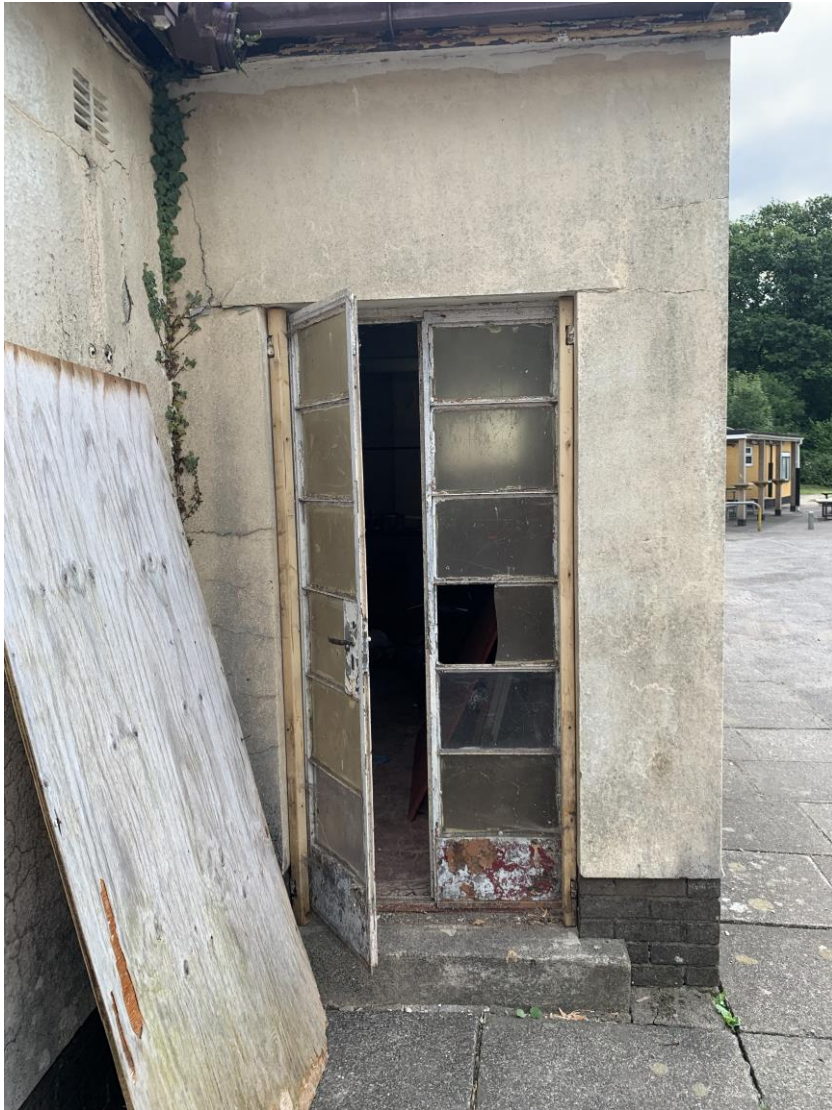
Photograph showing example of the poor condition of the steel crittall single glazed doors to front reception room.

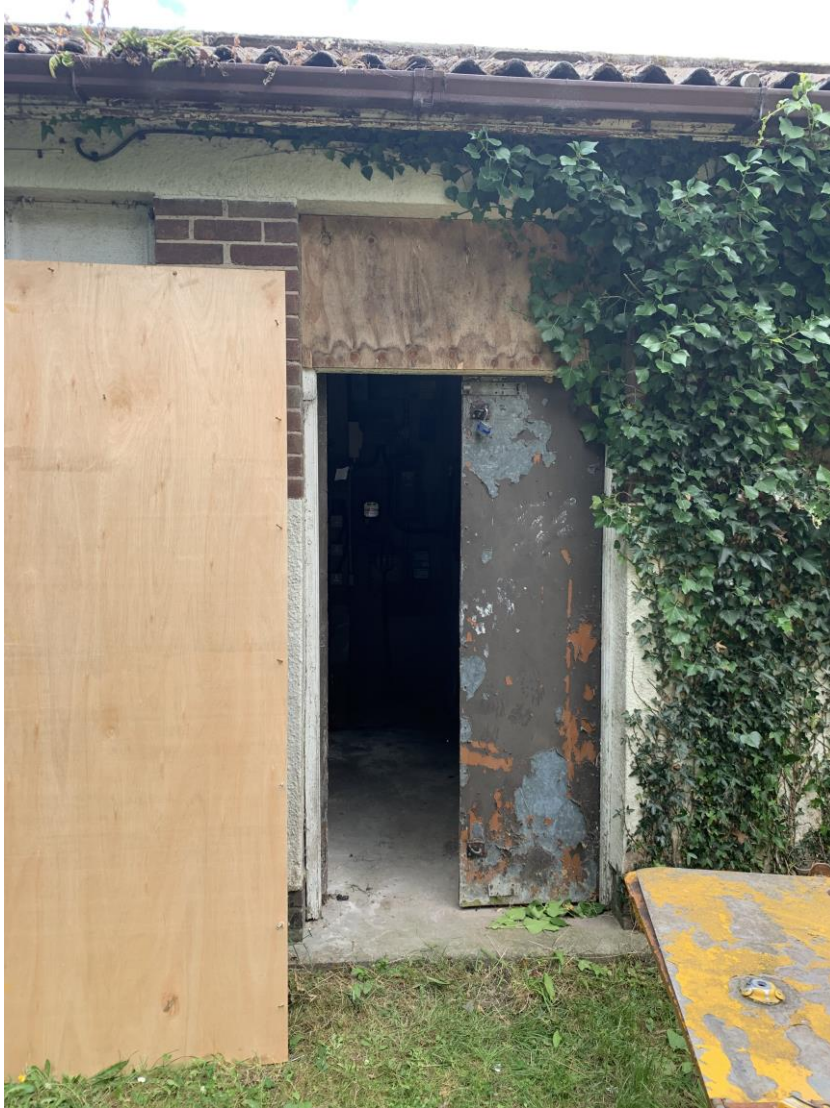
Photograph showing example of the condition to the timber door sets to rear store/boiler room.

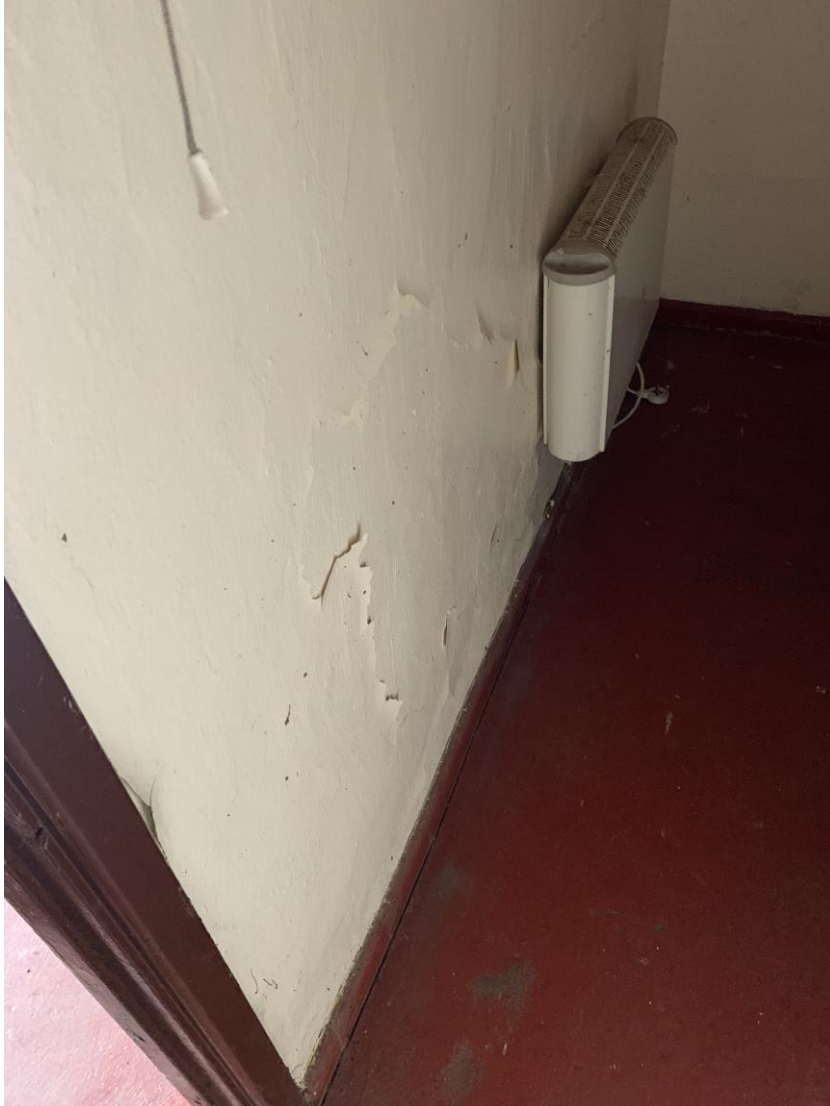
Photograph showing example of uneven surface finishes and de-bonded paint coatings along with low level contamination of plaster to internal walls.

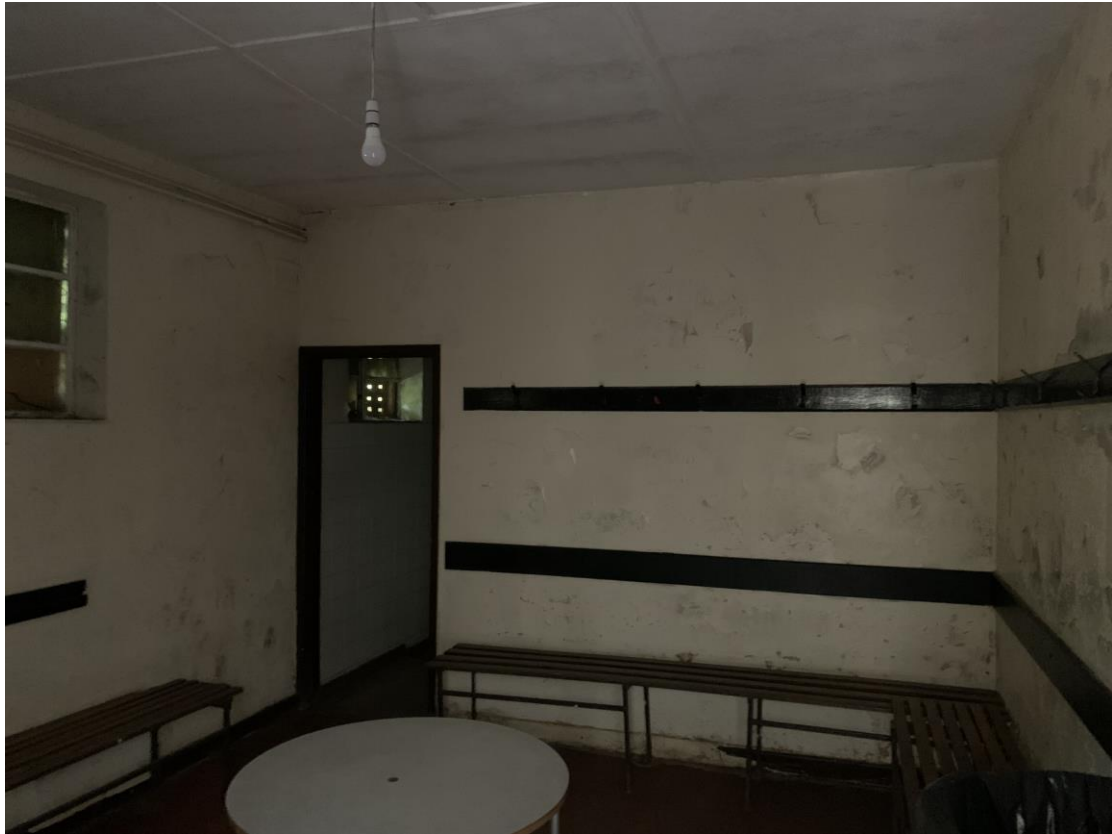
Photograph showing extensive contamination of plaster and de-bonding of paint coatings. Also extensive staining and discolouration noted to walls.

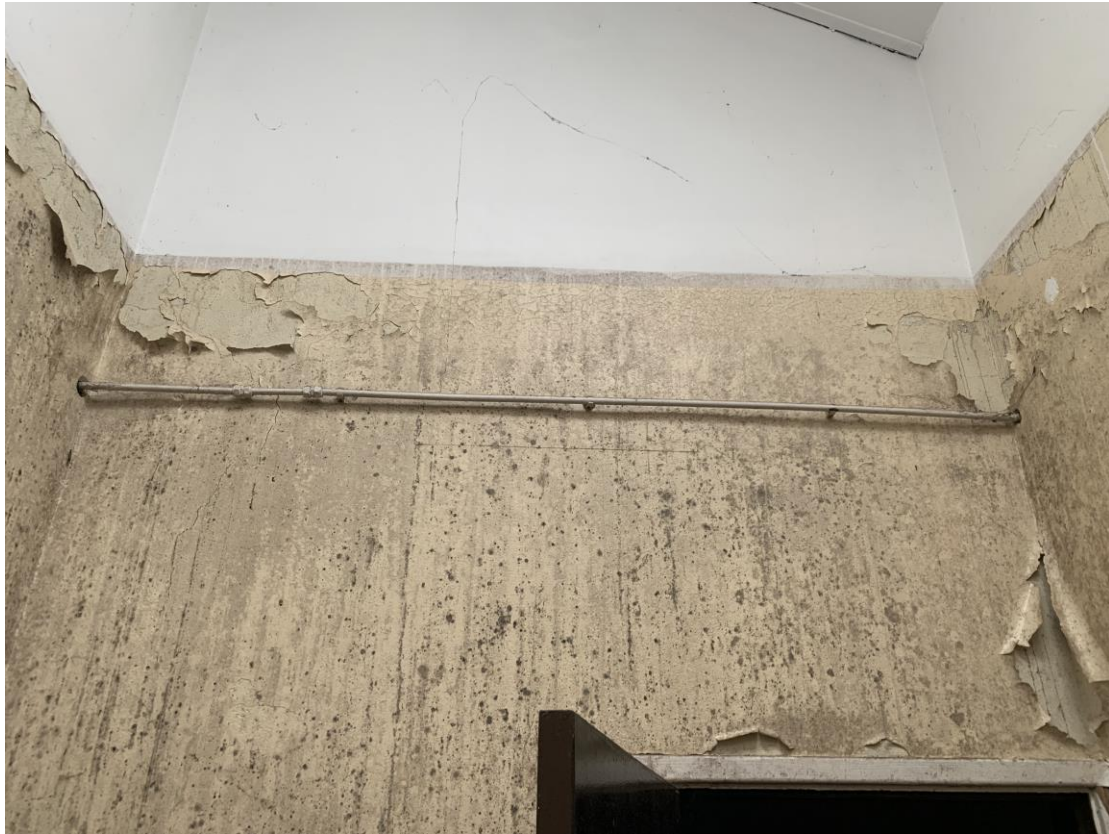
Photograph showing extensive de-bonding of decorative coatings along with black mould growth to wall finishes.

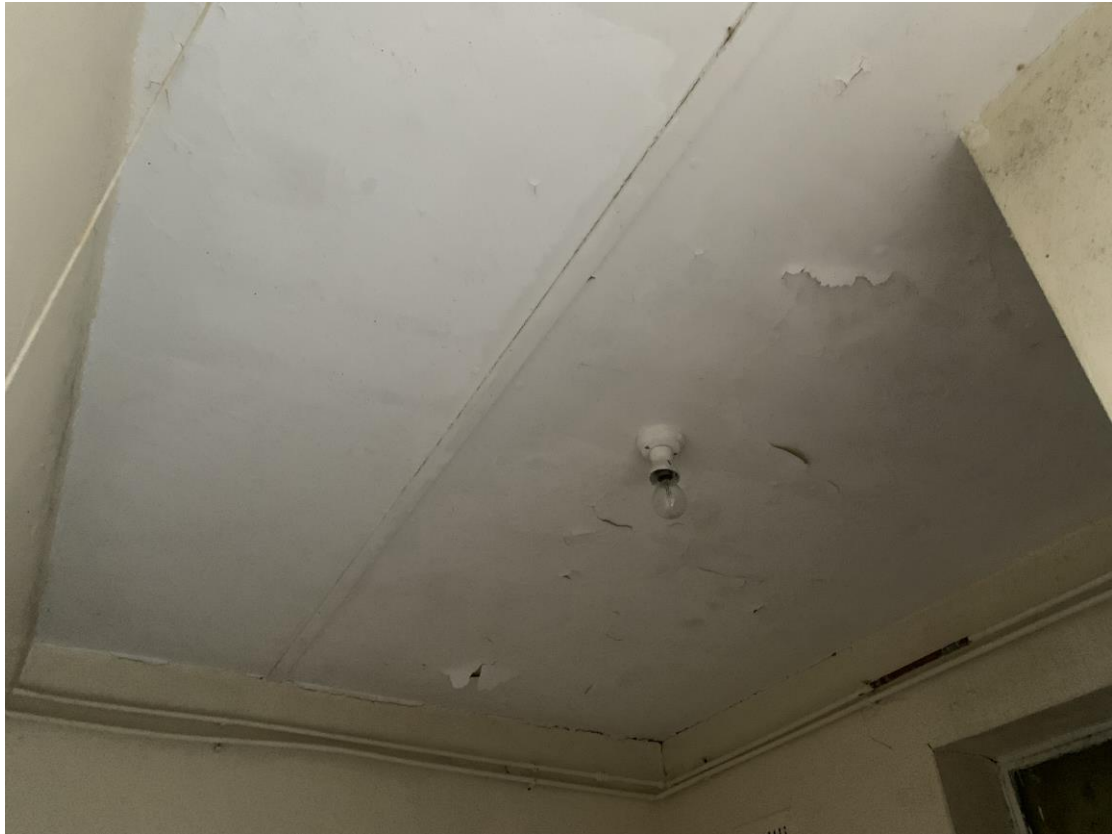
Photograph showing view of a fibre cement ceiling subject to extensive debonding of decorative finishes.

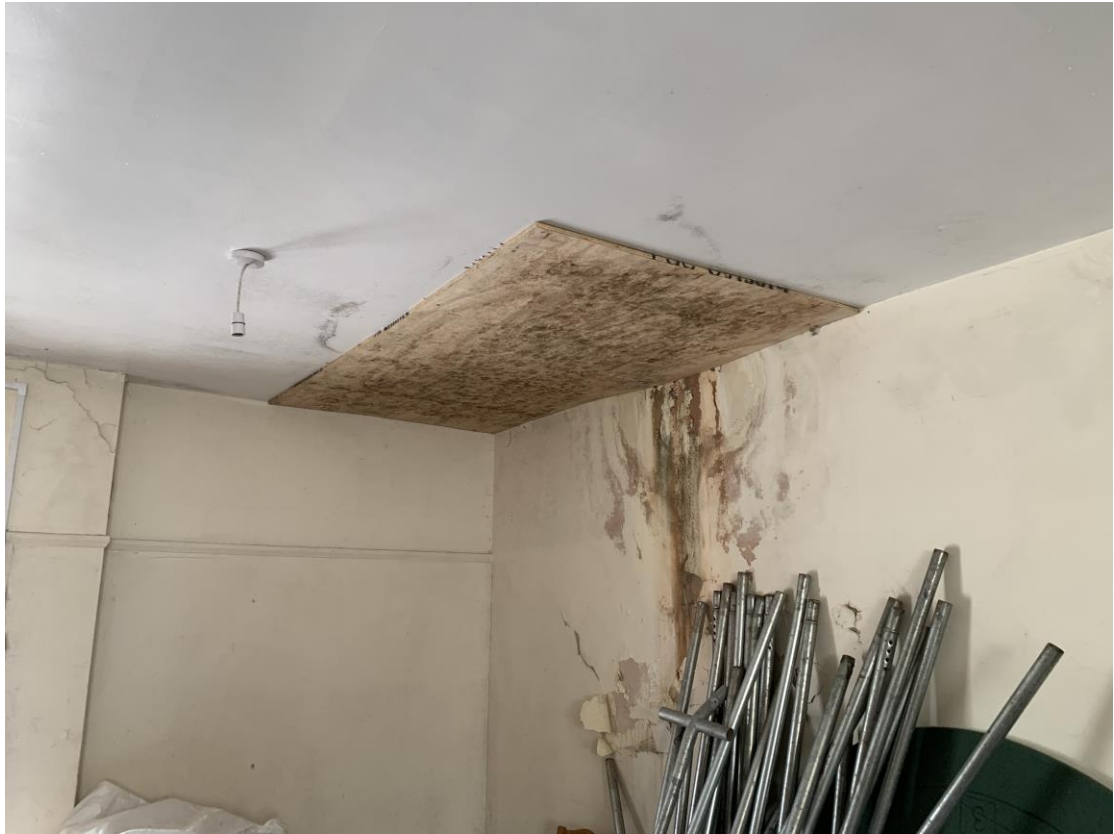
Photograph showing example of water damage to ceiling to the front reception/bar room area.

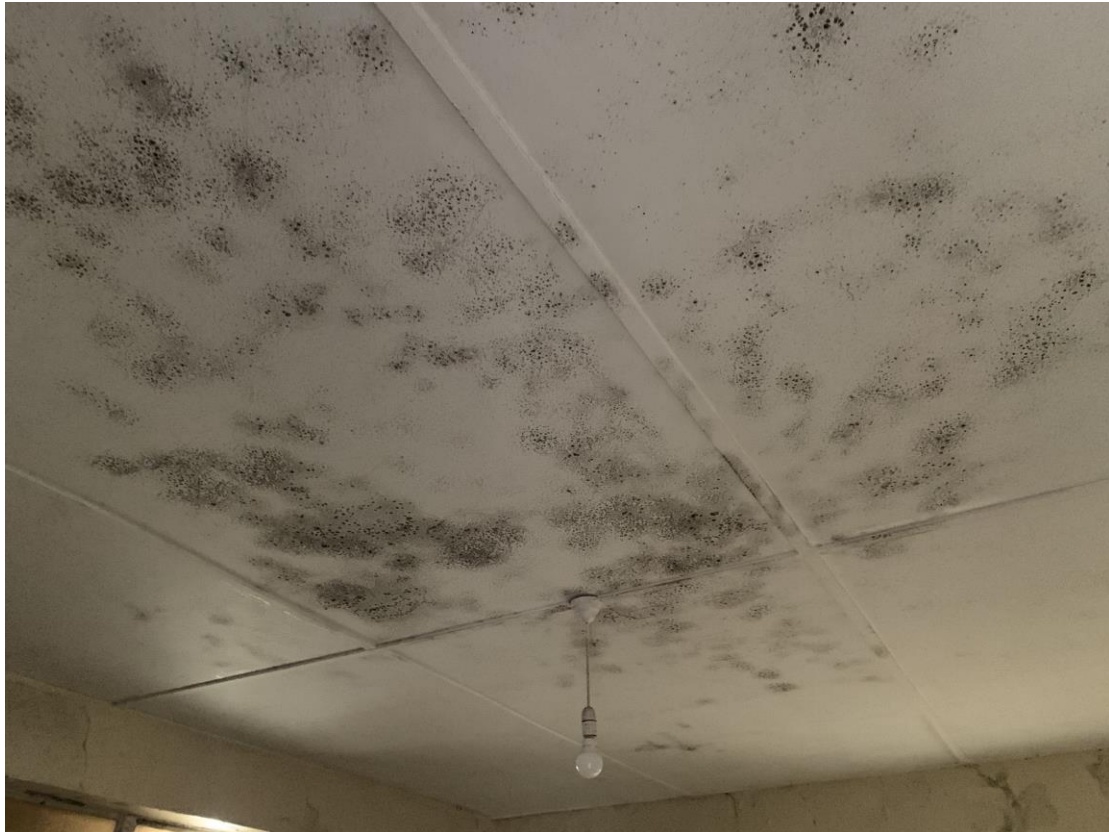
Photograph showing extensive staining, black mould growth and discolouration to ceiling to changing room to right side of property.

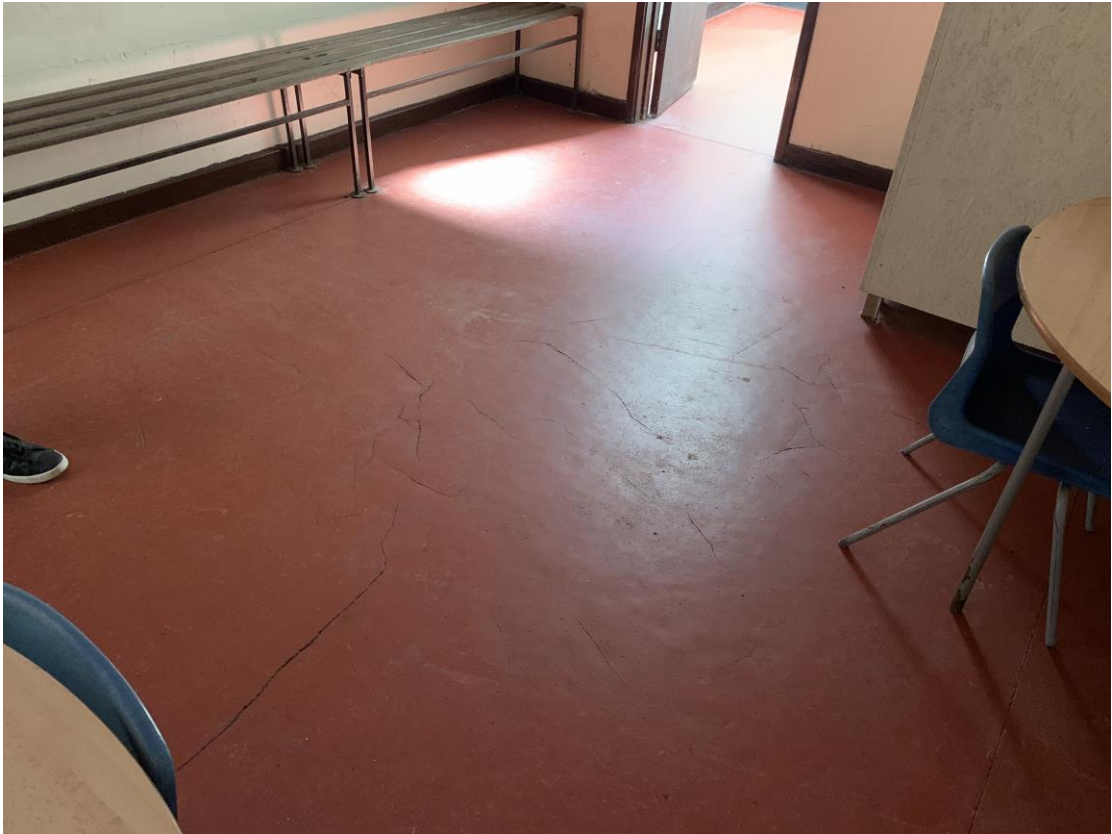
Photograph showing example of undulations and cracking to the flooring to changing room area.

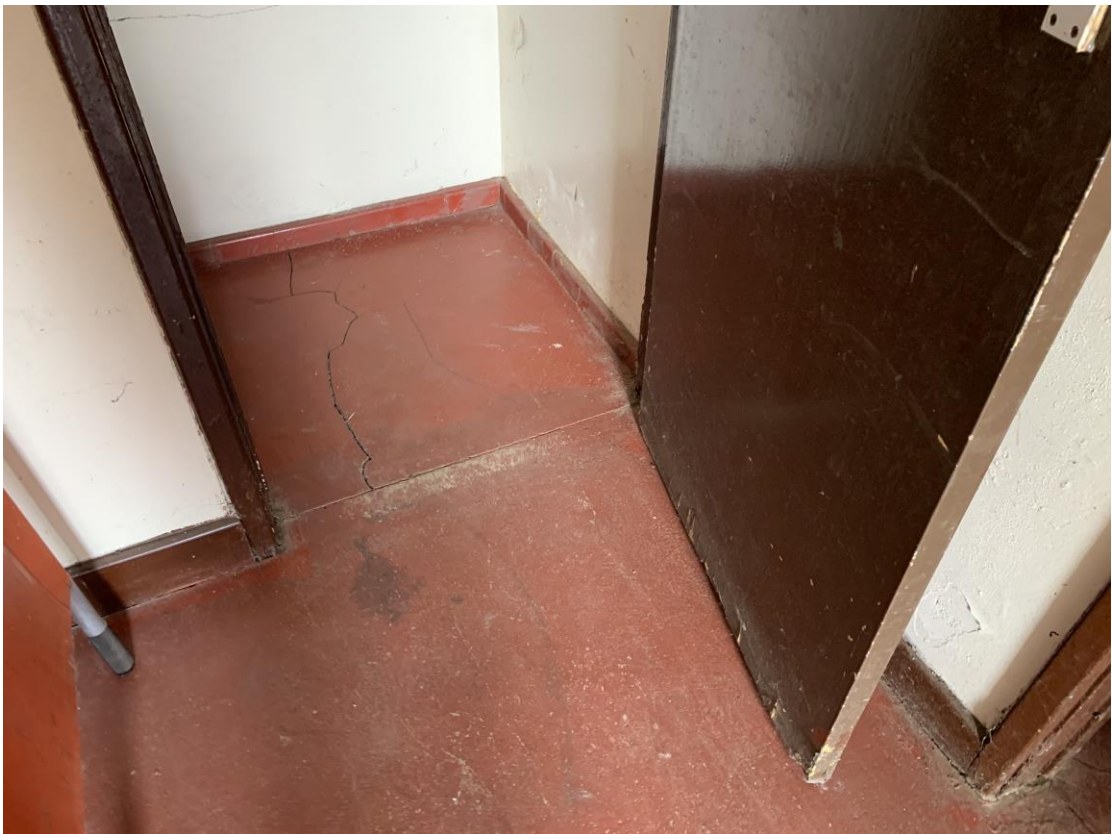
Photograph showing typical example of a crack within flooring.

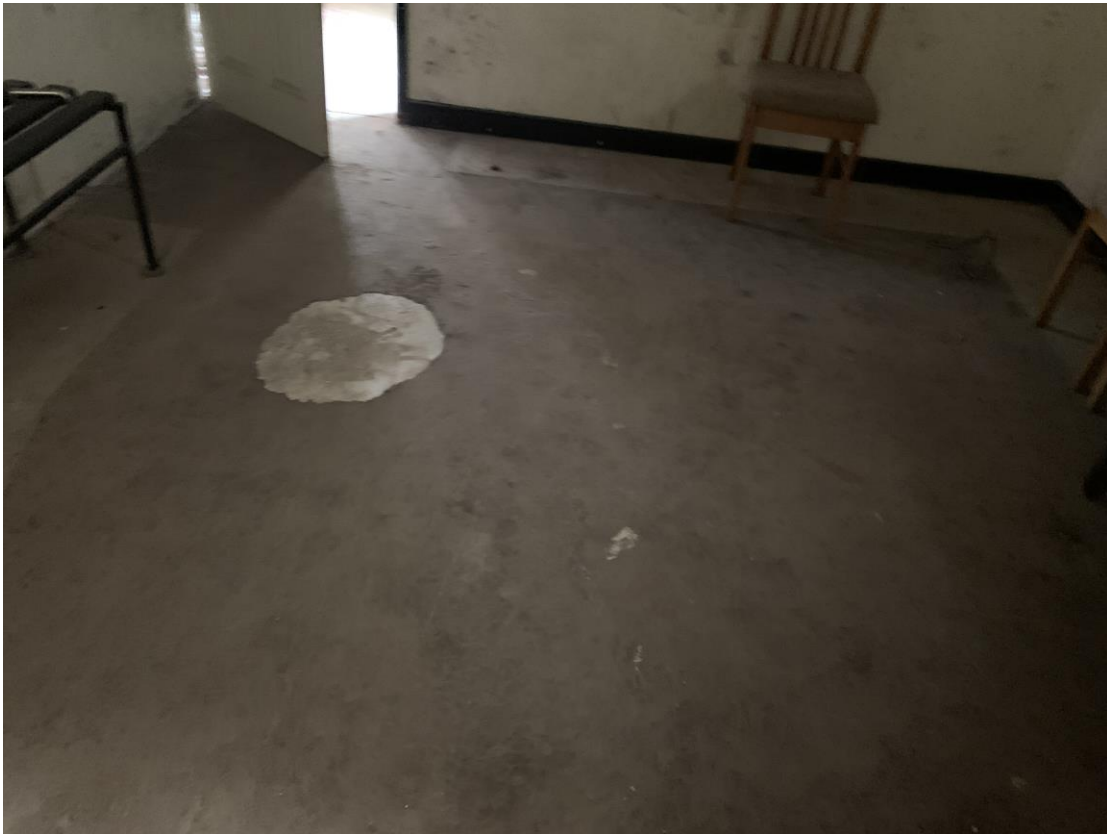
Photograph showing example of a proprietary floor coating that is subject to deterioration and de-bonding.

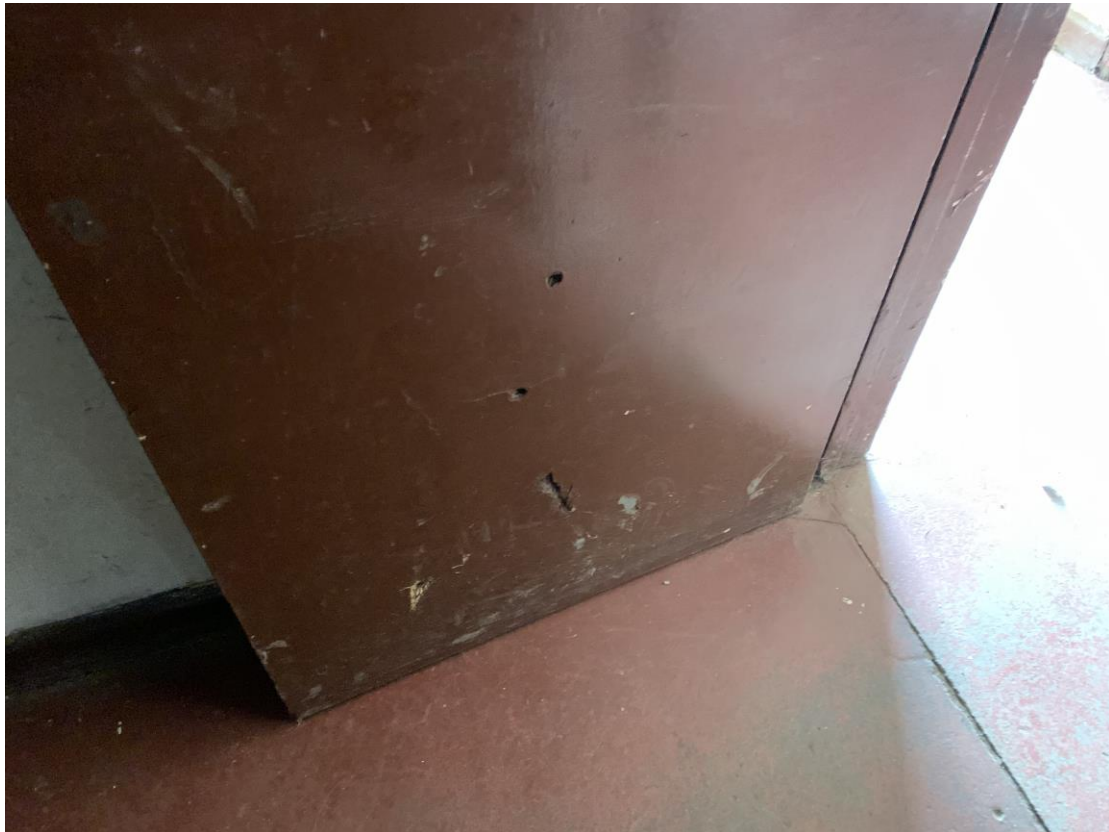
Photograph showing typical example of a door to base to one of the changing rooms.
