In Respect Of:-

**Llangeinor Football Club, Bettws Road,
Bridgend CF32 8PG**

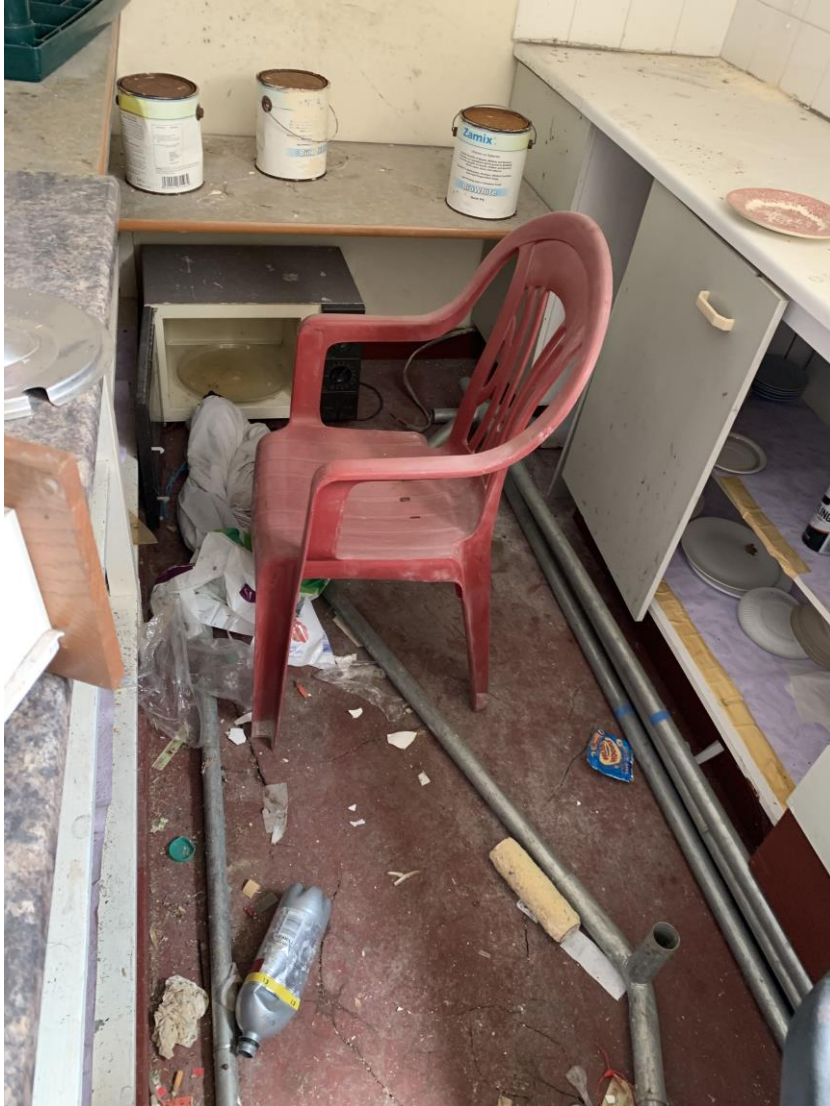
Photograph showing example of the poor condition and order to the fitted kitchen units.
