Bridgend County Borough Council

Section 19 Flood Investigation Report

Unnamed Storm – 6th to 7th September 2024

Document Ref – FRM – S19 – 06&07/09/2024 - 01

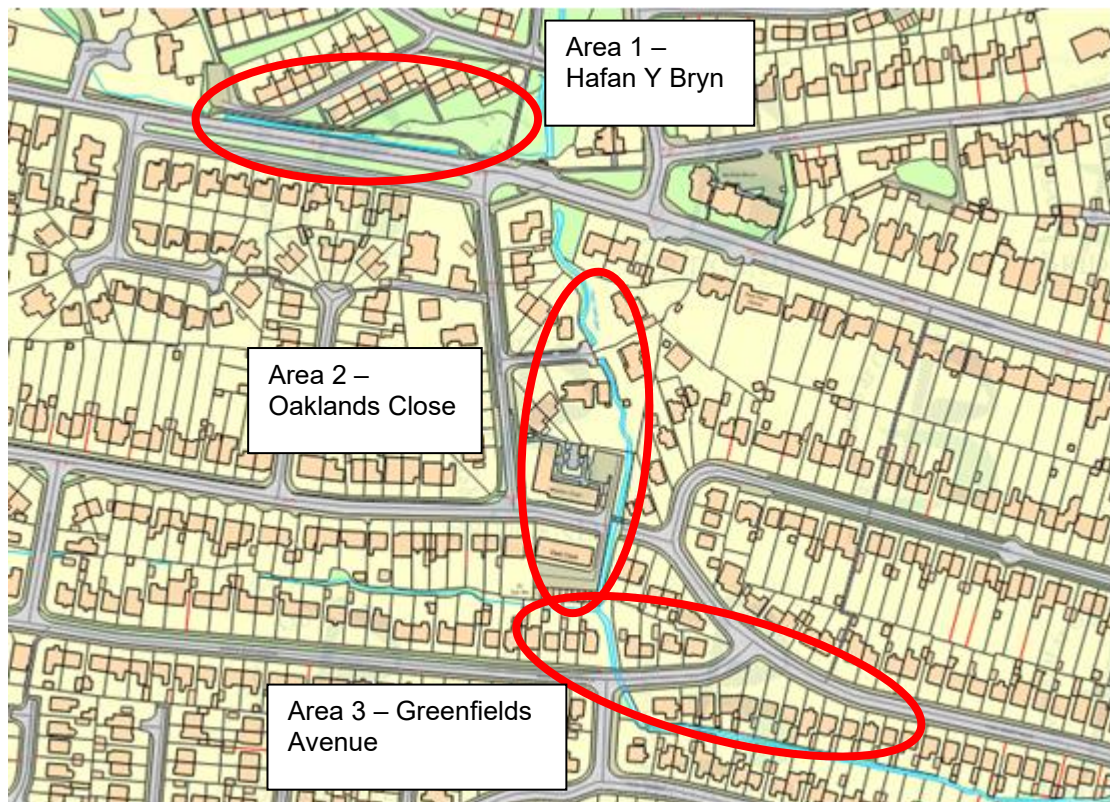
Figure 16 – Bryntirion Flood Areas

Figure 16 outlines the flood investigations areas in the Bryntirion area, which have been divided into three areas, Hafan Y Bryn, Oaklands Close/Western Court Flats/Park Court Flats and Greenfields Avenue/Park Court Road.

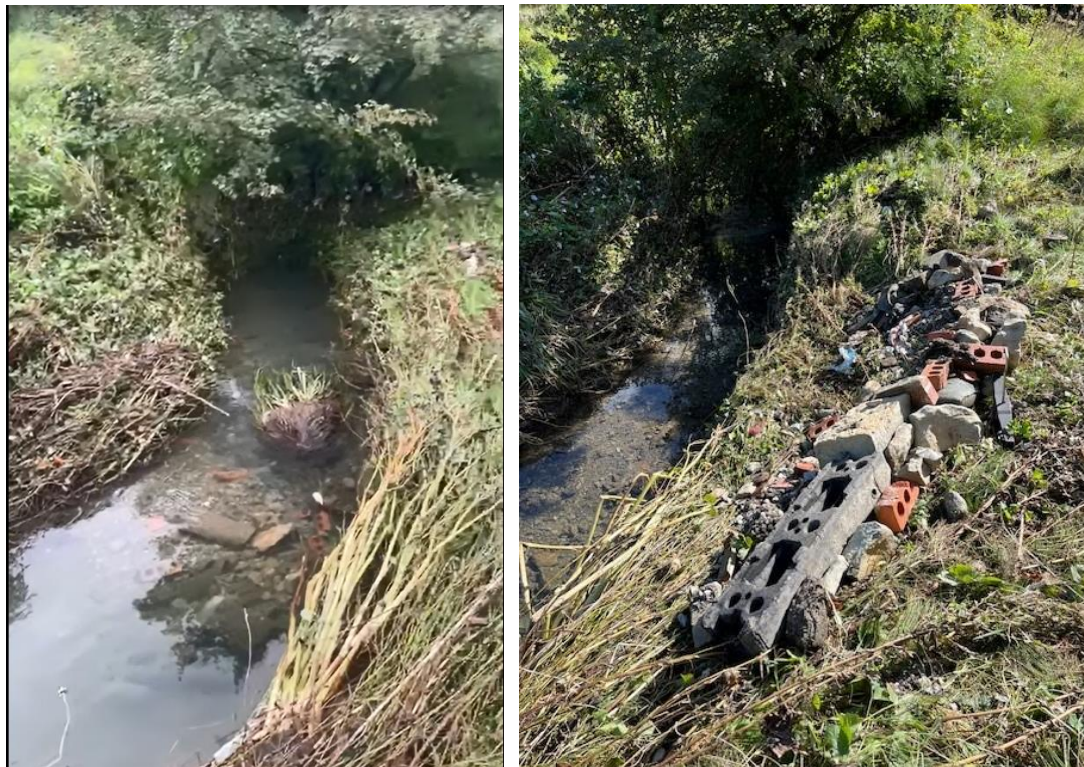
Figures 20 & 21 – Caer Castell House, Brackla – Nant Pontysanau Debris

Figure 20 identifies debris within the Nant Pontysanau prior to the storm event. Figure 21 identifies the debris that was subsequently removed following the storm events. Although debris was identified in the watercourse it was below the dry weather flow level, which is dictated by concrete weirs within the watercourse.

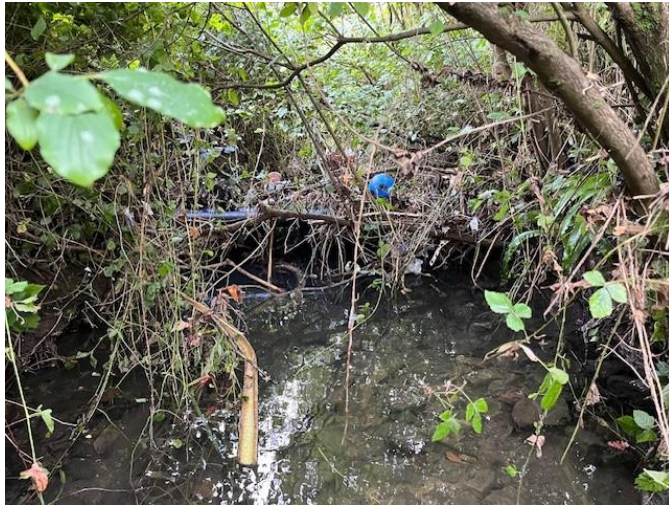
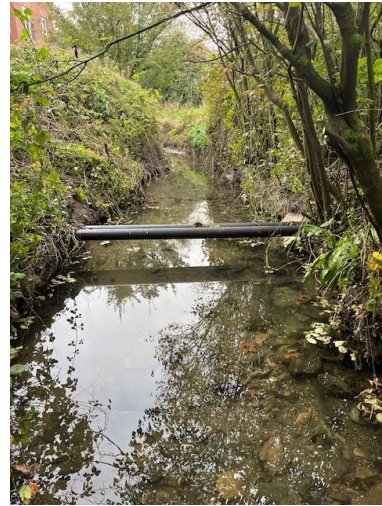
Figures 22 & 23 – Caer Castell House, Brackla – Nant Pontysanau Storm Debris

Figure 22 identifies storm debris within the Nant Pontysanau, which was subsequently removed by BCBC following the storm event, as shown in Figure 23.

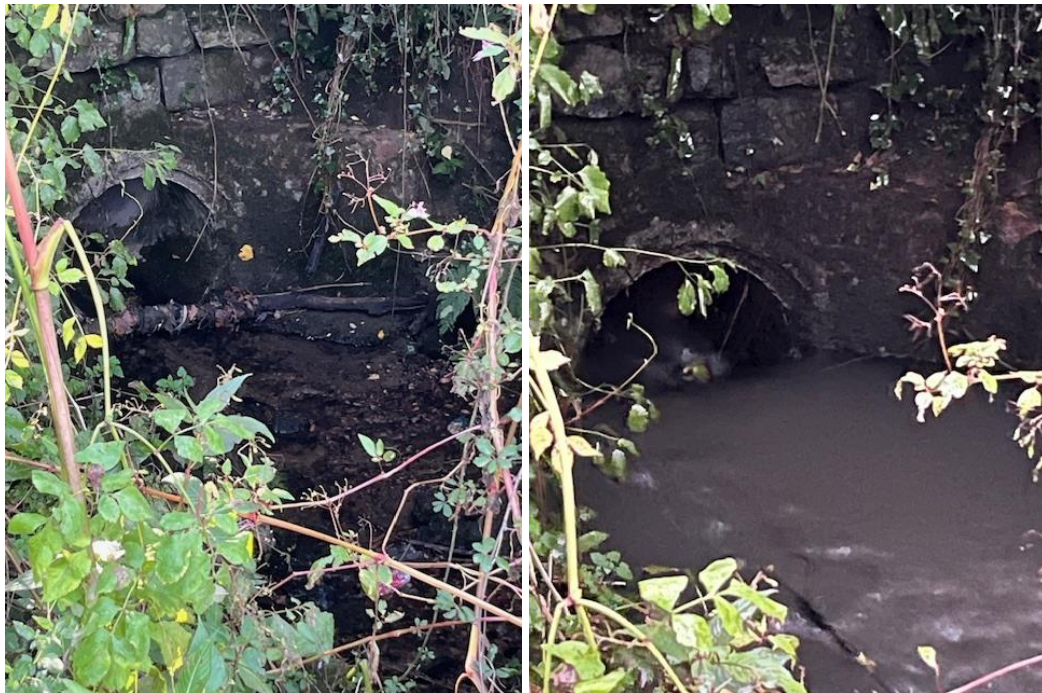
Figures 24 & 25 Network Rail Culvert downstream

Figures 24 & 25 identify the Network Rail culvert located downstream of the Brackla flood investigation area.

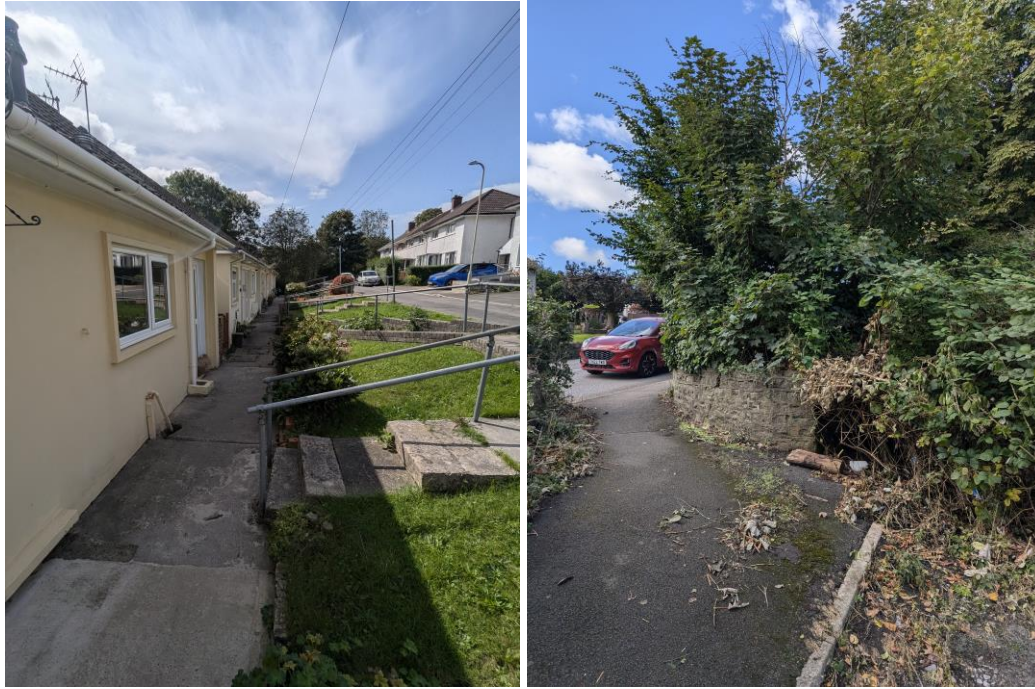
Figure 26 & 27 – Hafan Y Bryn Properties & Culvert Inlet Post Vegetation Clearance

Figure 26 identifies the bungalows that were subjected to flooding on Hafan y Bryn. Figure 27 identifies the location of the inlet to the culverted watercourse located to the west of Hafan Y Bryn. On inspection of the area and the general topography it is noted that there is a gap within the hedge line, which it is believed has been created to allow the flood water to disperse and acts as an exceedence route when the culvert capacity is exceeded.

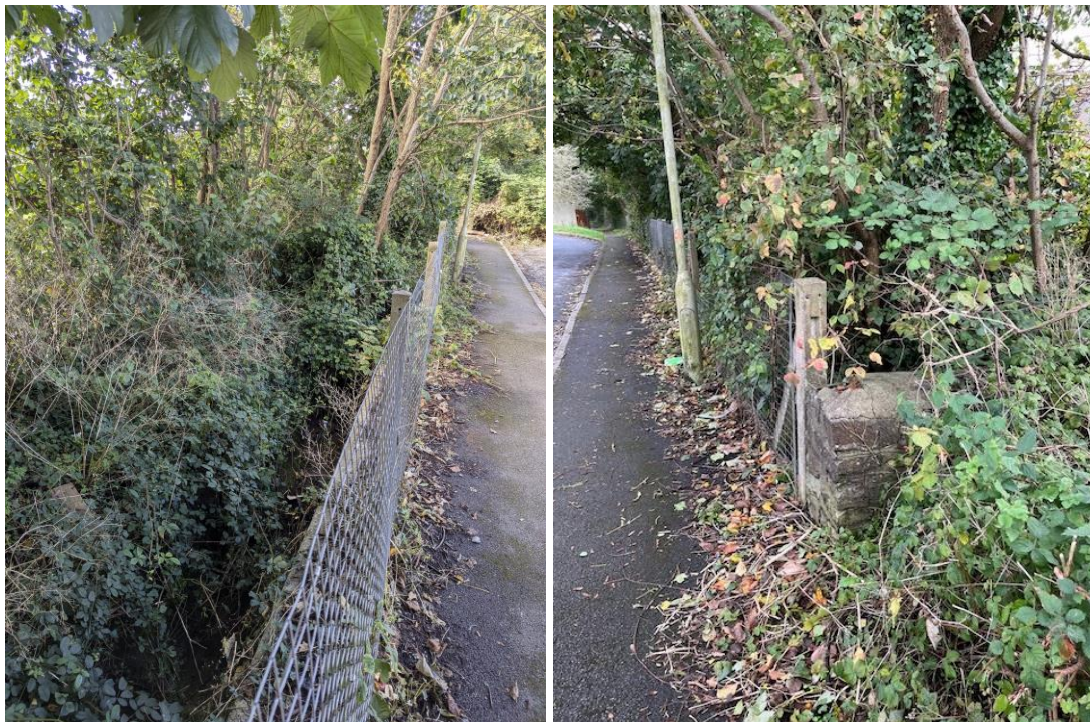
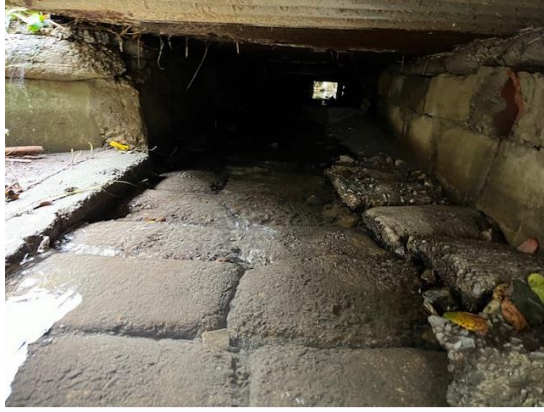
Figure 28 & 29 – Hafan Y Bryn Unnamed Watercourse

Figures 28 & 29 identifies the unnamed watercourse located south of Hafan Y Bryn.

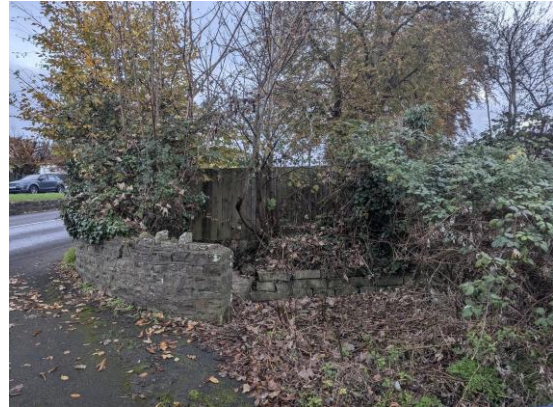
Figures 30 & 31 – Hafan Y Bryn Inlet Post Vegetation Clearance

Figures 30 & 31 identifies the Hafan y Bryn culvert inlet following vegetation clearance. No debris was identified within the culvert, indicating that hydraulic overload was the primary cause of flooding at this location.

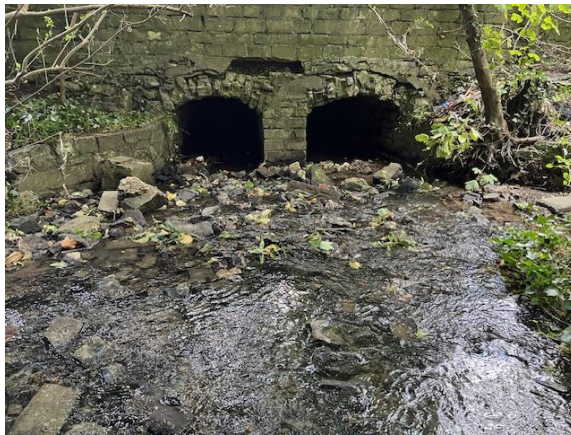
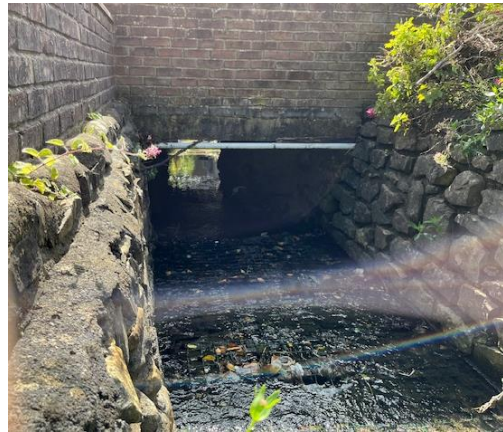
Figure 32 & 33 – Culverted watercourses Upstream of Oaklands Close

Figure 32 & 33 identifies the culvert inlets to two culverted watercourses upstream of Oaklands Close. Both culverts beneath Park Street and Oaklands Close were clear during the post storm inspection indicating that hydraulic overload was the primary cause of flooding at this location.
